STREAM INVENTORY REPORT

Johnson Creek, South Fork Big River, 2002

CALIFORNIA DEPARTMENT OF FISH AND GAME

2003

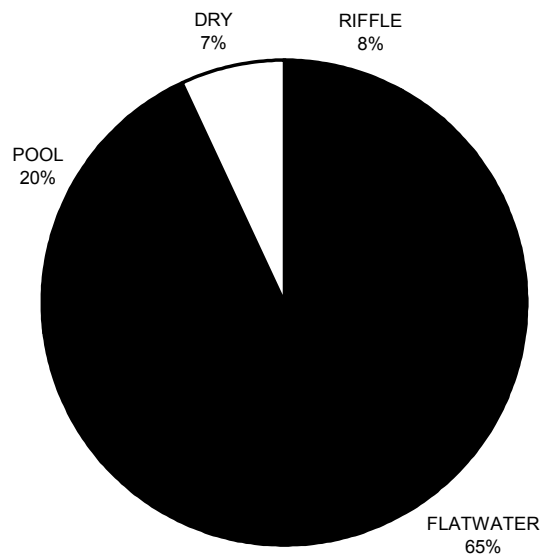
GRAPH 2

Table 1 summarizes the Level II riffle, flatwater, and pool habitat types. Based on frequency of occurrence there were 45% pool units, 35% flatwater units, 12% riffle units, and 9% dry units (Graph 1). Based on total length of Level II habitat types there were 65% flatwater units, 20% pool units, 8% riffle units, and 7% dry units (Graph 2).

Flatwater habitat types comprised 65% of the total length of this survey, pools 20%, riffles 8%, and dry channels 7%. The pools are relatively shallow, with only 17 of the 49 (35%) pools having a maximum depth greater than 2 feet. In general, pool enhancement projects are considered when primary pools comprise less than 40% of the length of total stream habitat. In first and second order streams, a primary pool is defined to have a maximum depth of at least two feet, occupy at least half the width of the low flow channel, and be as long as the low flow channel width. Installing structures that will increase or deepen pool habitat is recommended for

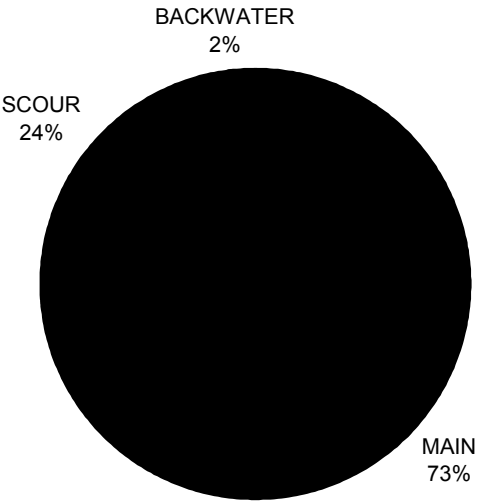
GRAPH 4

A total of 49 pools were identified (Table 3). Main channel pools were the most frequently encountered, at 73%, and comprised 75% of the total length of all pools (Graph 4).

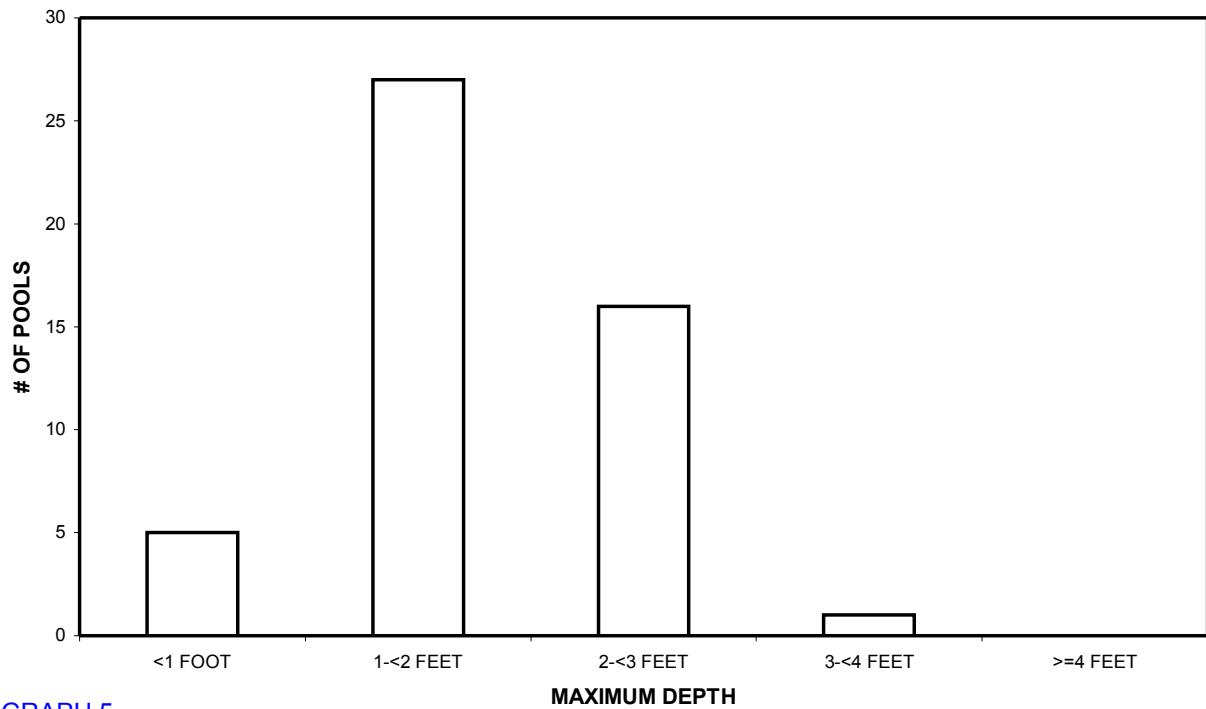
GRAPH 5

Table 4 is a summary of maximum pool depths by pool habitat types. Pool quality for salmonids increases with depth. Seventeen of the 49 pools (35%) had a depth of two feet or greater (Graph 5).

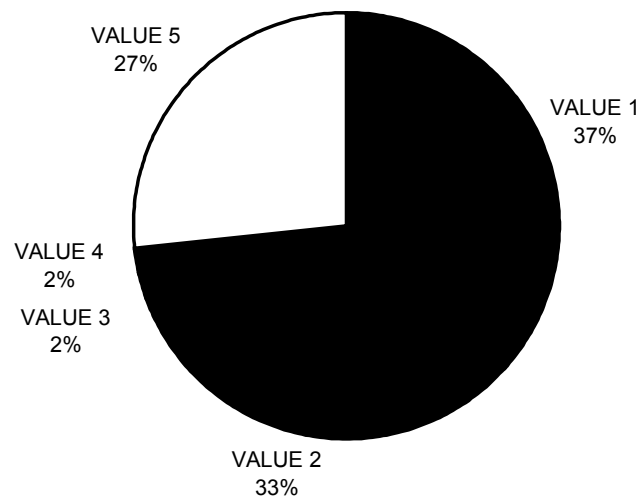
GRAPH 6

The depth of cobble embeddedness was estimated at pool tail-outs. Of the 49 pool tail-outs measured, 18 had a value of 1 (37%); 16 had a value of 2 (33%); 1 had a value of 3 (2%); 1 had a value of 4 (2%); and 13 had a value of 5 (27%) (Graph 6). On this scale, a value of 1 indicates the highest quality of spawning substrate.

Thirty-four of the 49 pool tail-outs measured had embeddedness ratings of 1 or 2. Two of the pool tail-outs had embeddedness ratings of 3 or 4. Thirteen of the pool tail-outs had a rating of 5, which is considered unsuitable for spawning. Cobble embeddedness measured to be 25% or less, a rating of 1, is considered to indicate good quality spawning substrate for salmon and steelhead. Sediment sources in Johnson Creek should be mapped and rated according to their potential sediment yields, and control measures should be taken.

- 5) Inventory and map sources of stream bank erosion and prioritize them according to present and potential sediment yield. Identified sites should then be treated to reduce the amount of fine sediments entering the stream.

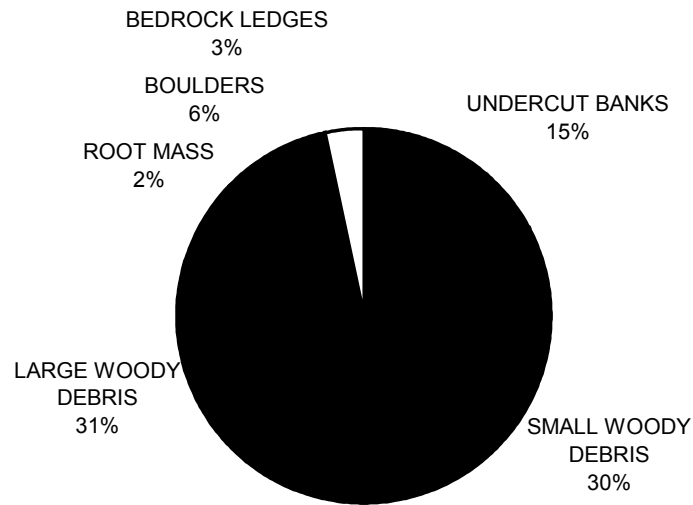
GRAPH 7

Table 5 summarizes mean percent cover by habitat type. Small woody debris is the dominant cover type in Johnson Creek. Graph 7 describes the pool cover in Johnson Creek. Large woody debris is the dominant pool cover type followed by small woody debris.

The mean shelter rating for pools was 51. The shelter rating in the flatwater habitats was 13. A pool shelter rating of approximately 100 is desirable. The amount of cover that now exists is being provided primarily by small woody debris in all habitat types. Additionally, large woody debris contributes a small amount. Increased log and root wad cover structures in the pool and flatwater habitats would enhance both summer and winter salmonid habitat. Log cover structure provides rearing fry with protection from predation, rest from water velocity, and also divides territorial units to reduce density related competition.

- 4) Increase woody cover in the pools and flatwater habitat units. Much of the existing cover is from small woody debris. Adding high quality complexity with log and root wad cover is desirable.

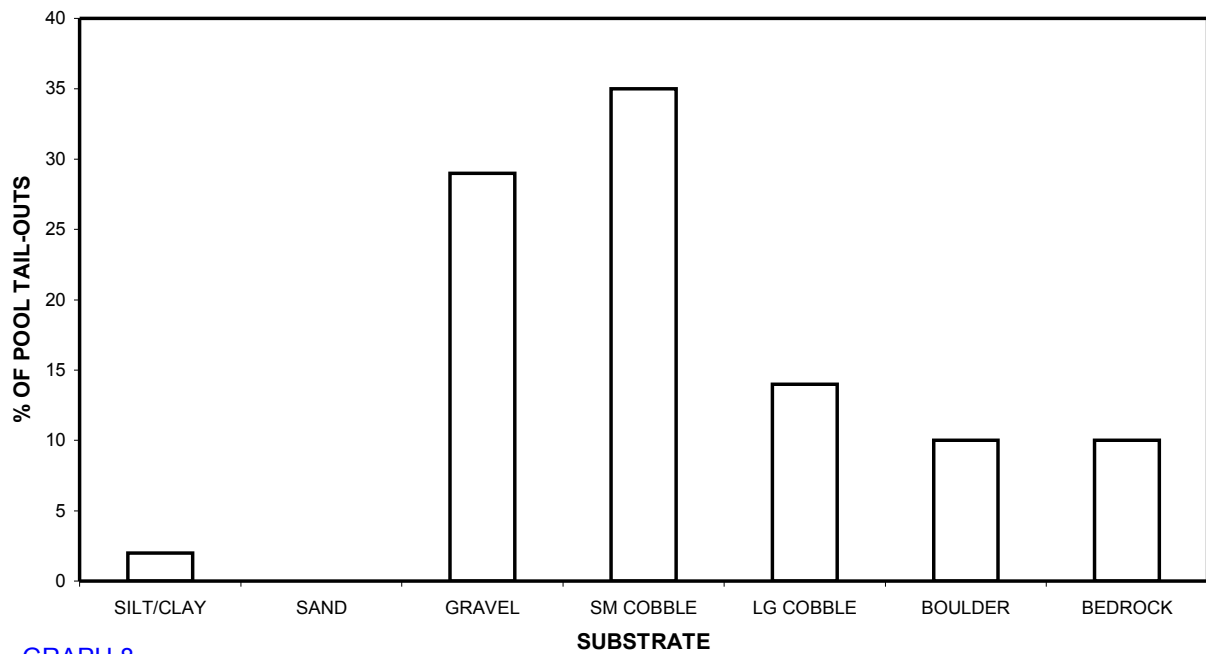
GRAPH 8

Table 6 summarizes the dominant substrate by habitat type. Graph 8 depicts the dominant substrate observed in pool tail-outs. Small cobble was the dominant substrate observed in 35% of pool tail-outs while gravel was the next most frequently observed substrate type, at 29%.

Thirty-one of the 49 pool tail-outs measured had gravel or small cobble as the dominant substrate. This is generally considered good for spawning salmonids.

- 8) Suitable size spawning substrate on Johnson Creek is limited to relatively few reaches. Projects should be designed at suitable sites to trap and sort spawning gravel.

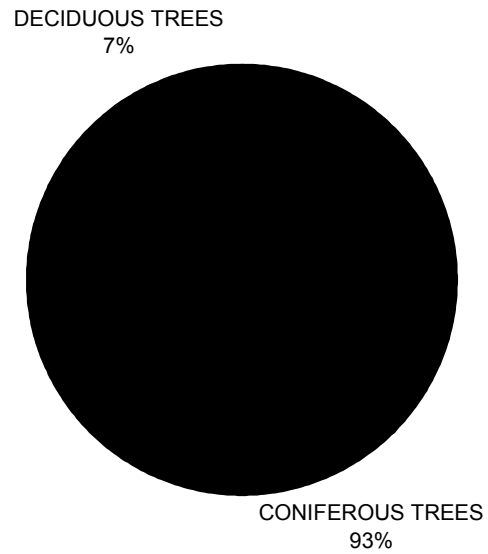
GRAPH 9

The mean percent canopy density for the surveyed length of Johnson Creek was 71%. The mean percentages of deciduous and coniferous trees were 7% and 93%, respectively. Graph 9 describes the mean percent canopy in Johnson Creek.

The mean percent canopy density for the stream was 77%. In general, revegetation projects are considered when canopy density is less than 80%.

- 7) Increase the canopy on Johnson Creek by planting willow, alder, redwood, and Douglas fir along the stream where shade canopy is not at acceptable levels. The reaches above this survey section should be inventoried and treated as well, since the water flowing here is affected from upstream. In many cases, planting will need to be coordinated to follow bank stabilization or upslope erosion control projects.

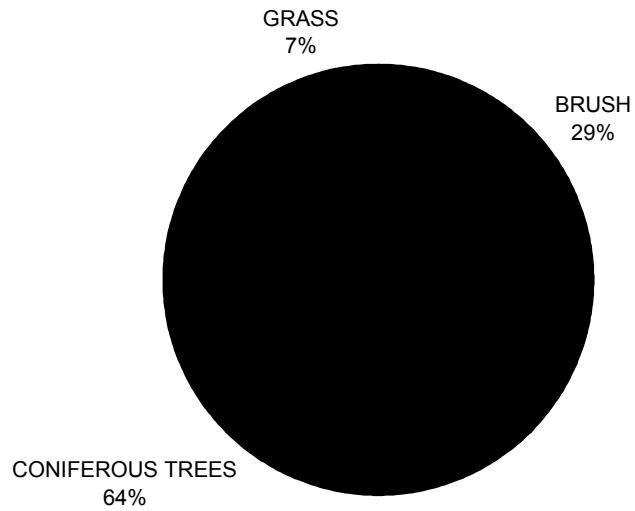
GRAPH 11

For the stream reach surveyed, the mean percent right bank vegetated was 70%. The mean percent left bank vegetated was 70%. The dominant elements composing the structure of the stream banks consisted of 55% sand/silt/clay, 24% cobble/gravel, 19% bedrock, and 2% boulder, (Graph 10). Coniferous trees were the dominant vegetation type observed in 64% of the units surveyed. Additionally, 29% of the units surveyed had brush as the dominant vegetation type, and 7% had grass as the dominant vegetation (Graph 11).

The percentage of right and left bank covered with vegetation was moderate at 70% and 70%, respectively. In areas of stream bank erosion or where bank vegetation is not at acceptable levels, planting endemic species of coniferous and deciduous trees, in conjunction with bank stabilization, is recommended.
