NORTH COAST WATERSHED AND FISHERY IMPROVEMENT PROGRAM

STREAM INVENTORY REPORT

North Fork Ramon Creek, Ramon Creek, 2002

CALIFORNIA DEPARTMENT OF FISH AND GAME

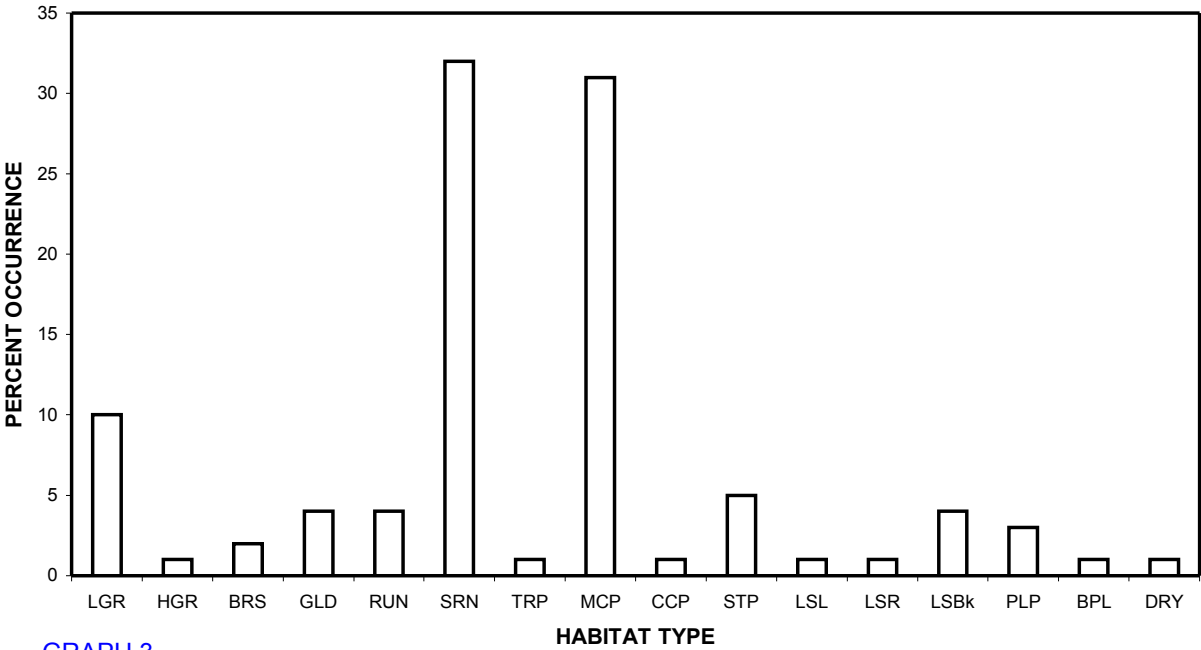
GRAPH 3

Seventeen Level IV habitat types were identified (Table 2). The most frequent habitat types by percent occurrence were mid-channel pools, 31%; step runs, 32%; and low gradient riffles, 10% (Graph 3). Based on percent total length, step runs made up 65%, mid-channel pools, 12%, and low gradient riffles, 10%.

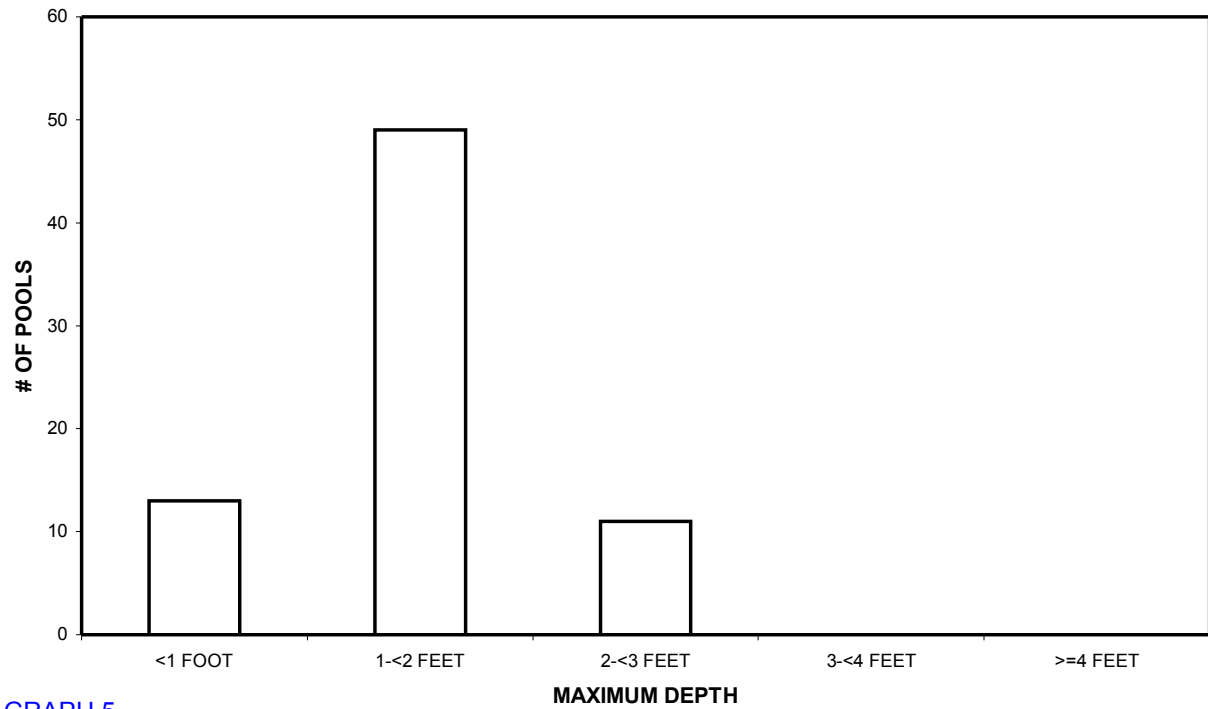
GRAPH 5

Table 4 is a summary of maximum pool depths by pool habitat types. Pool quality for salmonids increases with depth. Eleven of the 73 pools (15%) had a depth of two feet or greater (Graph 5).

Flatwater habitat types comprised 69% of the total length of this survey, riffles 11%, and pools 19%. The pools are relatively shallow, with 11 of the 73 (15%) pools having a maximum depth greater than 2 feet. In general, pool enhancement projects are considered when primary pools comprise less than 40% of the length of total stream habitat. In first and second order streams, a primary pool is defined to have a maximum depth of at least two feet, occupy at least half the width of the low flow channel, and be as long as the low flow channel width. Installing structures that will increase or deepen pool habitat is recommended for locations where their installation will not be threatened by high stream energy, or where their installation will not conflict with the modification of the numerous log debris accumulations (LDA's) in the stream.

- 3) Where feasible, design and engineer pool enhancement structures to increase the number of pools. This must be done where the banks are stable or in conjunction with stream bank armor to prevent erosion.

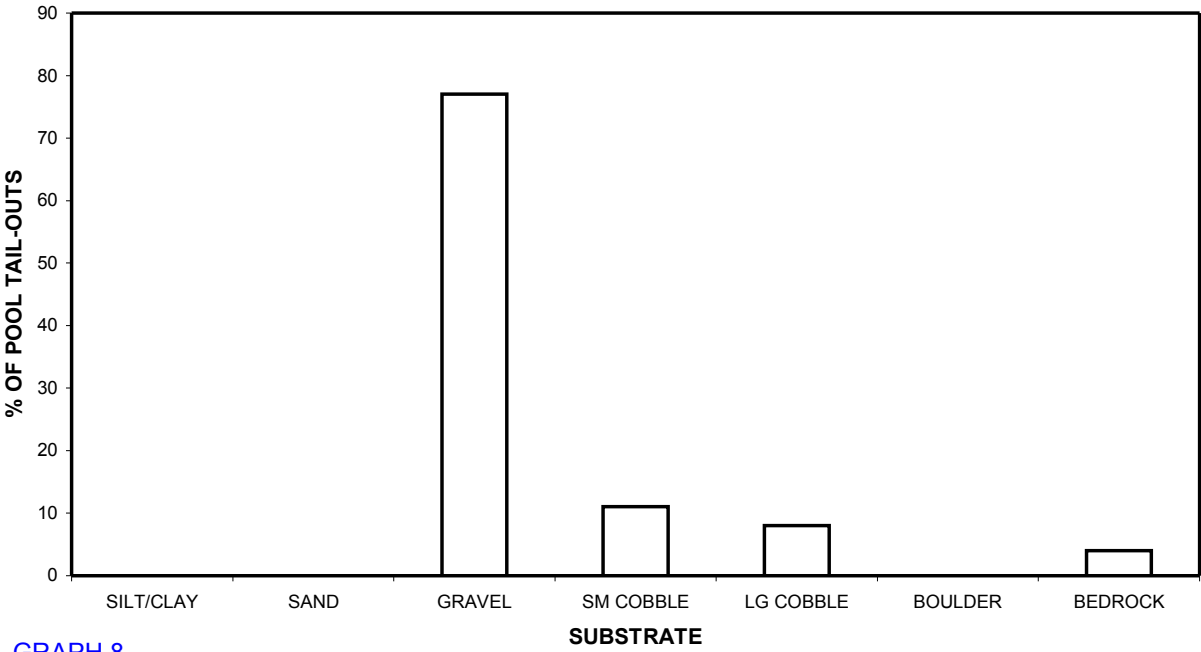
GRAPH 8

Table 6 summarizes the dominant substrate by habitat type. Graph 8 depicts the dominant substrate observed in pool tail-outs. Gravel was the dominant substrate observed in 77% of pool tail-outs while small cobble was the next most frequently observed substrate type, at 11%.

Sixty-four of the 73 pool tail-outs measured had gravel or small cobble as the dominant substrate. This is generally considered good spawning salmonids.

- 8) Suitable size spawning substrate on North Fork Ramon Creek is limited to relatively few reaches. Projects should be designed at suitable sites to trap and sort spawning gravel.
