NORTH COAST WATERSHED AND FISHERY IMPROVEMENT PROGRAM

STREAM INVENTORY REPORT

Left Bank Tributary to Martin Creek, Big River, 2002

CALIFORNIA DEPARTMENT OF FISH AND GAME

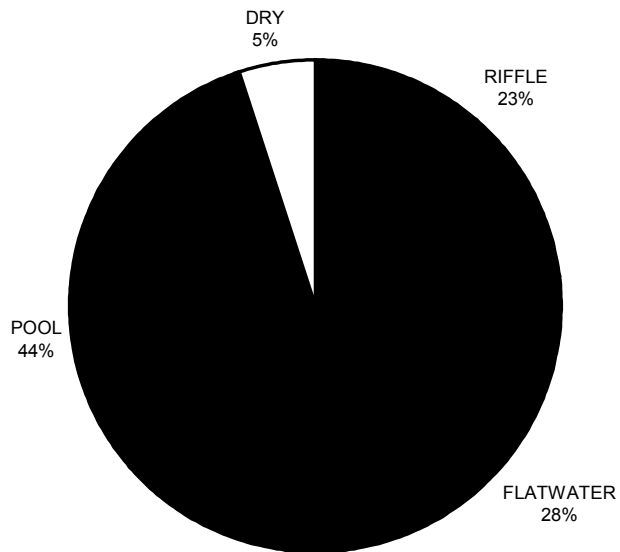
GRAPH 1

Table 1 summarizes the Level II riffle, flatwater, and pool habitat types. Based on frequency of occurrence there were 44% pool units, 28% flatwater units, 23% riffle units, and 5% dry units (Graph 1). Based on total length of Level II habitat types there were 47% flatwater units, 24% riffle units, 19% pool units, and 10% dry units (Graph 2).

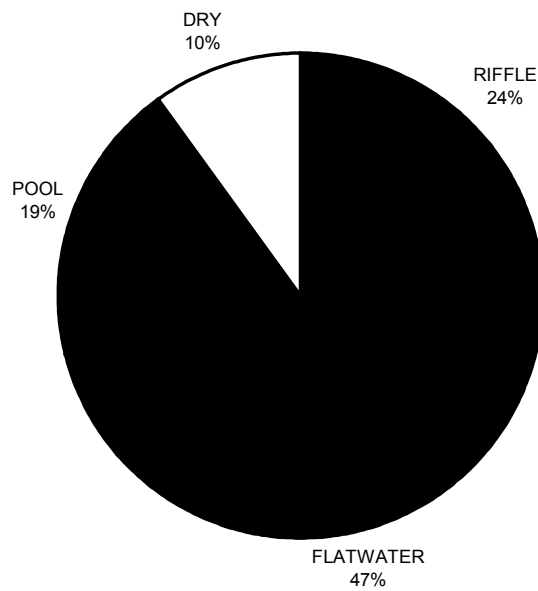
GRAPH 2

Flatwater habitat types comprised 47% of the total length of this survey, riffles 24%, pools 19%, and dry 10%. The pools are relatively shallow, with 8 of the 28 (29%) pools having a maximum depth greater than 2 feet. In general, pool enhancement projects are considered when primary pools comprise less than 40% of the length of total stream habitat. In first and second order streams, a primary pool is defined to have a maximum depth of at least two feet, occupy at least half the width of the low flow channel, and be as long as the low flow channel width. Installing structures that will increase or deepen pool habitat is recommended for locations where their installation will not be threatened by high stream energy, or where their installation will not conflict with the modification of the numerous log debris accumulations (LDA's) in the stream.

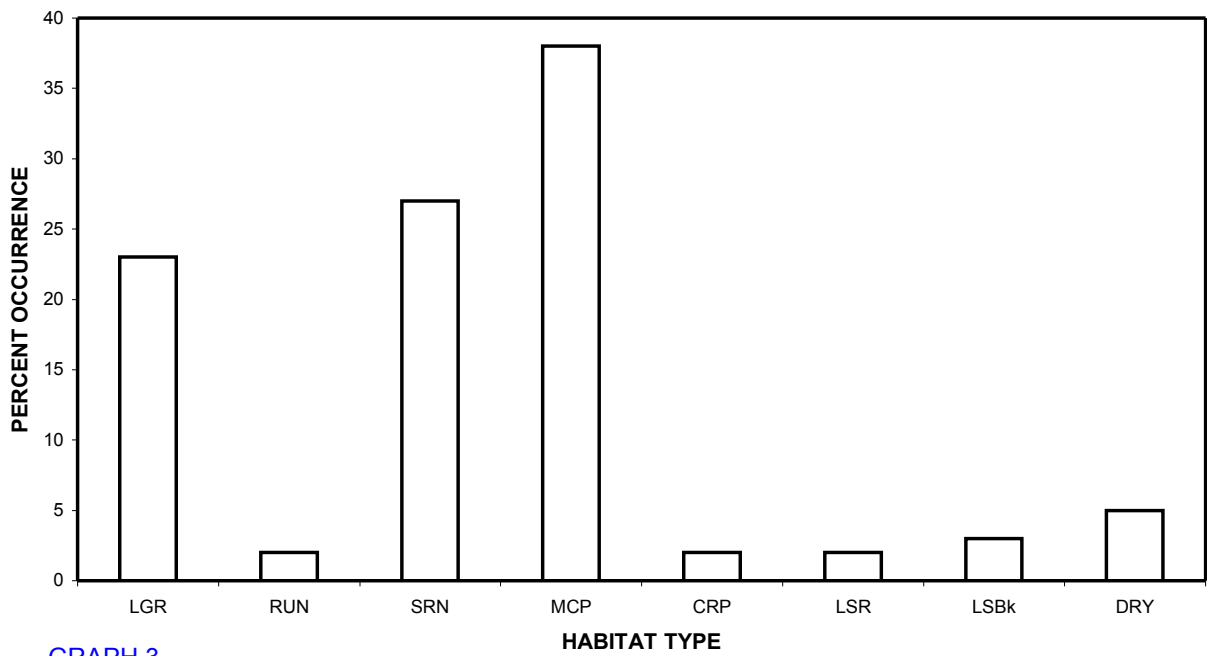
GRAPH 3

Eight Level IV habitat types were identified (Table 2). The most frequent habitat types by percent occurrence were mid-channel pools, 38%; step runs, 27%; and low gradient riffles, 23% (Graph 3). Based on percent total length, step runs made up 45%, low gradient riffles 24%, mid channel pools 15%, and dry 10%.

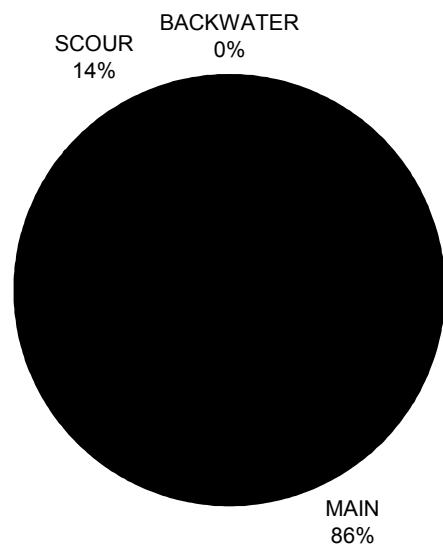
GRAPH 4

A total of 28 pools were identified (Table 3). Main channel pools were the most frequently encountered, at 86%, and comprised 78% of the total length of all pools (Graph 4).

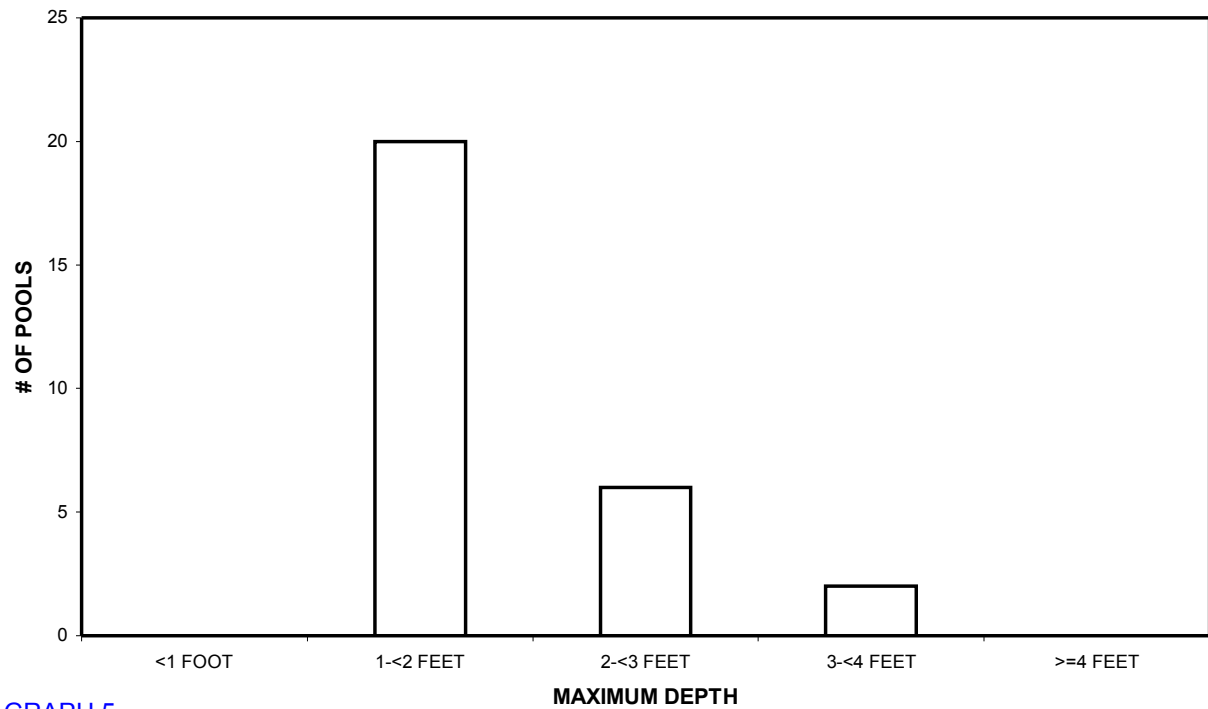
GRAPH 5

Table 4 is a summary of maximum pool depths by pool habitat types. Pool quality for salmonids increases with depth. Eight of the 28 pools (29%) had a depth of two feet or greater (Graph 5).

- 3) Where feasible, design and engineer pool enhancement structures to increase the number of pools. This must be done where the banks are stable or in conjunction with stream bank armor to prevent erosion.

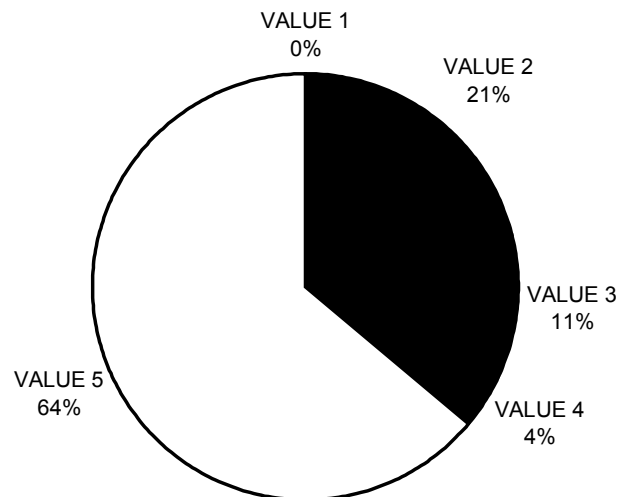
GRAPH 6

The depth of cobble embeddedness was estimated at pool tail-outs. Of the 28 pool tail-outs measured, 0 had a value of 1 (0%); 6 had a value of 2 (21%); 3 had a value of 3 (11%); 1 had a value of 4 (4%); and 18 had a value of 5 (64%) (Graph 6). On this scale, a value of 1 indicates the highest quality of spawning substrate.

Six of the 28 pool tail-outs measured had embeddedness ratings of 1 or 2. Four of the pool tail-outs had embeddedness ratings of 3 or 4. Eighteen of the pool tail-outs had a rating of 5, which is considered unsuitable for spawning. Cobble embeddedness measured to be 25% or less, a rating of 1, is considered to indicate good quality spawning substrate for salmon and steelhead. Sediment sources in Left Bank Tributary to Martin Creek should be mapped and rated according to their potential sediment yields, and control measures should be taken.

- 5) Inventory and map sources of stream bank erosion and prioritize them according to present and potential sediment yield. Identified sites should then be treated to reduce the amount of fine sediments entering the stream.

- 6) Active and potential sediment sources related to the road system need to be identified, mapped, and treated according to their potential for sediment yield to the stream and its tributaries.

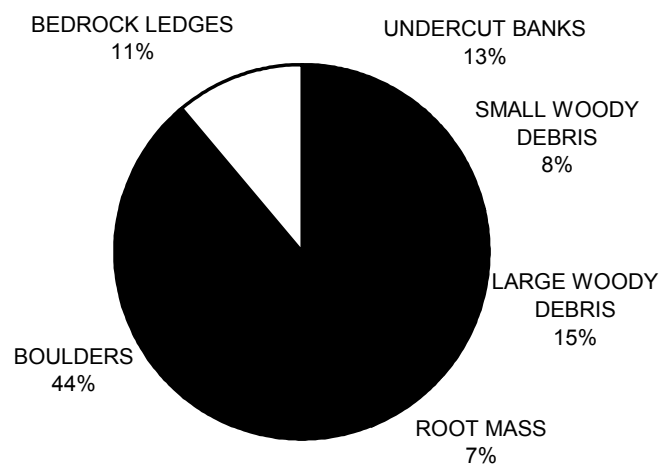
GRAPH 7

Table 5 summarizes mean percent cover by habitat type. Boulders are the dominant cover types in Left Bank Tributary to Martin Creek. Graph 7 describes the pool cover in Left Bank Tributary to Martin Creek. Boulders are the dominant pool cover type followed by large woody debris.

The mean shelter rating for pools was 25. The shelter rating in the flatwater habitats was 29. A pool shelter rating of approximately 100 is desirable. The amount of cover that now exists is being provided primarily by boulders in all habitat types. Additionally, large woody debris contributes a small amount. Log and root wad cover structures in the pool and flatwater habitats would enhance both summer and winter salmonid habitat. Log cover structure provides rearing

- 4) Increase woody cover in the pools and flatwater habitat units. Much of the existing cover is from boulders. Adding high quality complexity with log and root wad cover is desirable.

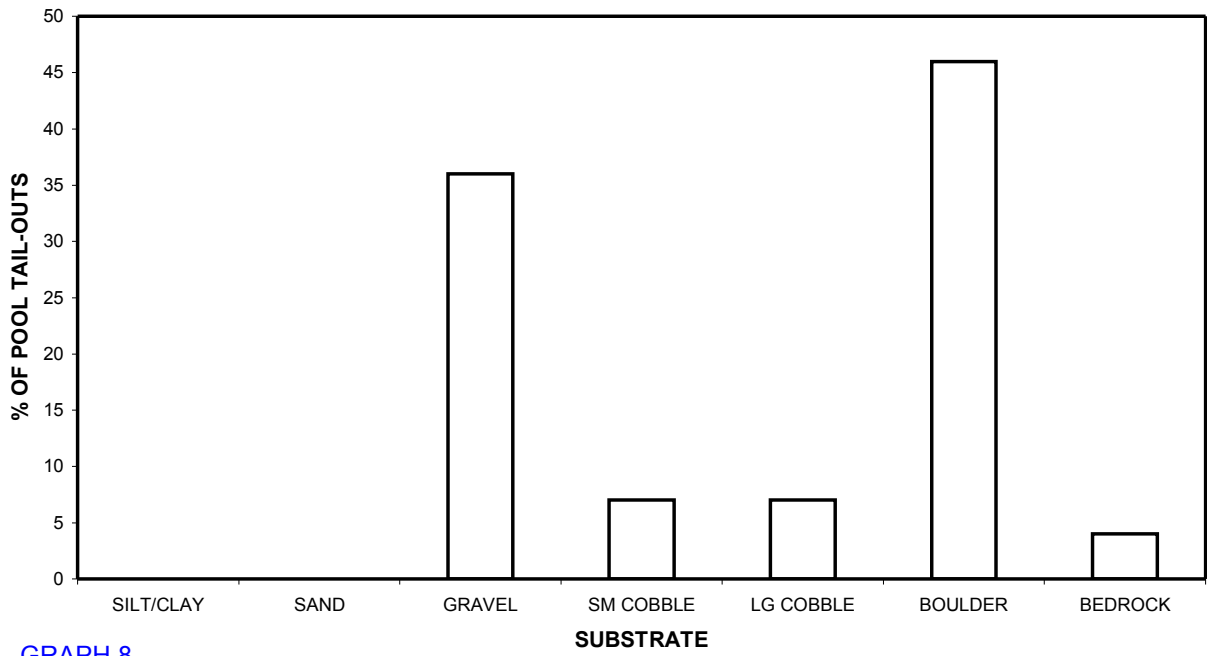
GRAPH 8

Table 6 summarizes the dominant substrate by habitat type. Graph 8 depicts the dominant substrate observed in pool tail-outs. Boulders were the dominant substrate observed in 46% of pool tail-outs while gravel was the next most frequently observed substrate type, at 36%.

Twenty-four of the 28 pool tail-outs measured had sand/silt/clay, large cobble, boulders or bedrock as the dominant substrate. This is generally considered unsuitable for spawning salmonids.

- 8) Suitable size spawning substrate on is limited to relatively few reaches. Projects should be designed at suitable sites to trap and sort spawning gravel.

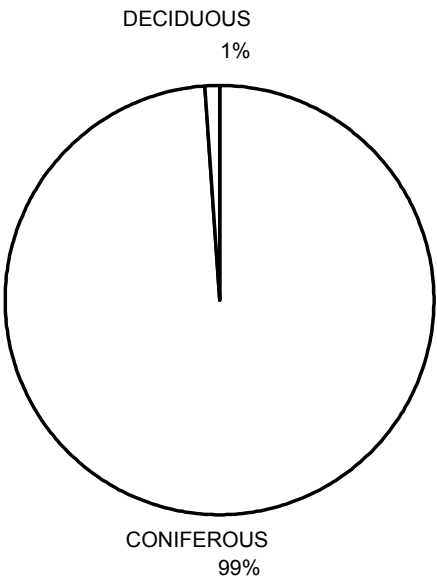
GRAPH 9

The mean percent canopy density for the surveyed length of Left Bank Tributary to Martin Creek was 90%. The mean percentages of deciduous and coniferous trees were 1% and 99%, respectively. Graph 9 describes the mean percent canopy in Left Bank Tributary to Martin Creek.

The mean percent canopy density for the stream was 90%. In general, revegetation projects are considered when canopy density is less than 80%.

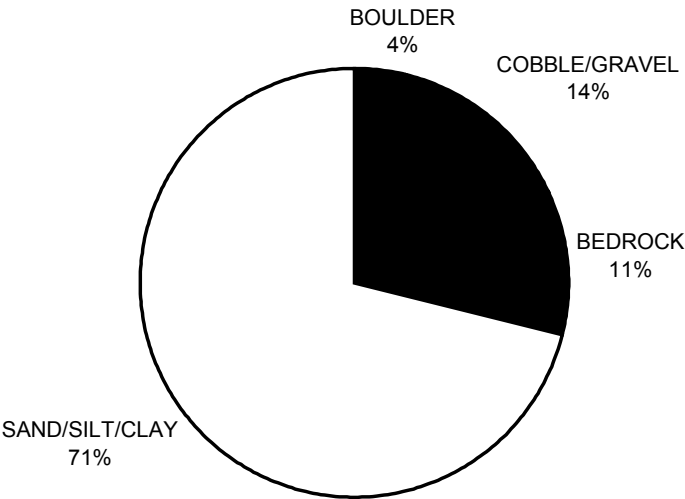
GRAPH 10

For the stream reach surveyed, the mean percent right bank vegetated was 58%. The mean percent left bank vegetated was 65%. The dominant elements composing the structure of the stream banks consisted of 71% sand/silt/clay, 14% cobble/gravel, 11% bedrock, and 4% boulder (Graph 10). Coniferous trees were the dominant vegetation type observed in 86% of the units surveyed. Additionally, 14% of the units surveyed had brush as the dominant vegetation type (Graph 11).

The percentage of right and left bank covered with vegetation was moderate at 58% and 65%, respectively. In areas of stream bank erosion or where bank vegetation is not at acceptable levels, planting endemic species of coniferous and deciduous trees, in conjunction with bank stabilization, is recommended.
