NORTH COAST WATERSHED AND FISHERY IMPROVEMENT PROGRAM

STREAM INVENTORY REPORT

Right Bank Tributary One to Martin Creek, Big River, 2002

CALIFORNIA DEPARTMENT OF FISH AND GAME

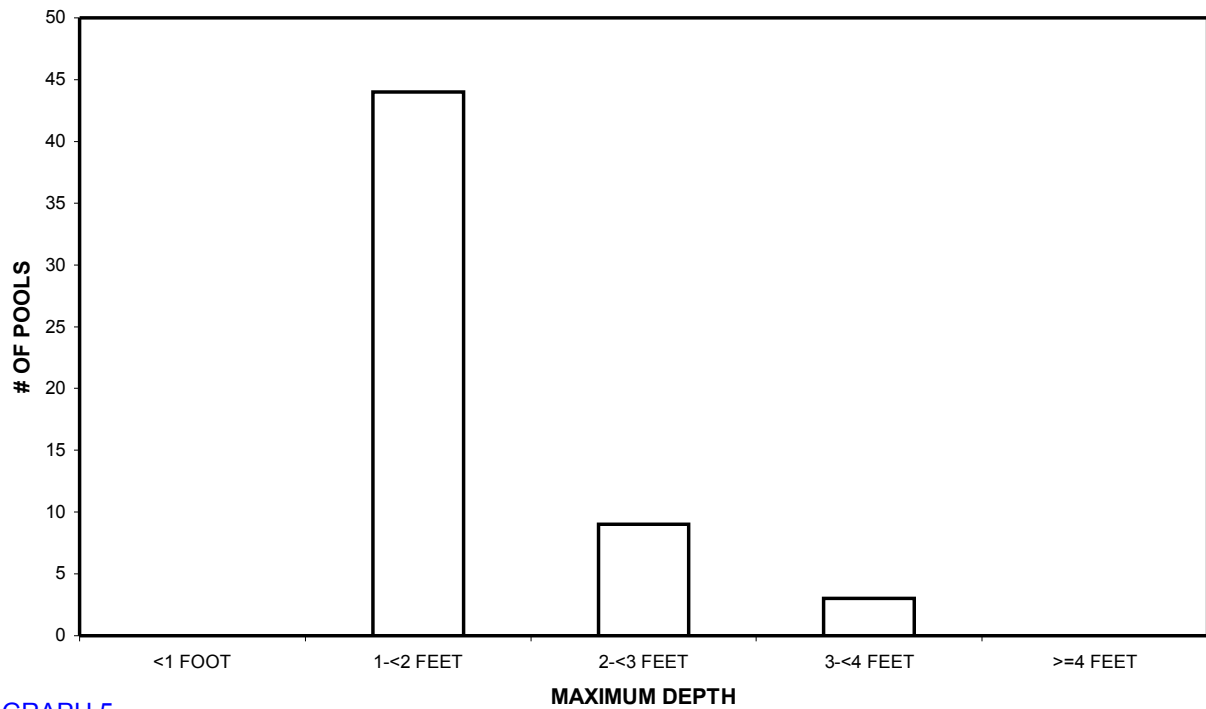
GRAPH 5

Table 4 is a summary of maximum pool depths by pool habitat types. Pool quality for salmonids increases with depth. Twelve of the 56 pools (21%) had a depth of two feet or greater (Graph 5).

Flatwater habitat types comprised 70% of the total length of this survey, riffles 14%, and pools 26%. The pools are relatively shallow, with 12 of the 56 (21%) pools having a maximum depth greater than 2 feet. In general, pool enhancement projects are considered when primary pools comprise less than 40% of the length of total stream habitat. In first and second order streams, a primary pool is defined to have a maximum depth of at least two feet, occupy at least half the width of the low flow channel, and be as long as the low flow channel width. Installing structures that will increase or deepen pool habitat is recommended for locations where their installation will not be threatened by high stream energy, or where their installation will not conflict with the modification of the numerous log debris accumulations (LDA's) in the stream.

- 3) Where feasible, design and engineer pool enhancement structures to increase the number of pools. This must be done where the banks are stable or in conjunction with stream bank armor to prevent erosion.

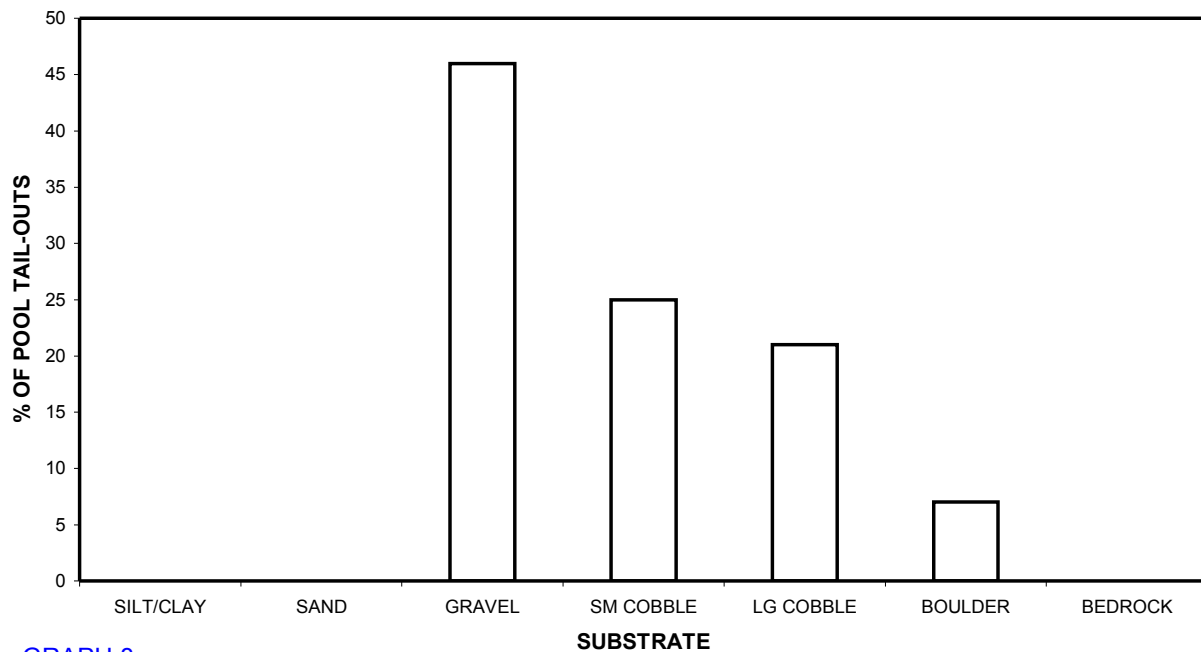
GRAPH 8

Table 6 summarizes the dominant substrate by habitat type. Graph 8 depicts the dominant substrate observed in pool tail-outs. Gravel was the dominant substrate observed in 46% of pool tail-outs while small cobble was the next most frequently observed substrate type, at 25%.

Forty of the 56 pool tail-outs measured had gravel and small cobble as the dominant substrate. This is generally considered good for spawning salmonids.

- 8) Suitable size spawning substrate on Right Bank Tributary One to Martin Creek is limited to relatively few reaches. Projects should be designed at suitable sites to trap and sort spawning gravel.
