STREAM INVENTORY REPORT

Right Bank Tributary Two to Martin Creek, Big River, 2002

CALIFORNIA DEPARTMENT OF FISH AND GAME

2003

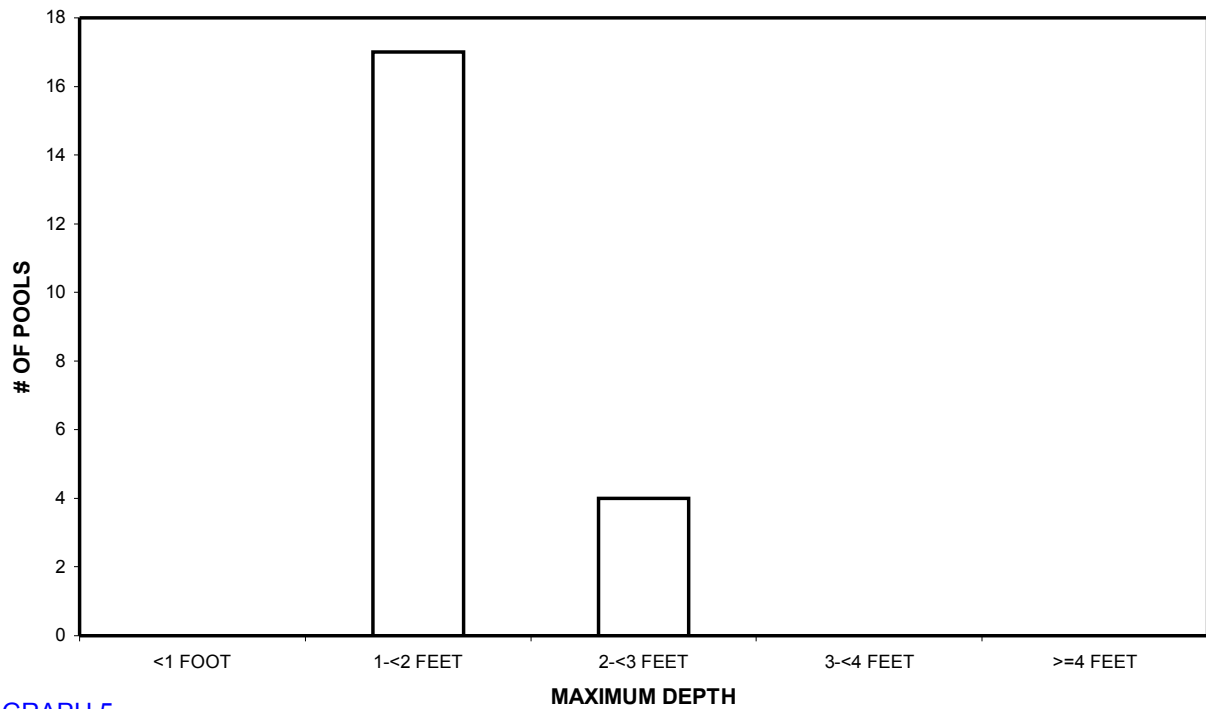
GRAPH 5

Table 4 is a summary of maximum pool depths by pool habitat types. Pool quality for salmonids increases with depth. Four of the 21 pools (19%) had a depth of two feet or greater (Graph 5). The depth of cobble embeddedness was estimated at pool tail-outs. Of the 21 pool tail-outs measured, 0 had a value of 1 (0%); 0 had a value of 2 (0%); 12 had a value of 3 (57%); 7 had a value of 4 (33%); and 2 had a value of 5 (10%) (Graph 6). On this scale, a value of 1 indicates the highest quality of spawning substrate.

Flatwater habitat types comprised 77% of the total length of this survey, pools 14%, and riffles 8%. The pools are relatively shallow, with 4 of the 21 (19%) pools having a maximum depth greater than 2 feet. In general, pool enhancement projects are considered when primary pools comprise less than 40% of the length of total stream habitat. In first and second order streams, a primary pool is defined to have a maximum depth of at least two feet, occupy at least half the width of the low flow channel, and be as long as the low flow channel width. Installing structures that will increase or deepen pool habitat is recommended for locations where their installation will not be threatened by high stream energy, or where their installation will not conflict with the modification of the numerous log debris accumulations (LDA's) in the stream.

- 3) Where feasible, design and engineer pool enhancement structures to increase the number of pools. This must be done where the banks are stable or in conjunction with stream bank armor to prevent erosion.

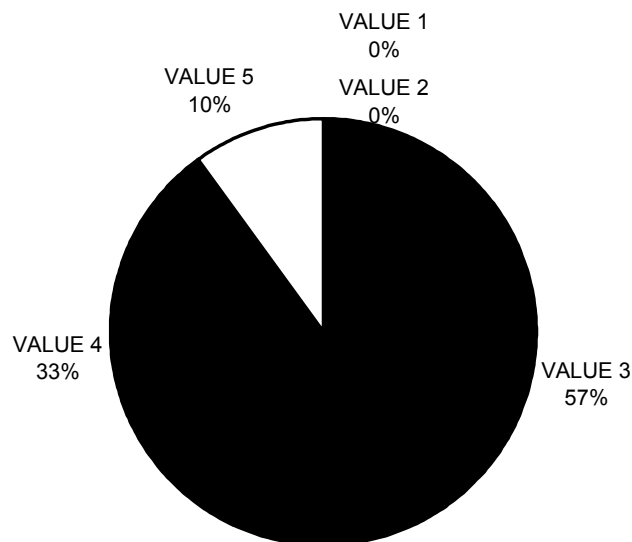
GRAPH 6

None of the 21 pool tail-outs measured had embeddedness ratings of 1 or 2. Nineteen of the pool tail-outs had embeddedness ratings of 3 or 4. Two of the pool tail-outs had a rating of 5, which is considered unsuitable for spawning. Cobble embeddedness measured to be 25% or less, a rating of 1, is considered to indicate good quality spawning substrate for salmon and steelhead. Sediment sources in Right Bank Tributary Two to Martin Creek should be mapped and rated according to their potential sediment yields, and control measures should be taken.

- 5) Inventory and map sources of stream bank erosion and prioritize them according to present and potential sediment yield. Identified sites should then be treated to reduce the amount of fine sediments entering the stream.

- 6) Active and potential sediment sources related to the road system need to be identified, mapped, and treated according to their potential for sediment yield to the stream and its tributaries.

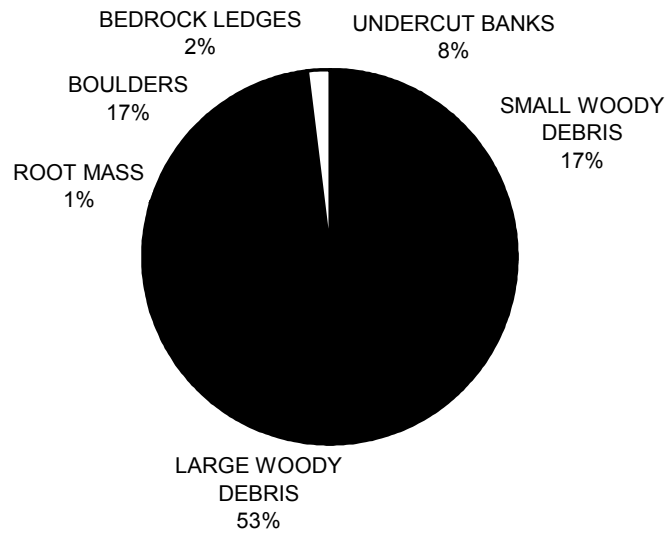
GRAPH 7

Table 5 summarizes mean percent cover by habitat type. Large woody debris is the dominant cover types in Right Bank Tributary Two to Martin Creek. Graph 7 describes the pool cover in Right Bank Tributary Two to Martin Creek. Large woody debris is the dominant pool cover type followed by small woody debris.

The mean shelter rating for pools was 34. The shelter rating in the flatwater habitats was 100. A pool shelter rating of approximately 100 is desirable. The amount of cover that now exists is being provided primarily by large woody debris in all habitat types. Additionally, small woody

debris contributes a small amount. Log and root wad cover structures in the pool and flatwater habitats would enhance both summer and winter salmonid habitat. Log cover structure provides rearing fry with protection from predation, rest from water velocity, and also divides territorial units to reduce density related competition.

- 4) Increase woody cover in the pools and flatwater habitat units. Much of the existing cover is from large woody debris. Adding high quality complexity with log and root wad cover is desirable.

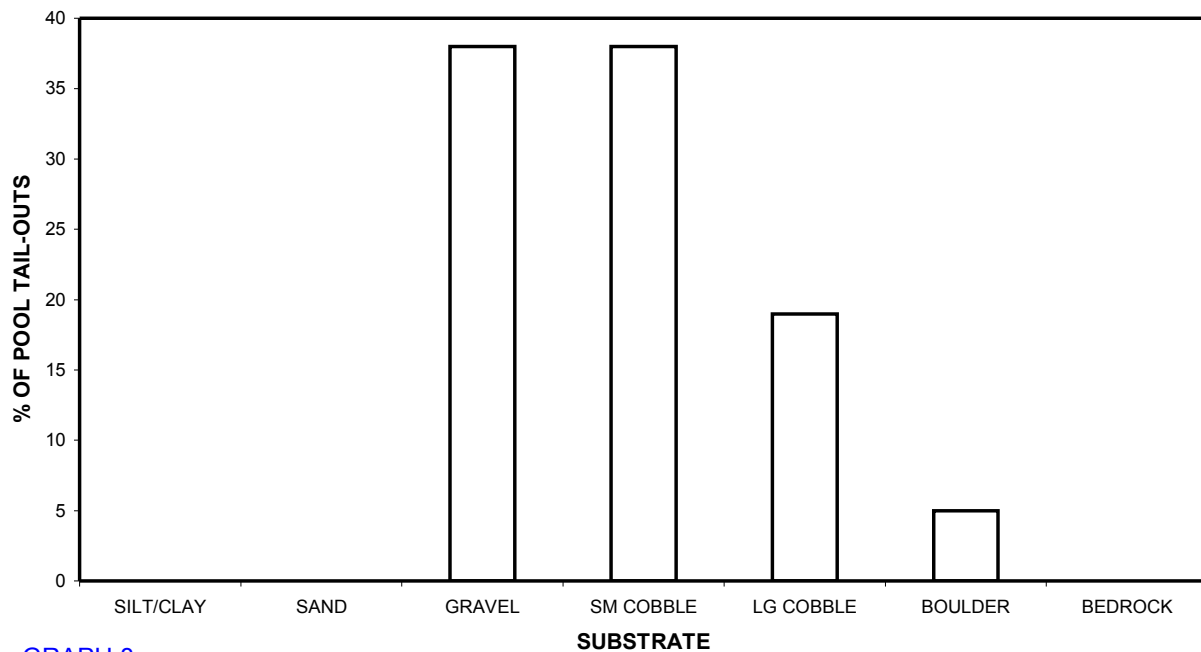
GRAPH 8

Table 6 summarizes the dominant substrate by habitat type. Graph 8 depicts the dominant substrate observed in pool tail-outs. Gravel was the dominant substrate observed in 38% of pool tail-outs while small cobble was an equally observed substrate type, at 38%.

Nineteen of the 21 pool tail-outs measured had gravel and small cobble as the dominant substrate. This is generally considered good for spawning salmonids.

- 8) Suitable size spawning substrate on Right Bank Tributary Two to Martin Creek is limited to relatively few reaches. Projects should be designed at suitable sites to trap and sort spawning gravel.
- 9) There are several log debris accumulations present on Right Bank Tributary Two to Martin Creek that are retaining large quantities of fine sediment. The modification of these debris accumulations is desirable, but must be done carefully, over time, to avoid excessive sediment loading in downstream reaches.
- 10) Due to the high gradient of the stream, access for migrating salmonids is an ongoing potential problem. Good water temperature and flow regimes exist in the stream and it offers good conditions for rearing fish. Fish passage should be monitored and improved where possible.

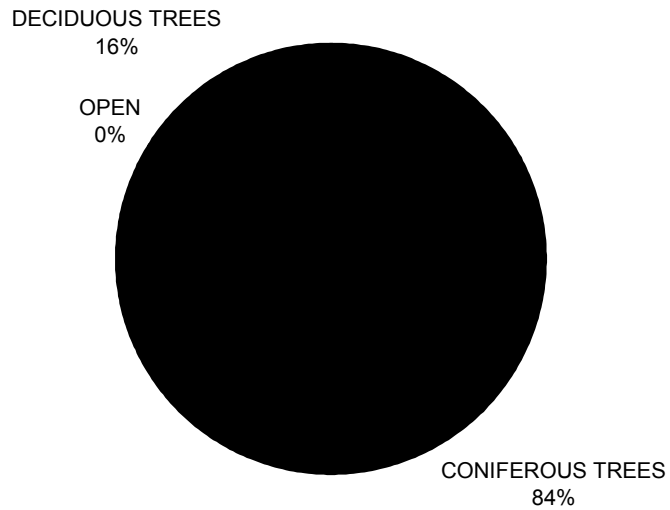
GRAPH 9

The mean percent canopy density for the surveyed length of Right Bank Tributary Two to Martin Creek was 86%. The mean percentages of deciduous and coniferous trees were 16% and 84%, respectively. Graph 9 describes the mean percent canopy in Right Bank Tributary Two to Martin Creek.

The mean percent canopy density for the stream was 85%. In general, revegetation projects are considered when canopy density is less than 80%.

- 7) Increase the canopy on Right Bank Tributary Two to Martin Creek by planting willow, alder, redwood, and Douglas fir along the stream where shade canopy is not at acceptable

levels. The reaches above this survey section should be inventoried and treated as well, since the water flowing here is affected from upstream. In many cases, planting will need to be coordinated to follow bank stabilization or upslope erosion control projects.

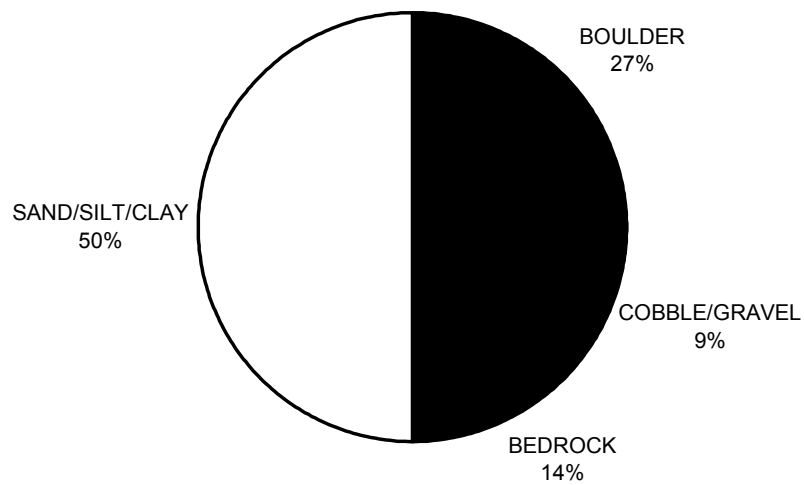
GRAPH 10

For the stream reach surveyed, the mean percent right bank vegetated was 30%. The mean percent left bank vegetated was 24%. The dominant elements composing the structure of the stream banks consisted of 50% sand/silt/clay, 14% bedrock, 27% boulder, and 9% cobble/gravel (Graph 10). Coniferous trees were the dominant vegetation type observed in 95% of the units surveyed. Additionally, 5% of the units surveyed had deciduous trees as the dominant vegetation type (Graph 11).

The percentage of right and left bank covered with vegetation was moderate at 30% and 24%, respectively. In areas of stream bank erosion or where bank vegetation is not at acceptable levels, planting endemic species of coniferous and deciduous trees, in conjunction with bank stabilization, is recommended.
