## OAK TREE REPORT

**Prepared For:**  
Grimes Rock, Inc.  
P.O. Box 4535  
Saticoy, CA 93007-4535

**Site Address:**  
Grimes Rock, Inc.  
3500 Grimes Canyon Road  
Fillmore, CA 93015

**August 2, 1999**

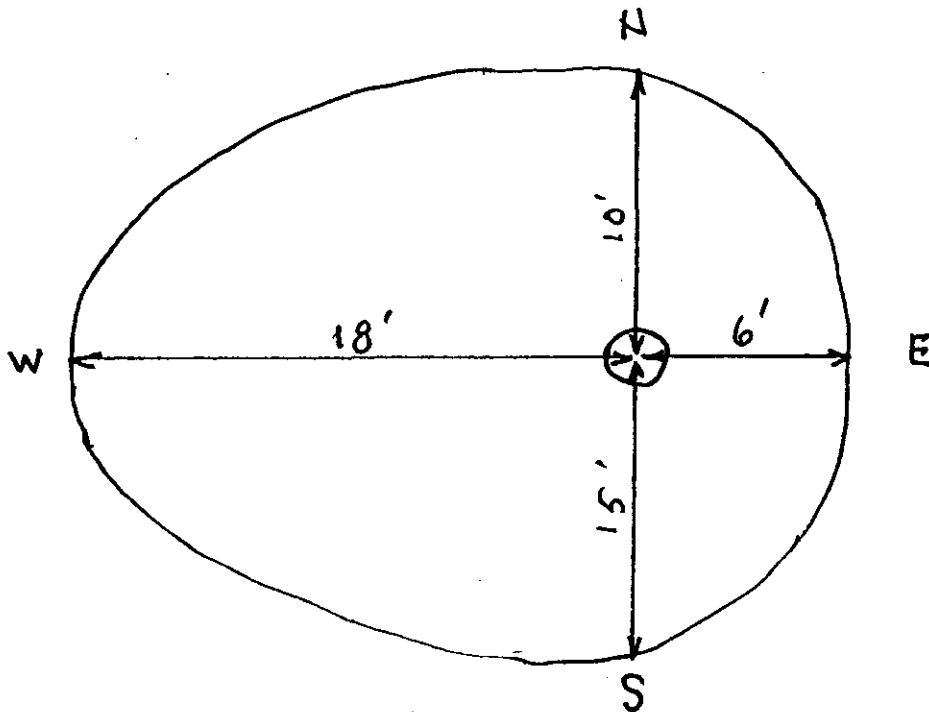
**PLAN VIEW**

<u>Specie</u>	Coastal Live Oak	<u>Height</u>	42'
<u>Rate of Vigor</u>	C+	<u>Visual Appearance</u>	C+
<u>Drip Line</u>	North 10'	South 15'	East 6' West 18'

Description This tree has a single trunk and is straight and tall. Branches and leaves are thin. There are some dead limbs and some black scale. The tree is on a very steep slope.

Girth The single trunk is 17" in diameter at 4'6" above the ground

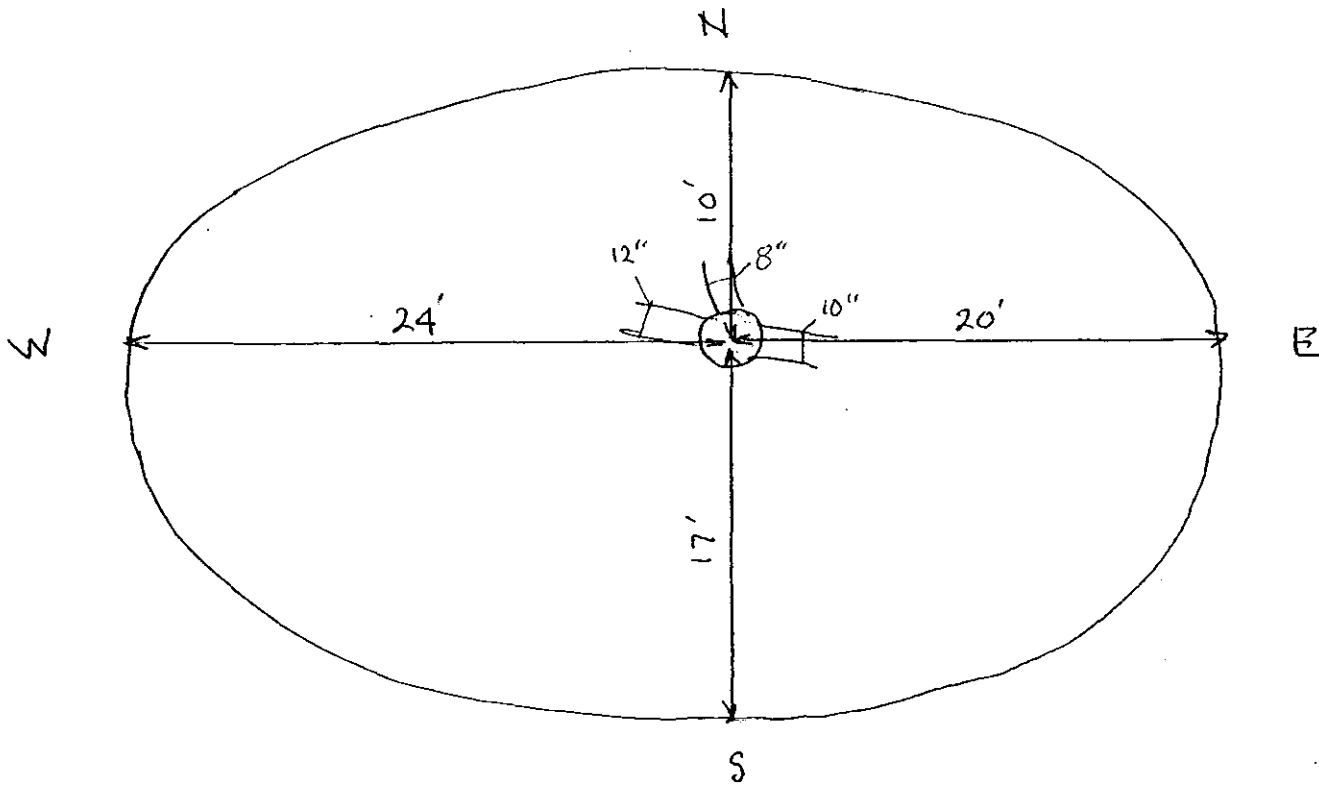
**PLAN VIEW**

<u>Specie</u>	Coastal Live Oak	<u>Height</u>	28'
<u>Rate of Vigor</u>	D+	<u>Visual Appearance</u>	D+
<u>Drip Line</u>	North 10'	South 17'	East 20' West 24'

Description This tree has a triple trunk. Two of the three trunks do not get 4'6" above the ground. Some branches curve to the ground even on the down hill side. The tree has some broken limbs, some cavities, and is off color. Branches and leaves are thin. The tree is on a steep slope.

Girth. One 12" Two 10" (under 4'6") Three 8" (under 4'6")

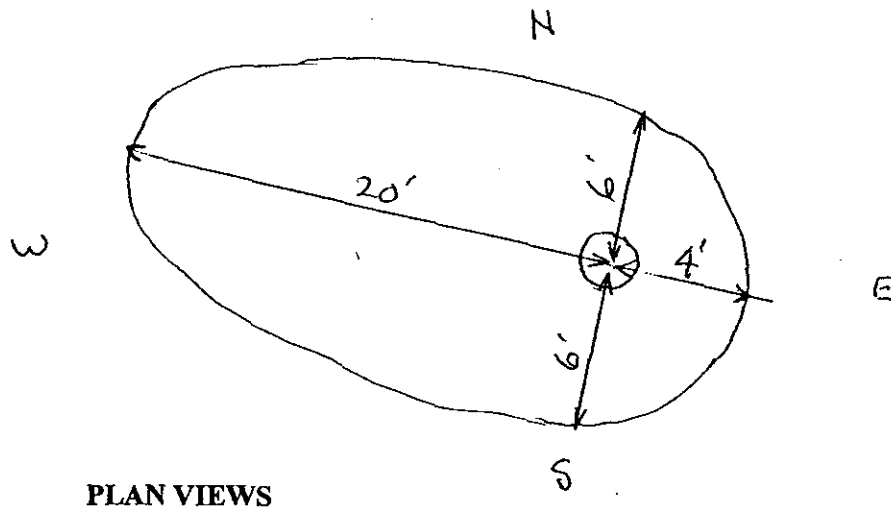
**PLAN VIEWS**

<u>Specie</u>	Coastal Live Oak	<u>Height</u>	14'
<u>Rate of Vigor</u>	D-	<u>Visual Appearance</u>	D-
<u>Drip Line</u>	North 6'	South 6'	East 4' West 20'

Description This tree appears to be a regrowth from a fallen tree. There is a large dead trunk lying to the west of two smaller new trunks. One of these trunks is vertical and the other is horizontal and does not get up to 4'6" above the ground. Branches and leaves are thin. Some branches are crooked and turn back on themselves. The tree is on a steep slope.

Girth. One 6" Two 6" (under 4'6")

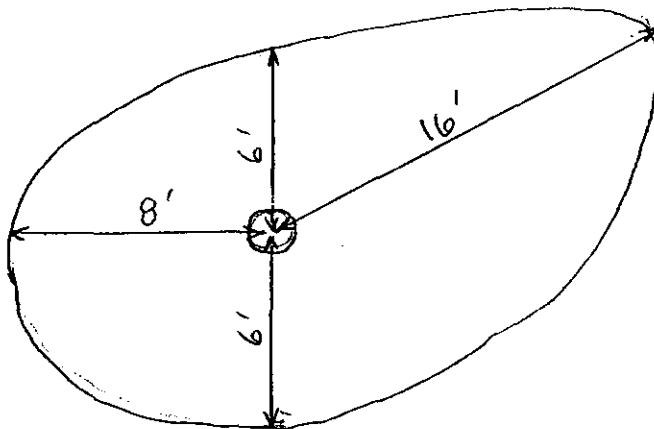
PLAN VIEW

<u>Specie</u>	Coastal Live Oak	<u>Height</u>	18'
<u>Rate of Vigor</u>	C-	<u>Visual Appearance</u>	C
<u>Drip Line</u>	North 6'	South 6'	Northeast 16' West 8'

Description This tree branches into three trunks before they reach 4'6" above the ground. The central, most vertical trunk is dead and is broken off. The other two trunks do not reach 4'6" above the ground. One trunk has several limbs that extend some distance to the northeast, which gives the tree an unbalanced appearance. The tree is on a very steep slope.

Girth. One 5"(dead) Two 4" (under 4'6") Three 4"(under 4'6')

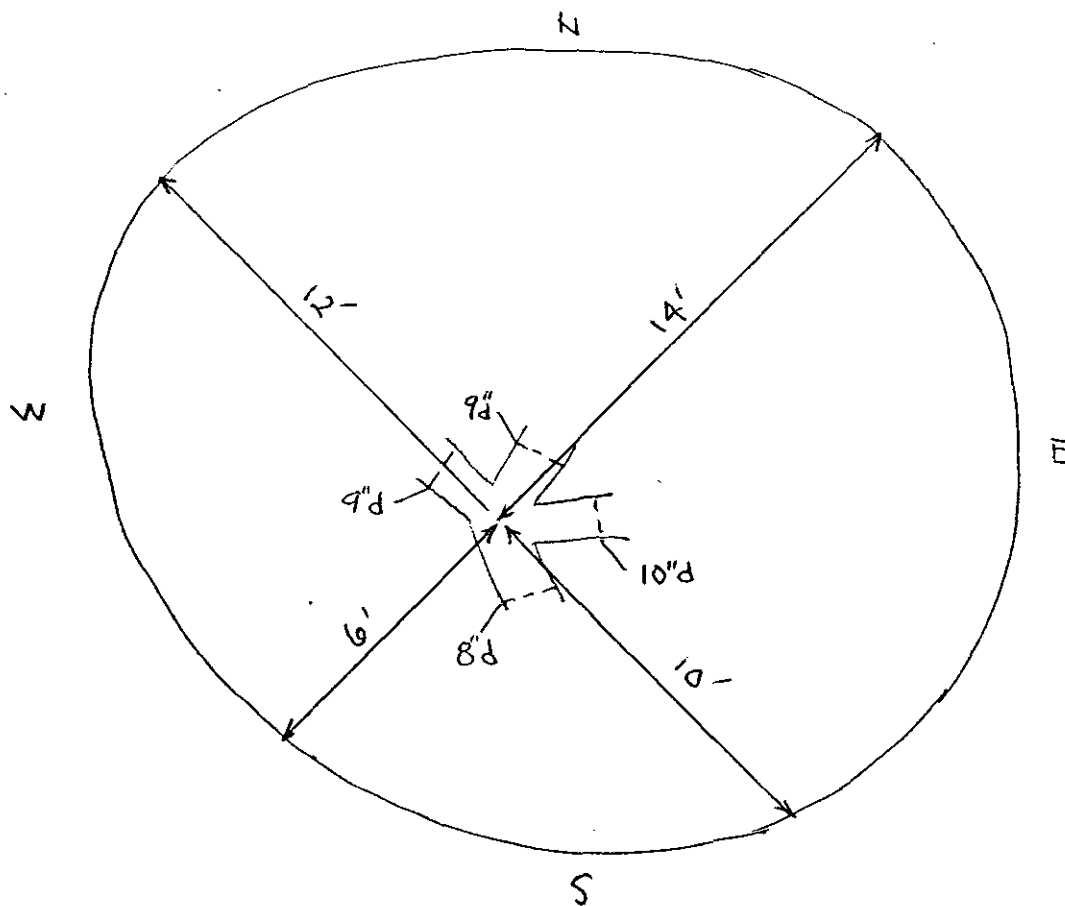
PLAN VIEW

<u>Specie</u>	Coastal Live Oak	<u>Height</u>	30'
<u>Rate of Vigor</u>	C+	<u>Visual Appearance</u>	C+
<u>Drip Line</u>	Northeast 14'	Northwest 12'	Southeast 10' Southwest 6'
<u>Description</u> This tree has four trunks which are fairly vertical. There are some dead limbs. The tree is on a very steep slope.			
<u>Girth</u>	One 9"	Two 9"	Three 10" Four 8.5"

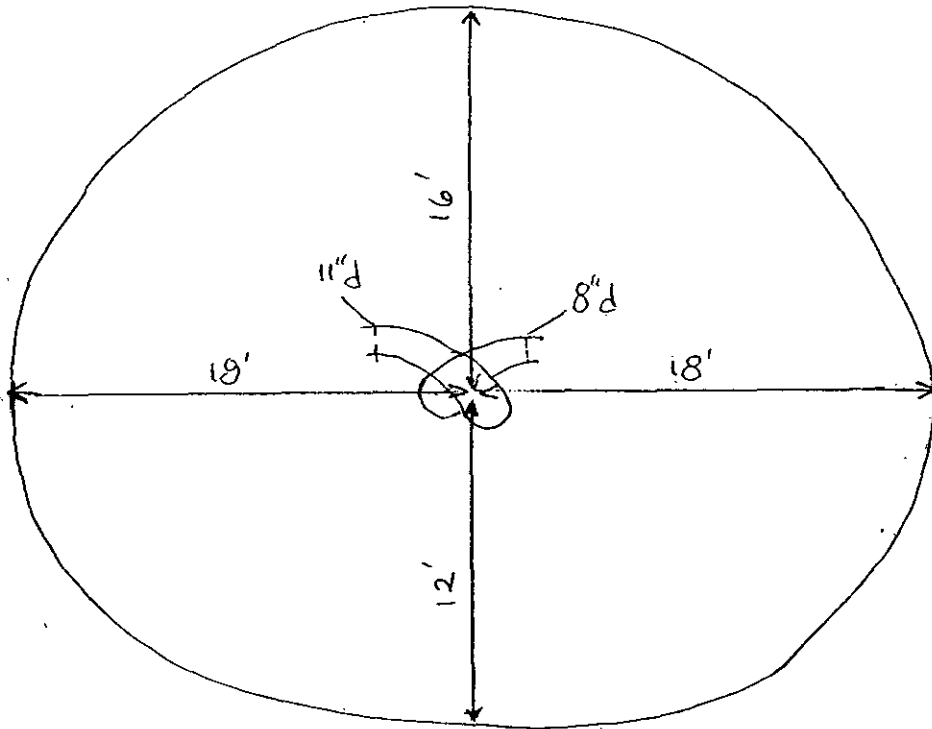
**PLAN VIEW**

<u>Specie</u>	Coastal Live Oak	<u>Height</u>	23'
<u>Rate of Vigor</u>	D+	<u>Visual Appearance</u>	D+
<u>Drip Line</u>	North 16'	South 12'	East 18' West 18'

Description This tree has multiple twisted trunks. Two are over 3" in diameter. Both have exposed sap wood and cavities with exudation. The tree is on a very steep slope.

Girth. One 11"(hollow) Two 8"

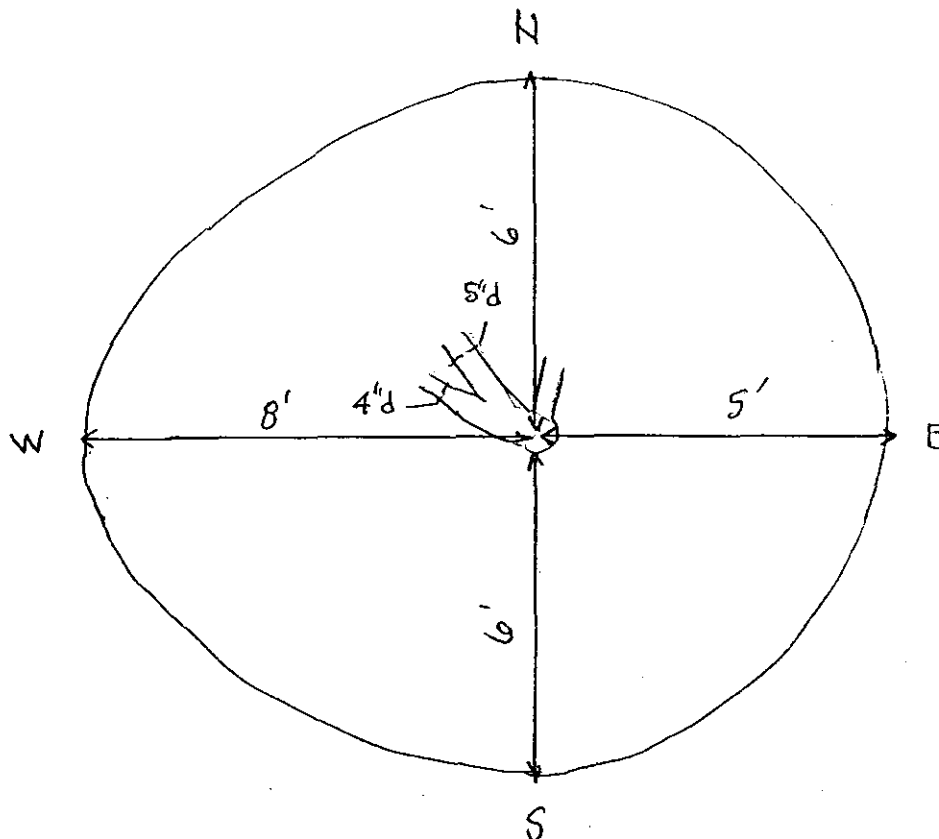
**PLAN VIEW**

Specie Coastal Live Oak Height 12'

Rate of Vigor D- Visual Appearance D-

Drip Line North 6' South 6' East 5' West 8'

Description This tree has multiple trunks with most being under 3" at 4'6" above the ground. Many do not get up to 4'6" and some curve to touch the ground. The biggest trunk divides into three limbs. Some limbs are broken. The tree appears to be dying. The tree is on a very steep slope.

Girth. One 5" Two 4"
