CHAPTER 9

BOTANICAL RESOURCES

Tapo Rock and Sand Quarry EIR
 County of Ventura
 Resource Management Agency
 Planning Division

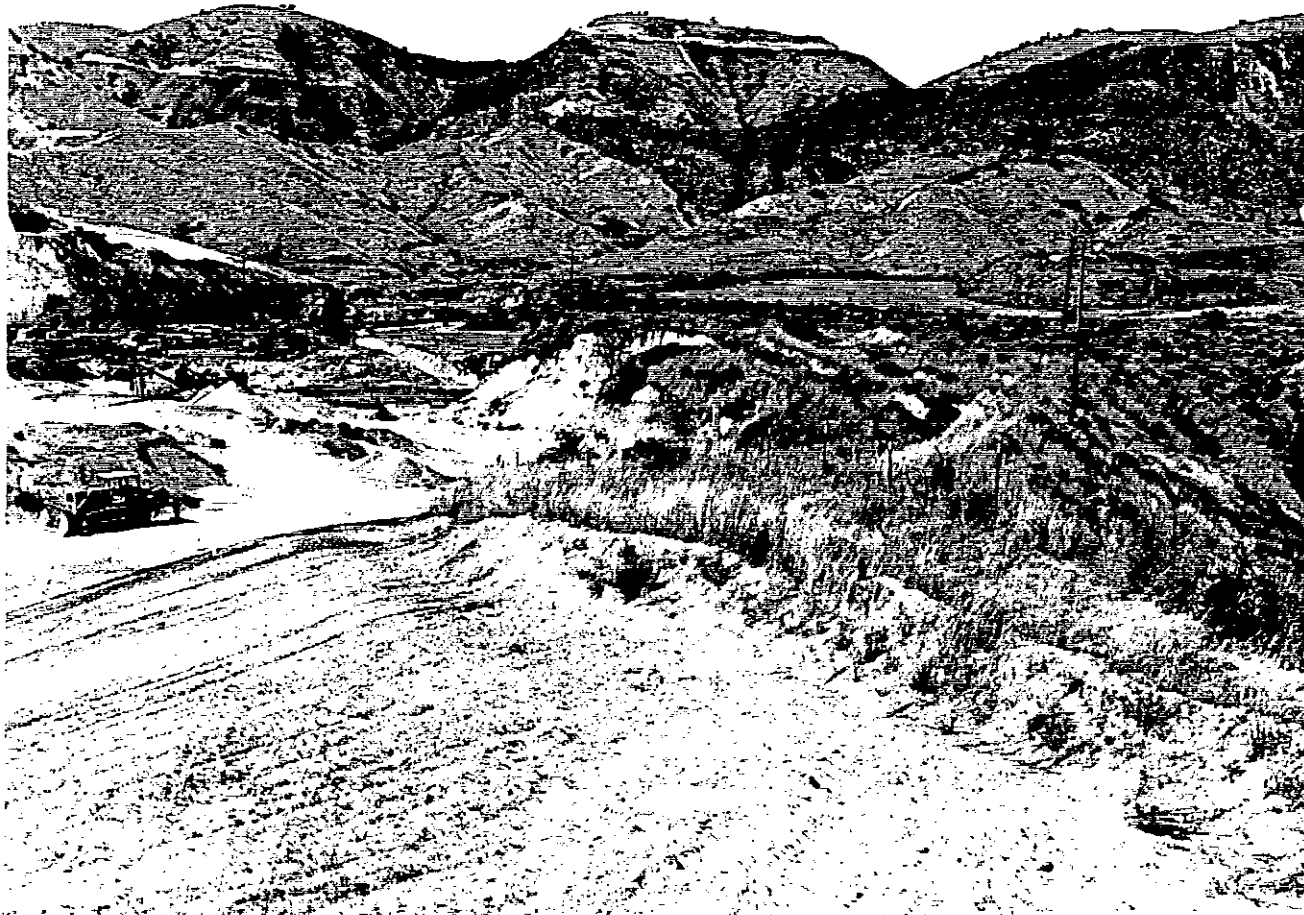
Figure 9-2

Existing Vegetation Conditions in the Vicinity of Phase I, II, and III

Existing habitat conditions within the vicinity of Phases I, II, III are displayed in the foreground of this photograph. A mixture of re-established typical coastal sage scrub vegetation mixed with ruderal and invasive plants is included within the boundary of mining Phases I, II, and III. The areas in the immediate vicinity of the proposed mining operation have been quarried extensively. In the canyon north of the Phase I, II, III component of the project, substantial quarrying was done in the 1960s and 1970s. Visible in the eroding ridgeline north of the project are mining tailings and equipment which was used to extract fossil shell embedded in the landforms surrounding the northern perimeter of the project. This operation has been abandoned.

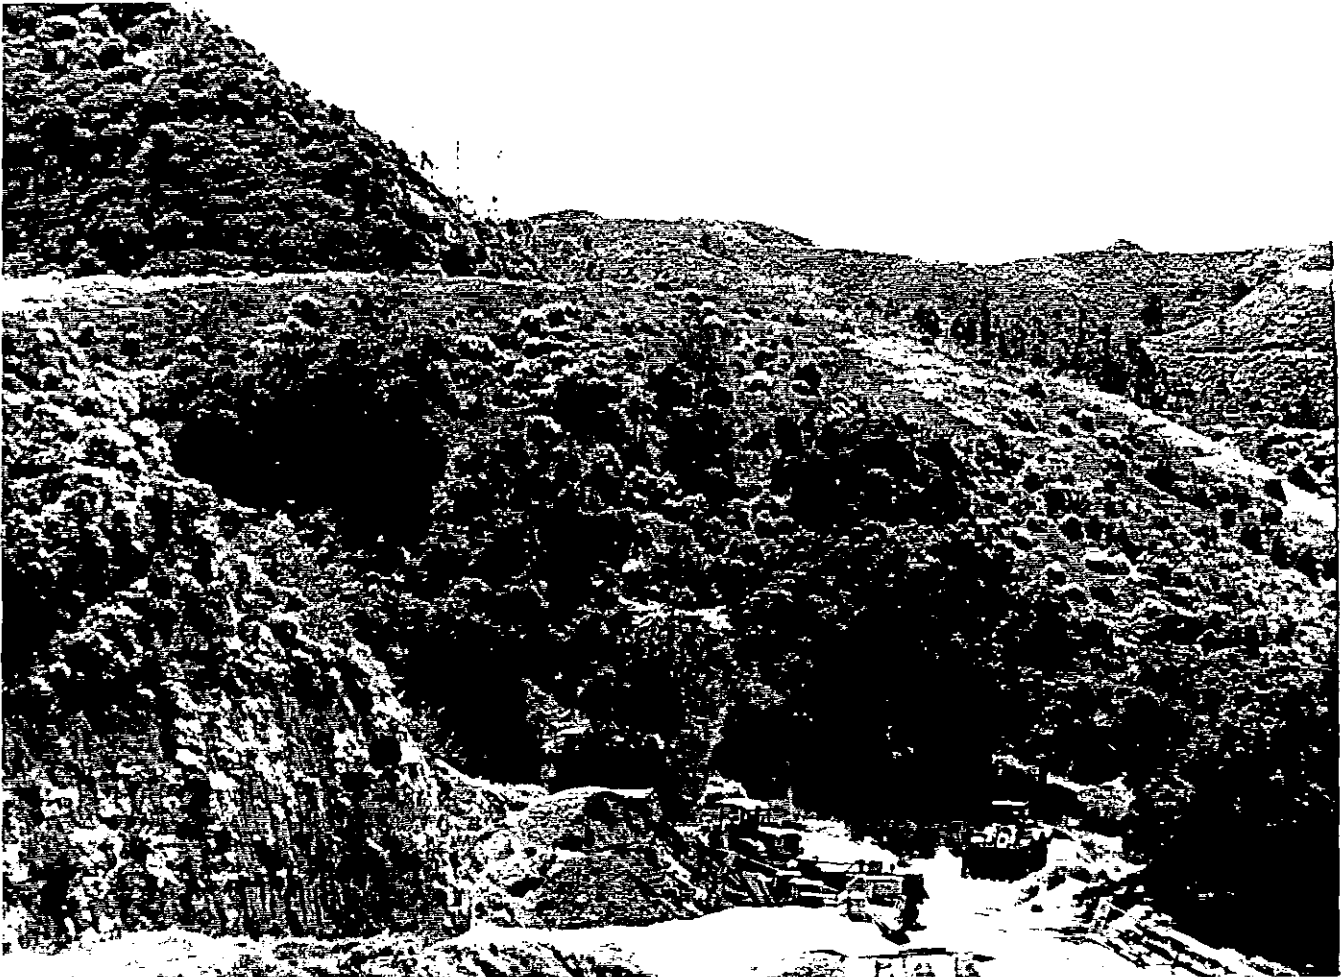
Figure 9-3

Vegetation Conditions in the Phase VI

This photograph illustrates existing vegetation conditions within Phase VI and the perimeter of previously excavated portions of the quarry in south of Phase V. The landform comprising Phase VI would be the last phase of work to be performed under the present excavation timing. Obtaining access to the Phase VI site will require careful planning to avoid impacts to the relict stand of Quercus agrifolia illustrated in the area which is to be used to access this Phase area. This photograph also illustrates the type of re-colonization that occurs naturally on the steep slopes left after mining has been completed.
