INITIAL STUDY CHECKLIST

Job: LU07-0032

Rationale: Grading for development of single family residence

SITE PHOTOGRAPHS

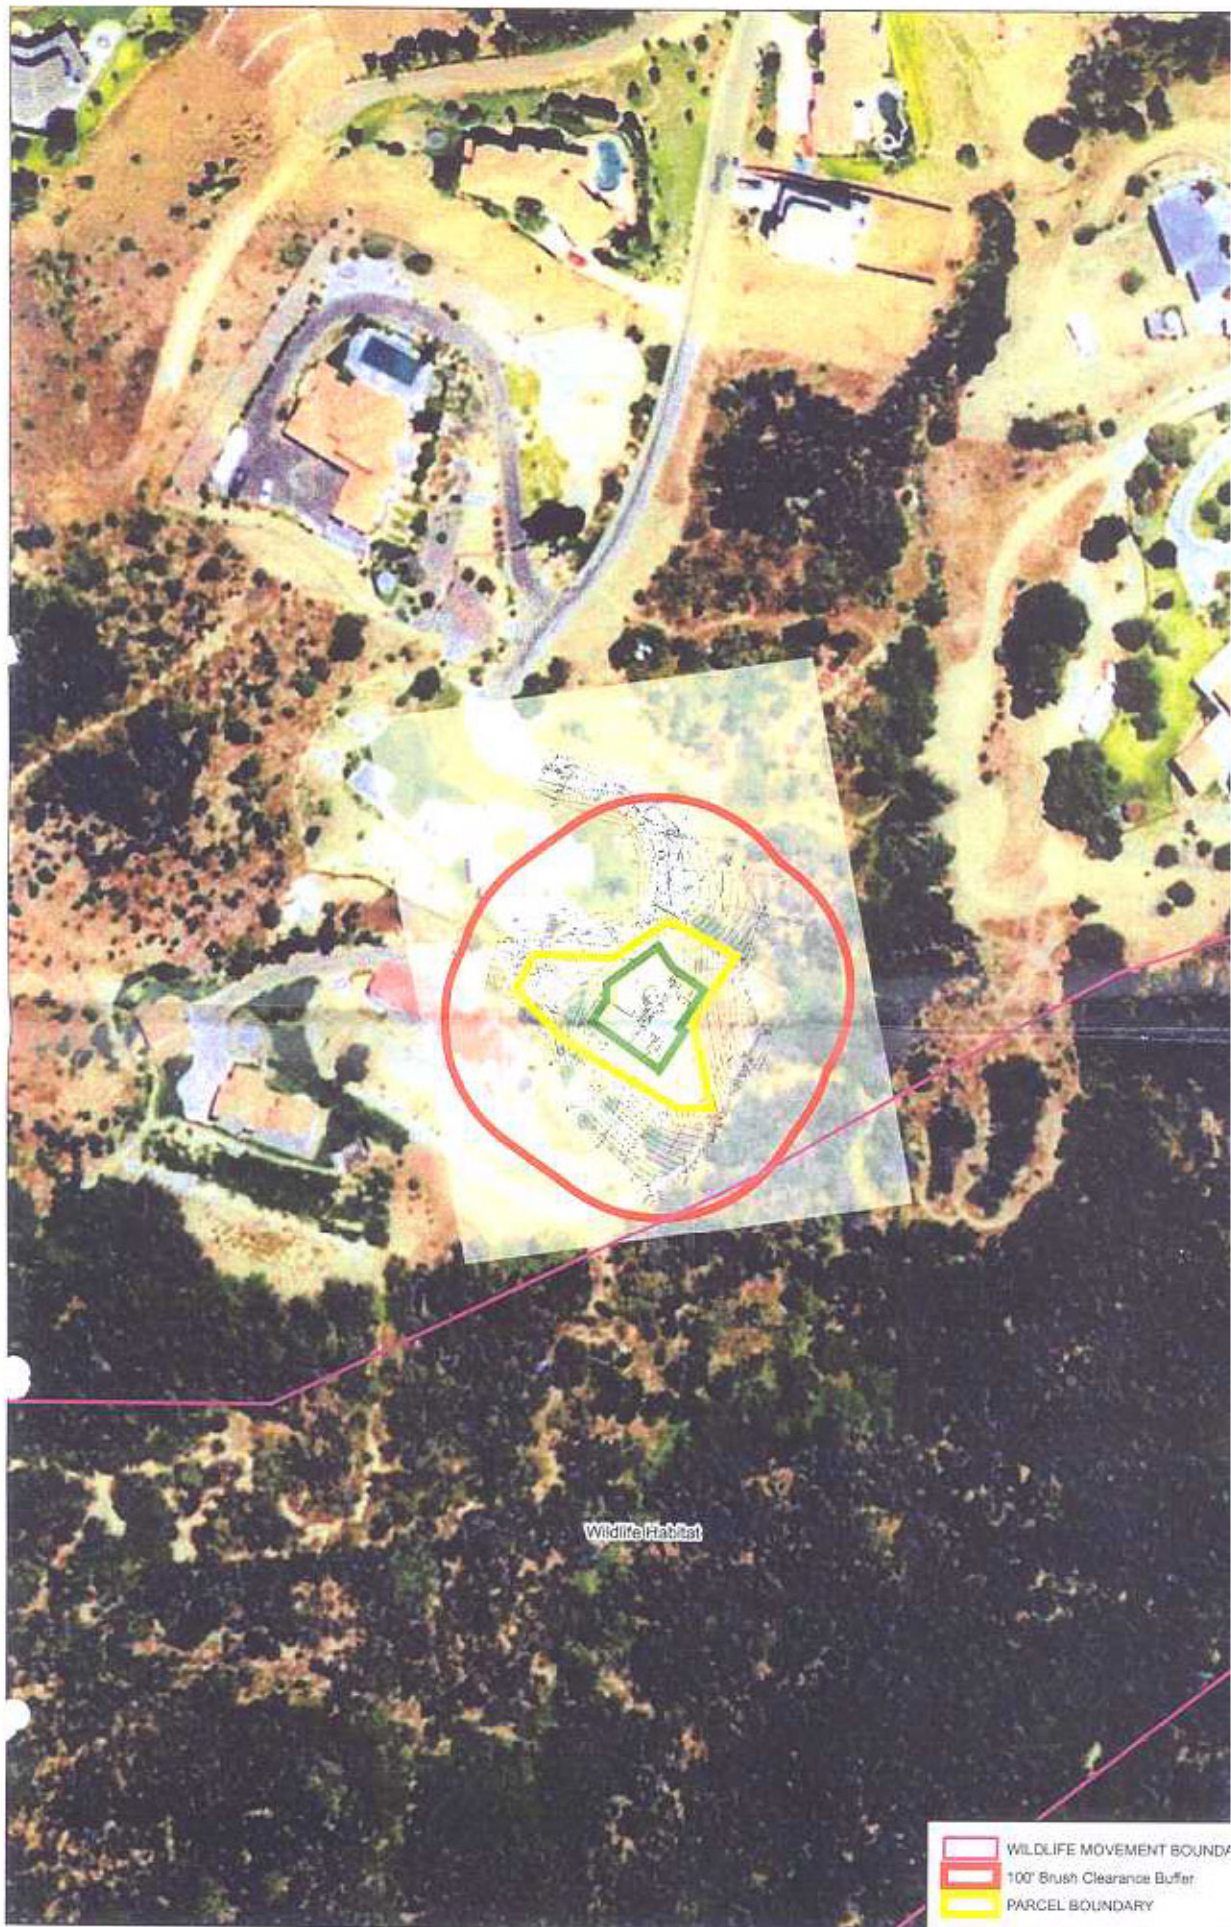
PROJECT SITE MAP

- WILDLIFE MOVEMENT BOUNDARY
- 100' Brush Clearance Buffer
- PARCEL BOUNDARY

LU07-0032
673-0-150-58 & 673-0-150-69
MAP #6B LANDSCAPE WILDLIFE MOVEMENT

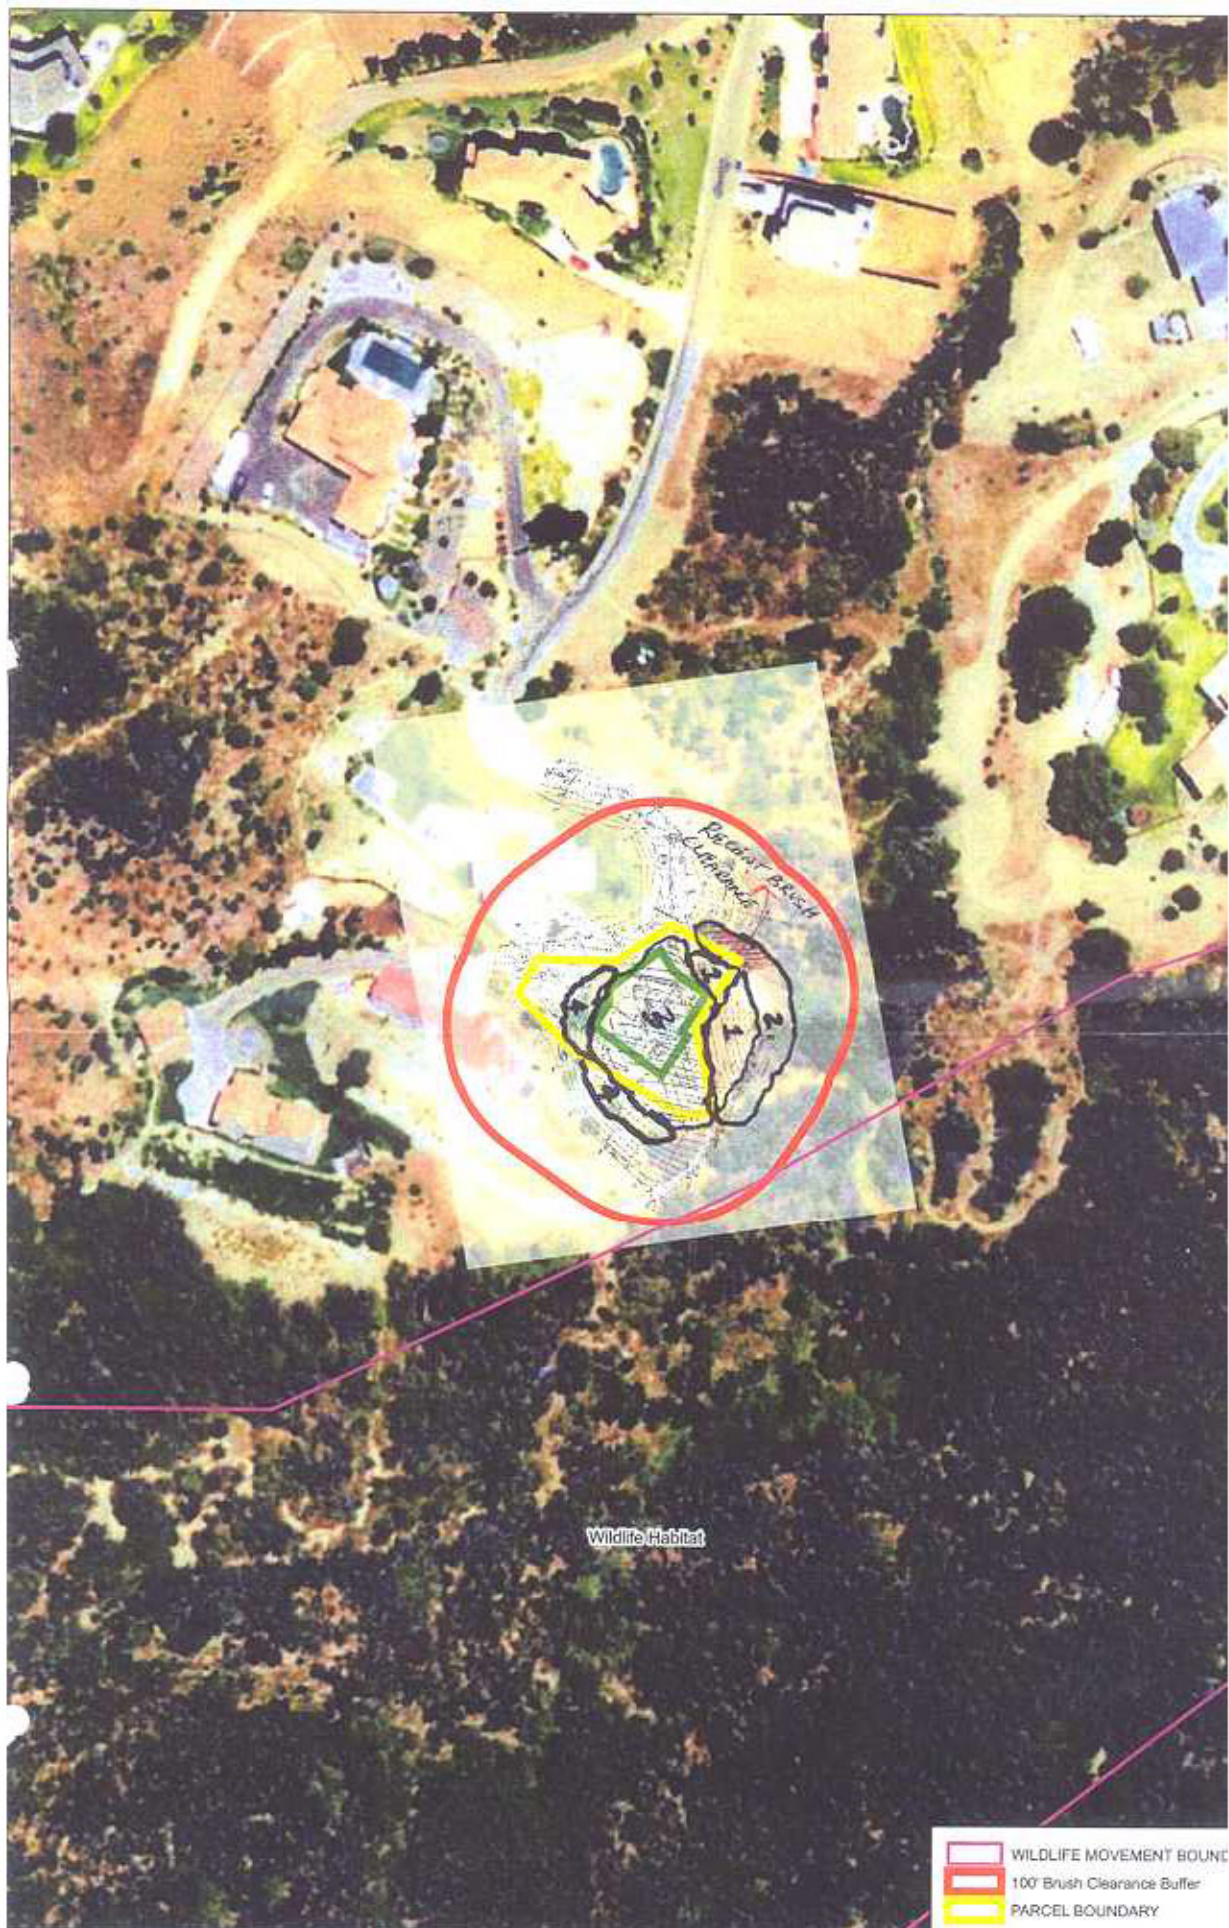
VEGETATION MAP

Wildlife Habitat

- WILDLIFE MOVEMENT BOUND
- 100' Brush Clearance Buffer
- PARCEL BOUNDARY

The development of the single-family residence (Area 3 shown on the vegetation map provided in **Attachment B**) is located on a flat area of the proposed Project Site that has been previously disturbed/graded and is dominated by non-native ruderal species. Currently, a trailer is parked on the graded pad proposed for development. The western and southern portions of the Subject Property (Area 4) are vegetated with ornamental/landscape plants. The eastern portion of the proposed Project Site (Area 1) is located on a downhill slope dominated by mix of ruderal and native plant species including deerweed (*Lotus scoparius*), mustard (*Brassica sp.*), goldenbush (*Hazardia sp.*), wedgeleaf ceanothus (*Ceanothus cuneatus*), and coyote brush (*Baccharis pilularis*). Other species found in Area 1 include black sage (*Salvia mellifera*), tree tobacco (*Nicotiana glauca*), bindweed (*Convolvulus sp.*), star thistle (*Centaurea sp.*), and horseweed (*Conyza sp.*). Area 2, located to the east of Area 1 beyond the Subject Property boundary is vegetated with coyote brush, wedgeleaf ceanothus, black sage, toyon (*Heteromeles arbutifolia*), and monkey flower (*Mimulus auranticus*). The northern portion of Area 2 has been cleared of vegetation. A concreted drainage channel is located adjacent to the southern portion of the Subject Property and also runs along the toe of the slope on eastern boundary of Area 1. This channel does not support vegetation.

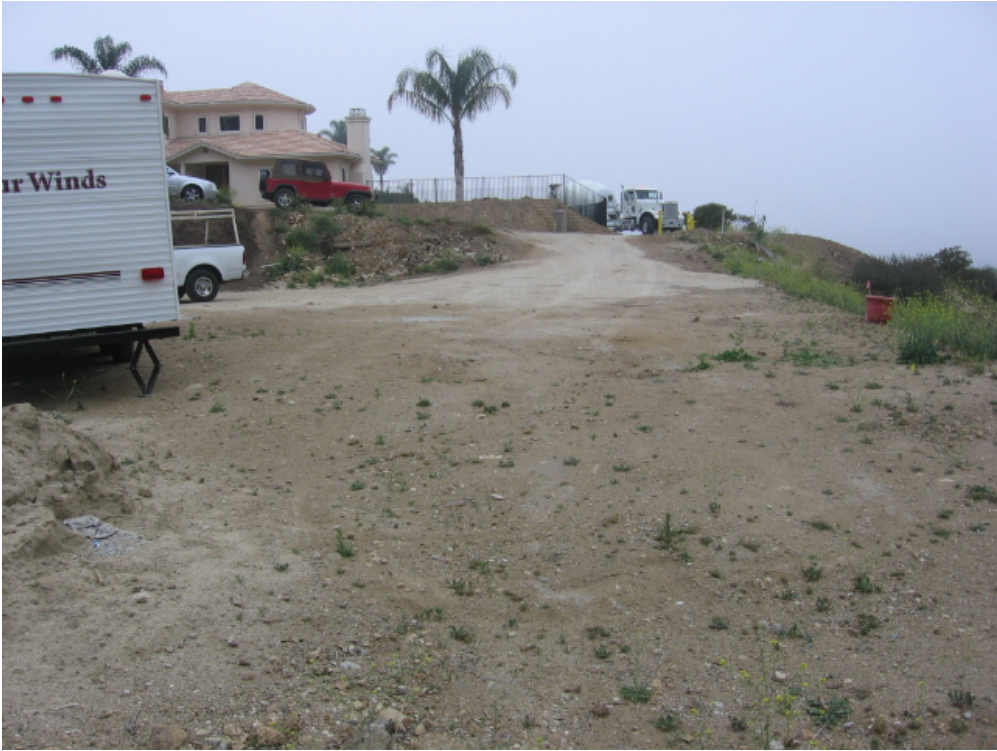
ENSR		PHOTOGRAPHIC LOG	
Client Name: Ventura County Planning Division		Site Location: 1459 Topa View Trail	
Project No. 07020-024-001			
Photo No. 1	Date: 5/18/07

Direction Photo Taken: North			
Description: Building pad area looking north towards driveway access			
Photo No. 2	Date: 5/18/07

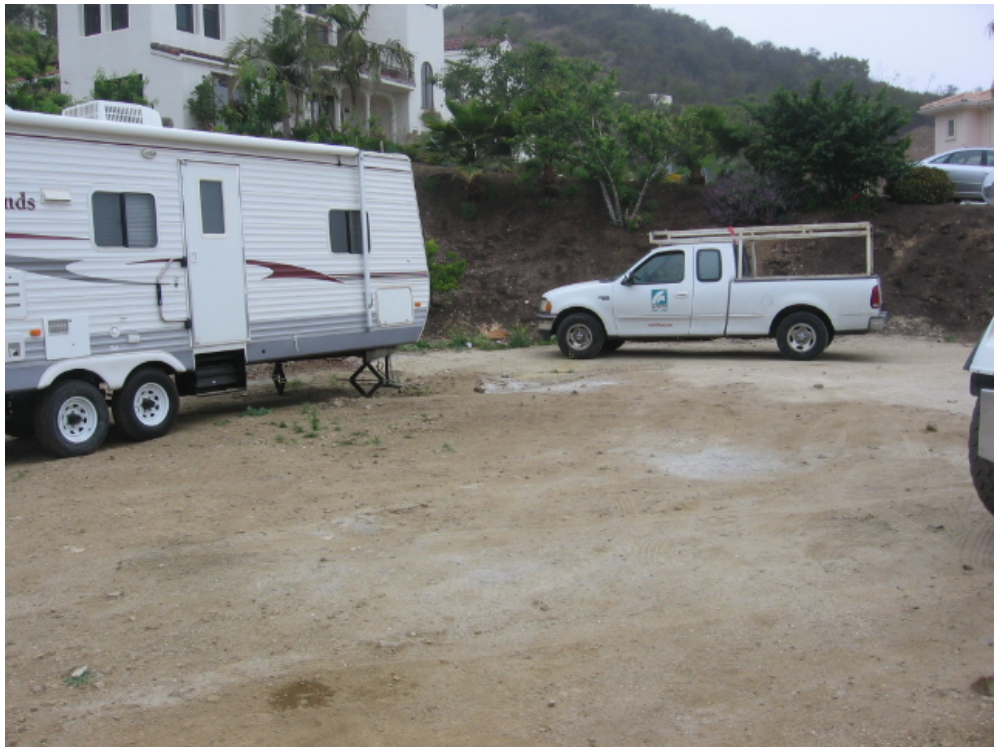
Direction Photo Taken: Southwest			
Description: Building pad showing landscaped slope to neighboring residence.

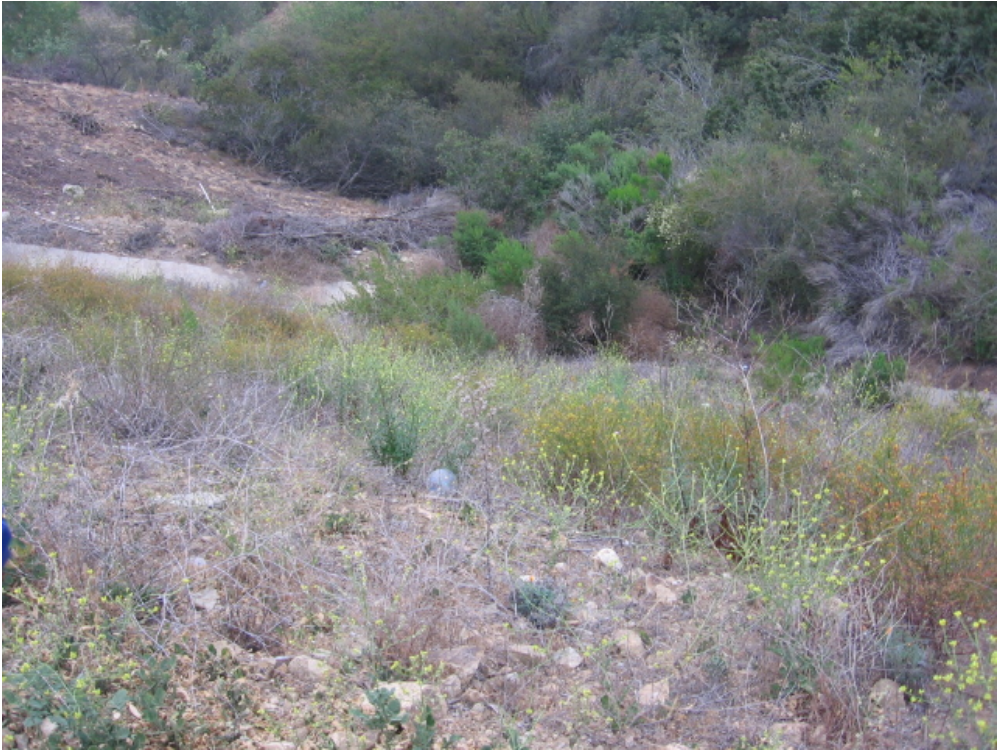
ENSR		PHOTOGRAPHIC LOG	
Client Name: Ventura County Planning Division		Site Location: 1459 Topa View Trail	
Project No. 07020-024-001			
Photo No. 3	Date: 5/18/07

Direction Photo Taken: North-northeast			
Description: Slope below building pad.			
Photo No. 4	Date: 5/18/07

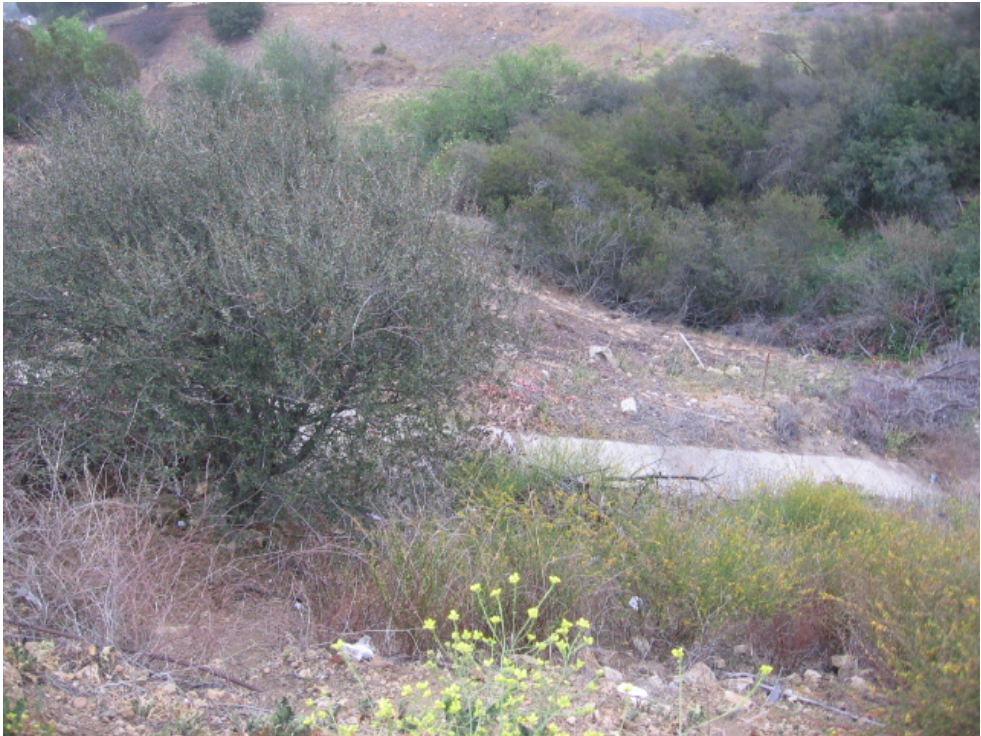
Direction Photo Taken: Northeast			
Description: North side of area below building pad.

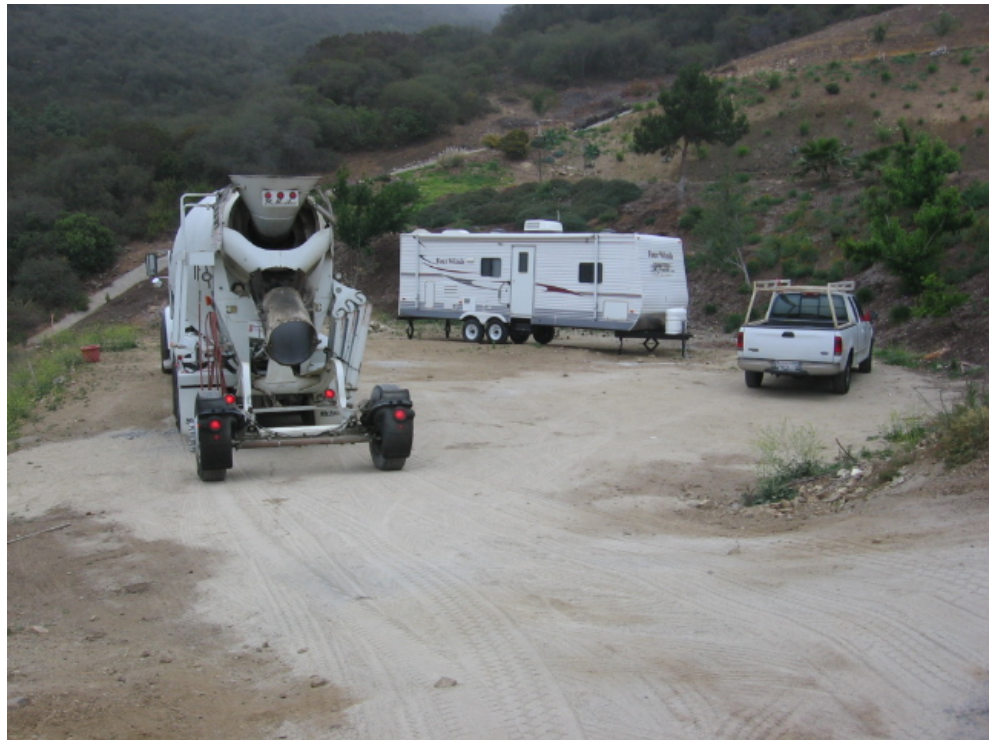
Photo No.
5

Building pad site from driveway area (concrete truck was at the incorrect address).

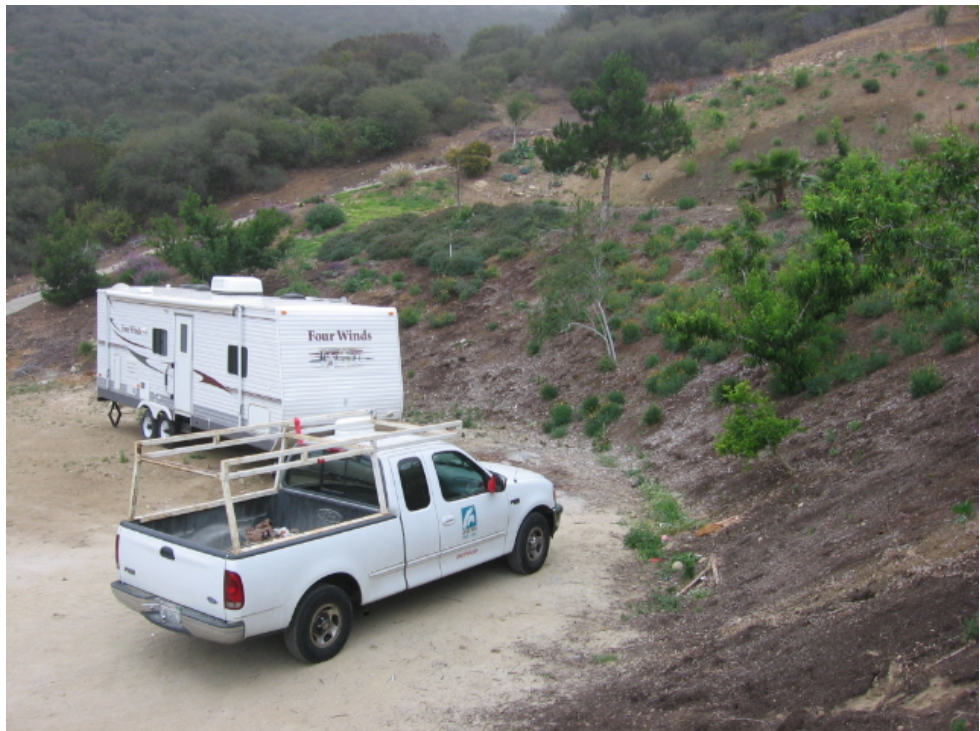
Photo No.
6

Building pad and disturbed/landscaped area.

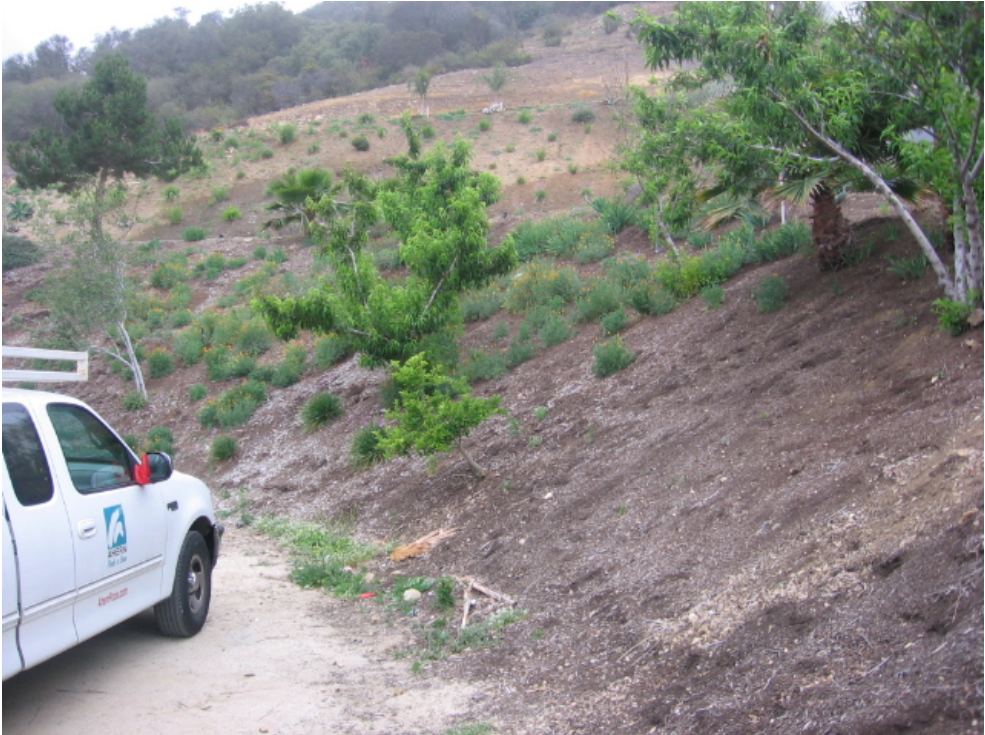
ENSR		PHOTOGRAPHIC LOG
Client Name: Ventura County Planning Division		Site Location: 1459 Topa View Trail
Project No. 07020-024-001		
Photo No. 7	Date: 5/18/07

Direction Photo Taken: Southwest		
Description: Landscaped slope adjacent to building pad (construction truck was using site as staging/parking only).		
Photo No. 8	Date: 5/18/07

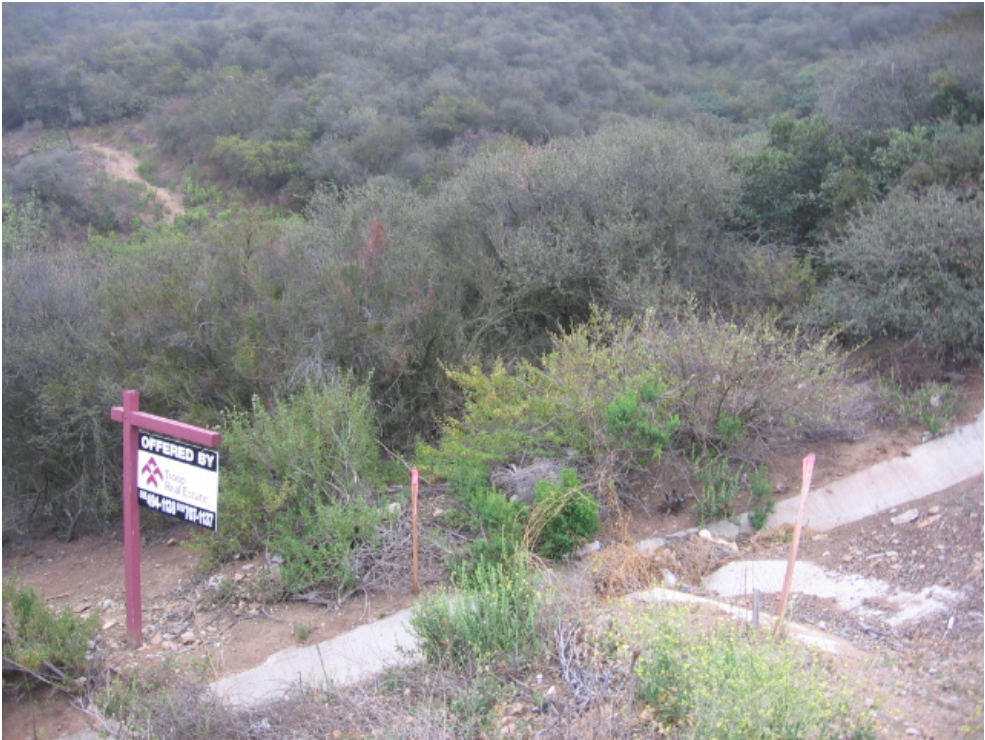
Direction Photo Taken: Southeast		
Description: South side of parcel, drainage channel generally separates disturbed area from undisturbed area.

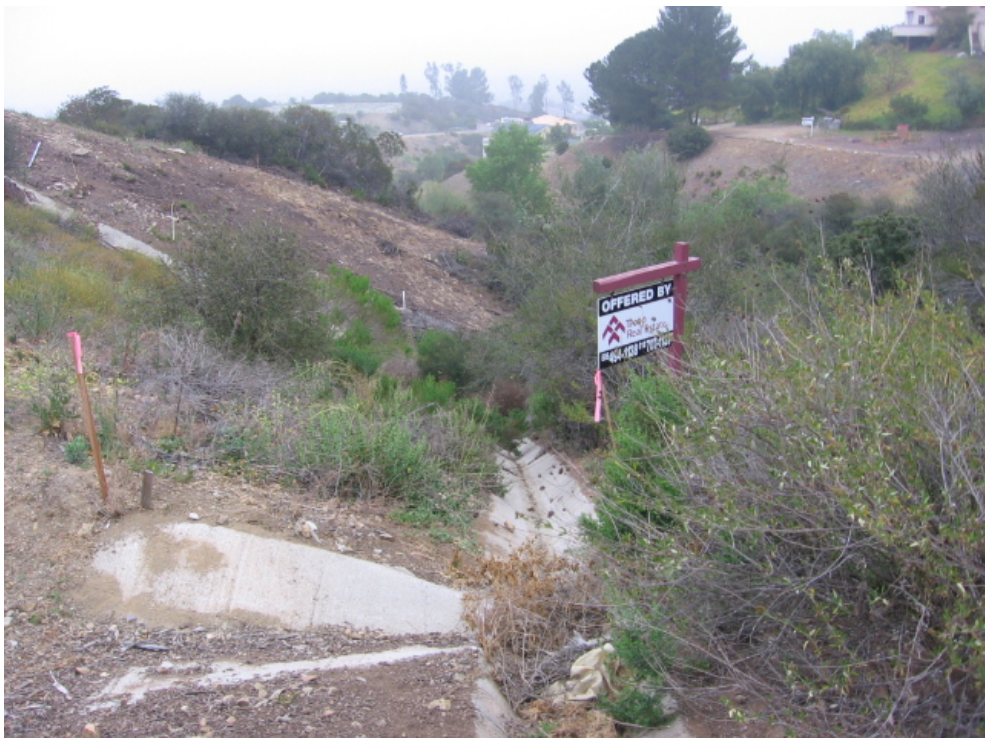
ENSR		PHOTOGRAPHIC LOG	
Client Name: Ventura County Planning Division		Site Location: 1459 Topa View Trail	Project No. 07020-024-001
Photo No. 9	Date: 5/18/07

Direction Photo Taken: North			
Description: East side of parcel, drainage channel separating disturbed from undisturbed areas. Note area in upper left quadrant of photo has been cleared since County aerial image was acquired.			
Photo No. 10	Date: 5/18/07

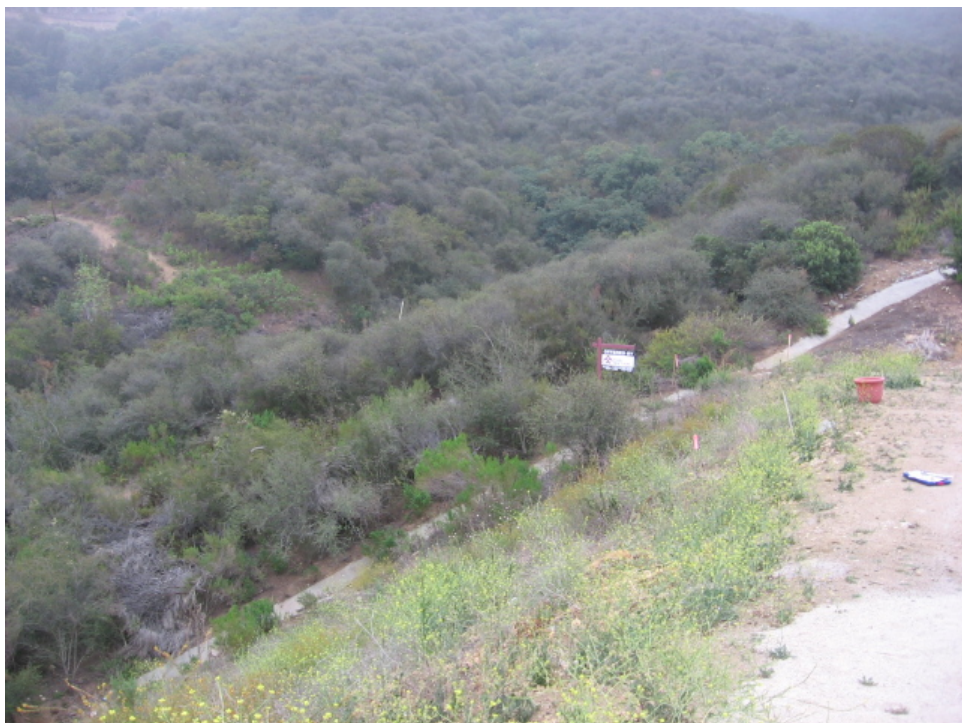
Direction Photo Taken: Southeast			
Description: East side of building pad showing slope break and drainage channel.
