**WETLAND FUNCTIONAL ASSESSMENT  
OF THE GRAMCKOW  
PROPERTY PROJECT,  
RANCHO MATILIJA, CALIFORNIA  
(COUNTY OF VENTURA PROJECT: ZO 04-0000008)**

**July 2006**

**Wetland Functional Assessment of the  
Gramckow Property Project,  
Rancho Matilija, California**  
(County of Ventura Project: ZO 04-0000008)

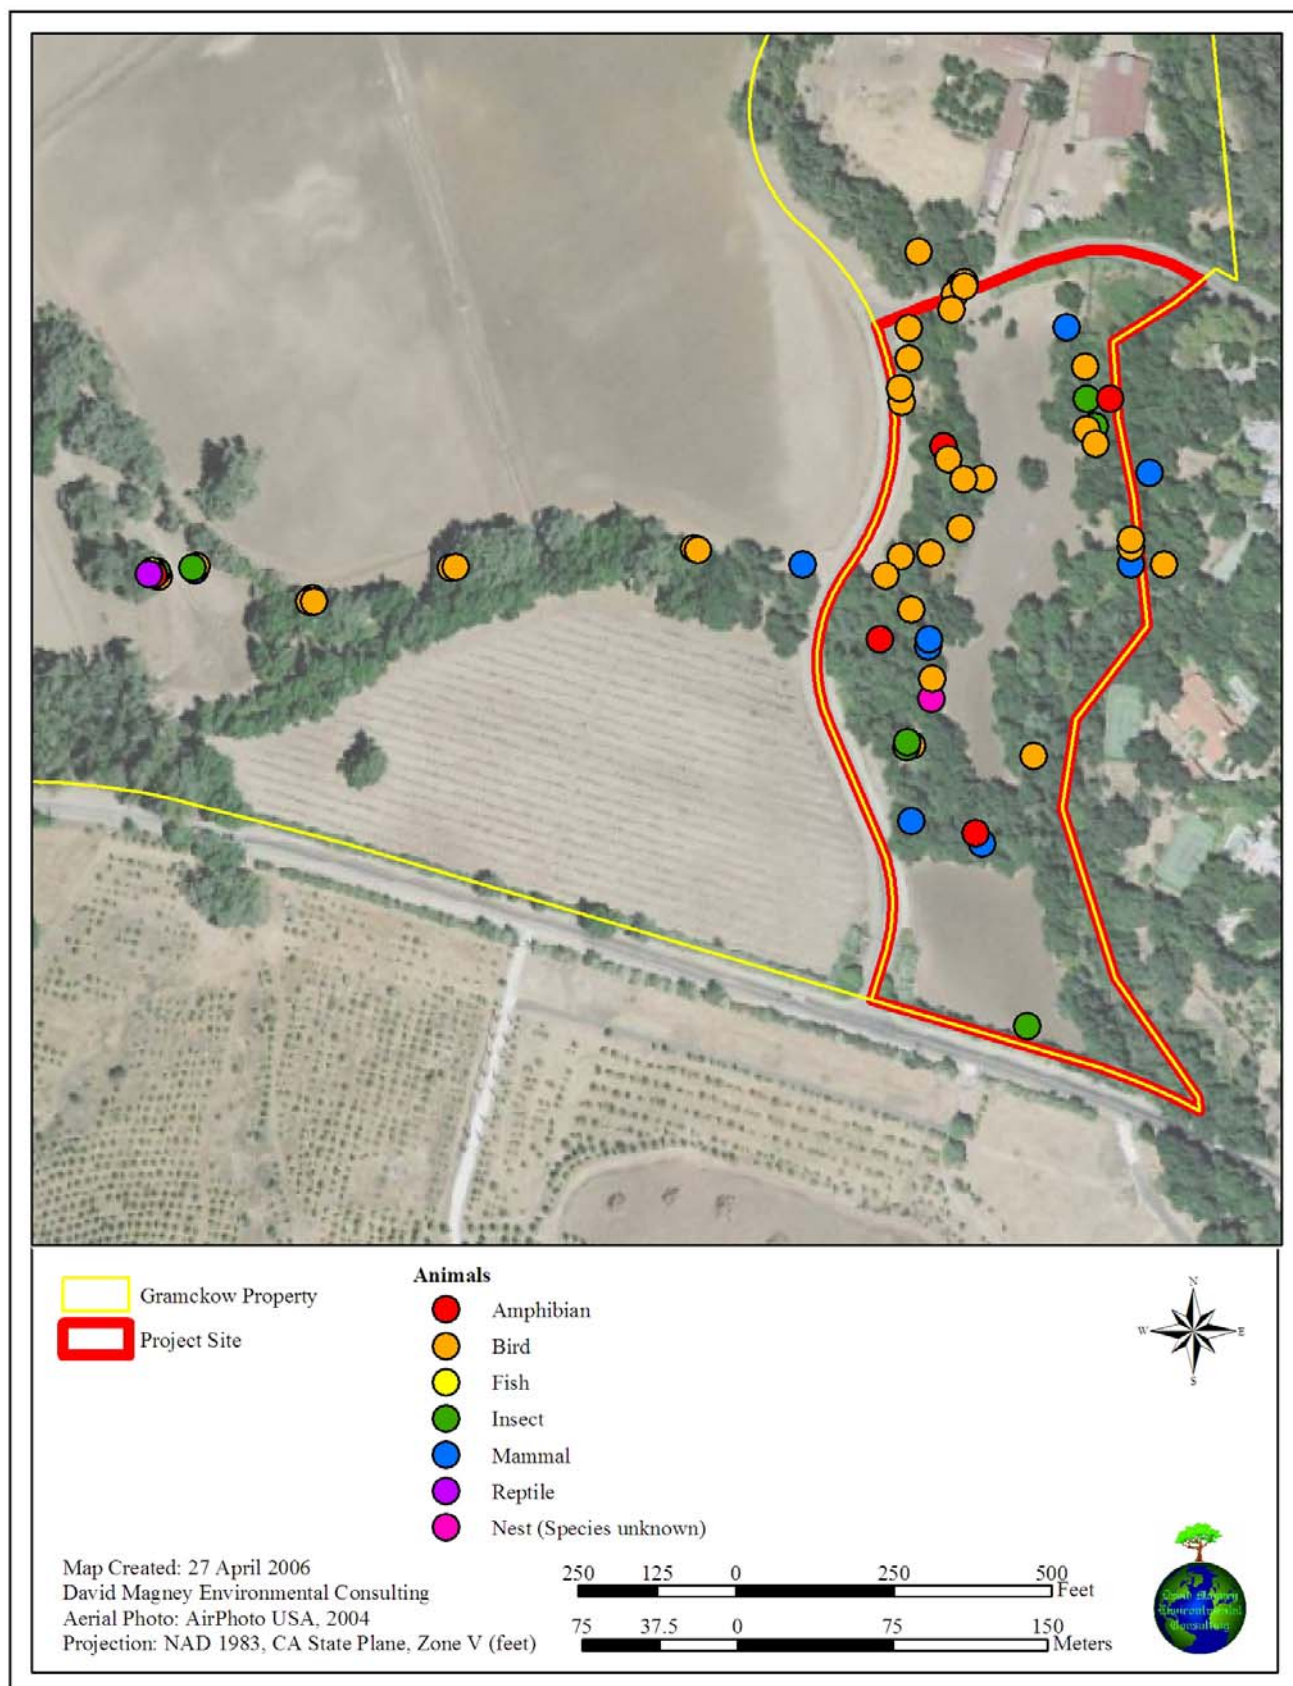
**Figure 4. Wildlife Observation Locations at the Gramckow Property**

Figure 4, Wildlife Observation Locations at the Gramckow Property (following Table 2), shows where all wildlife were observed during the biological resources surveys conducted on the property and during the HGM assessment conducted within the creeks onsite.

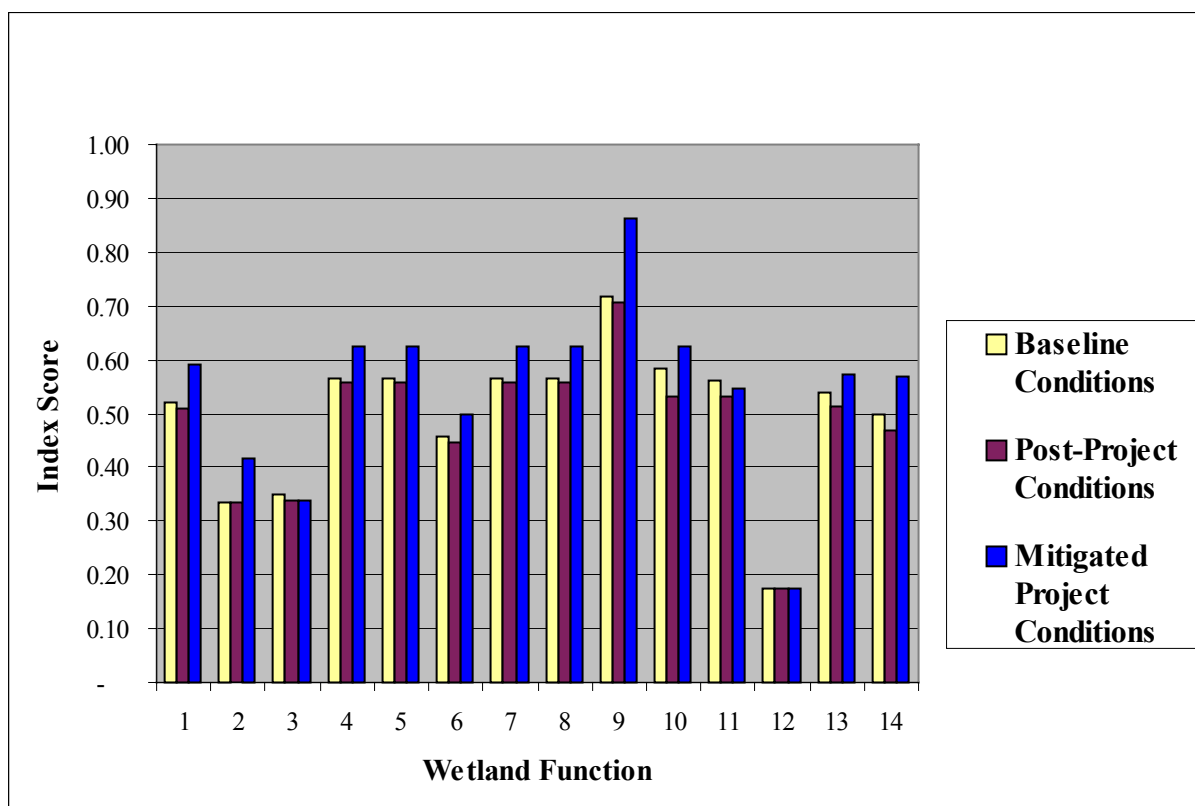
**Figure 6a. West Tributary of Live Oak Creek – Change Comparison Chart of  
 Wetland Functions between Pre-, Post-, and Mitigated-Project Conditions**

<sup>8</sup> Note: the rate of change represents the percent change from existing (baseline) conditions.

This section discusses and compares the three parts of the HGM assessment; the baseline (pre-project), the post-project, and the mitigated-project. Tables 10 a & b, Comparison of Pre-, Post-, and Mitigated-Project Wetland Function Index Scores, display the results of the three assessments side-by-side so that comparisons can be made. Figures 6 a & b, Change Comparison Chart of Wetland Functions Between Pre-, Post-, and Mitigated-Project Conditions, are intended as companions to Tables 10 a & b, and graphically illustrate the wetland function index scores for baseline (existing) conditions and compare them to projected post-project and mitigated-project index scores. These figures illustrate the differences between the three scenarios.

The proposed project is expected to have no effect on the surface and subsurface water storage and exchange capabilities on either tributary, with the index score remaining unchanged at 0.33 for the west tributary and 0.28 for the east tributary. due to the poor condition of the buffer zone under existing conditions. (See Table 10 and Figure 6.) There would be *no impact* to this function.

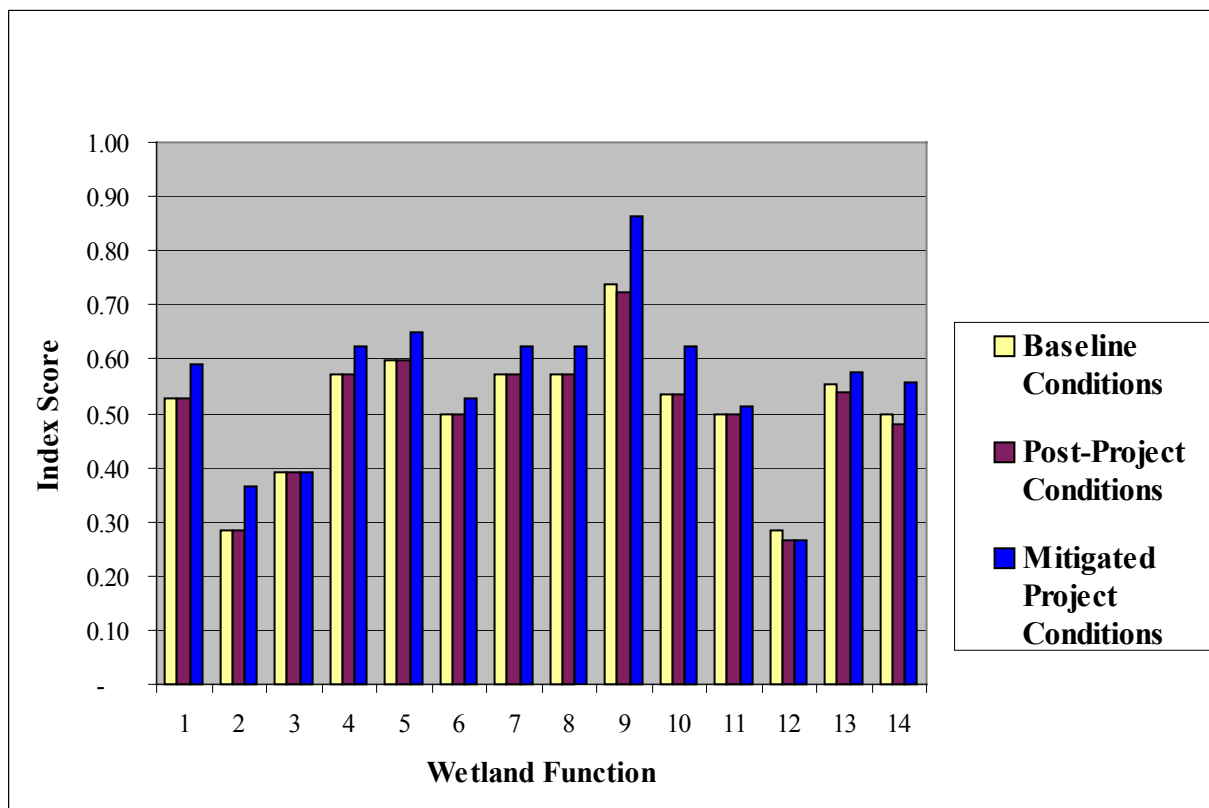
**Figure 6b. East Tributary of Live Oak Creek – Change Comparison Chart of Wetland Functions between Pre-, Post-Project, and Mitigated-Project Conditions**

<sup>9</sup>Note: the rate of change represents the percent change from existing (baseline) conditions.
