Response Strategy Site:	Santa Margarita	River Headwate	rs (MAR-060)	S Page 2 of 3		
	Site D	escription and F	eld Notes			
Site Location/Segment: MAR-RV-D-005	Site Description and Field Notes: Temecula and Murrieta Creeks join at this site. The natural sediment bottom forms a pond that empties into Santa Margarita River Canyon.					
Gradient: Low	River Width: 10 m (33 ft)	Vehicular Acce 4WD Pickup	ess? Recreational Use? None	Boat Launches: None		
Site Contact/s:	(619) 507-0944	a Ecological Rese	rve			
ESI Shoreline Type:	4-Sandy bars					
		Site Images				
RR	RL			RLS		
Upstream Murrieta Creek			Upstream Temecula Creek			
RL Downstream Santa Marga	arita River					
RR = River Right RL =		Pho	to Date: 8/1/2019

Response Strategy Map (overview)

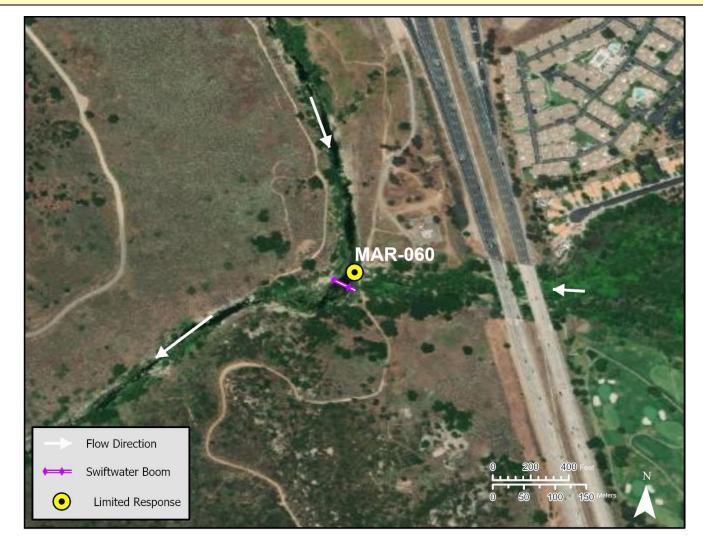
Implementation: Hand deploy boom as needed according to conditions and weather forecast.

Table of Response Resources						
Туре	Sub-Type	Size	Unit	QTY - Unit	Special Equipment or Comments	
Boom		6	inch	50 feet		
Stakes				4 each	Secure boom in place	
Personnel				4
