NORTH COAST WATERSHED AND FISHERY IMPROVEMENT PROGRAM

STREAM INVENTORY REPORT

Right Bank Tributary One to Martin Creek, Big River, 2002

CALIFORNIA DEPARTMENT OF FISH AND GAME

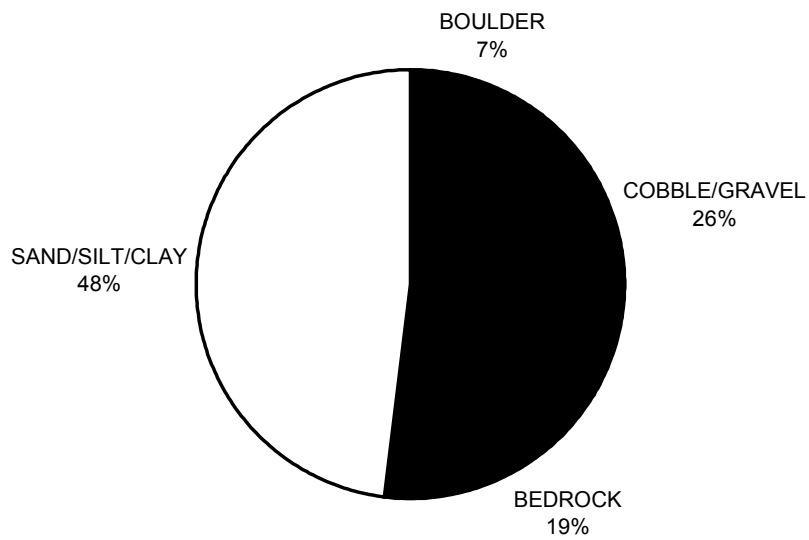
GRAPH 10

For the stream reach surveyed, the mean percent right bank vegetated was 68%. The mean percent left bank vegetated was 61%. The dominant elements composing the structure of the stream banks consisted of 48% sand/silt/clay, 26% cobble/gravel, 19% bedrock, and 7% boulder (Graph 10). Coniferous trees were the dominant vegetation type observed in 57% of the units surveyed. Additionally, 40% of the units surveyed had brush as the dominant vegetation type (Graph 11).

RIGHT BANK TRIBUTARY 1 MARTIN CREEK DOMINANT BANK COMPOSITION IN SURVEY REACH

The percentage of right and left bank covered with vegetation was moderate at 68% and 61%, respectively. In areas of stream bank erosion or where bank vegetation is not at acceptable levels, planting endemic species of coniferous and deciduous trees, in conjunction with bank stabilization, is recommended.
