STREAM INVENTORY REPORT

Right Bank Tributary Two to Martin Creek, Big River, 2002

CALIFORNIA DEPARTMENT OF FISH AND GAME

2003

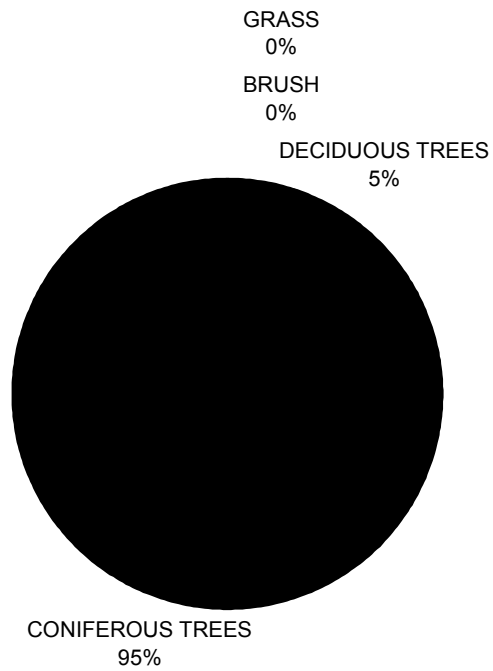
GRAPH 11

For the stream reach surveyed, the mean percent right bank vegetated was 30%. The mean percent left bank vegetated was 24%. The dominant elements composing the structure of the stream banks consisted of 50% sand/silt/clay, 14% bedrock, 27% boulder, and 9% cobble/gravel (Graph 10). Coniferous trees were the dominant vegetation type observed in 95% of the units surveyed. Additionally, 5% of the units surveyed had deciduous trees as the dominant vegetation type (Graph 11).

The percentage of right and left bank covered with vegetation was moderate at 30% and 24%, respectively. In areas of stream bank erosion or where bank vegetation is not at acceptable levels, planting endemic species of coniferous and deciduous trees, in conjunction with bank stabilization, is recommended.
