## 2-351 -B/A Site Summary- Yerba Buena Island

Yerba Buena Island is the prominent rocky island mid-span of the Bay Bridge. The sensitive portion of the shoreline is the southerly shore from the lighthouse at the south tip to just north of the west Bay Bridge span (just short of the underwater cable crossing). Shoreline and access under management of USCG. There are small cobble pocket beaches on the south side of the island which are used by pinnipeds and birds.

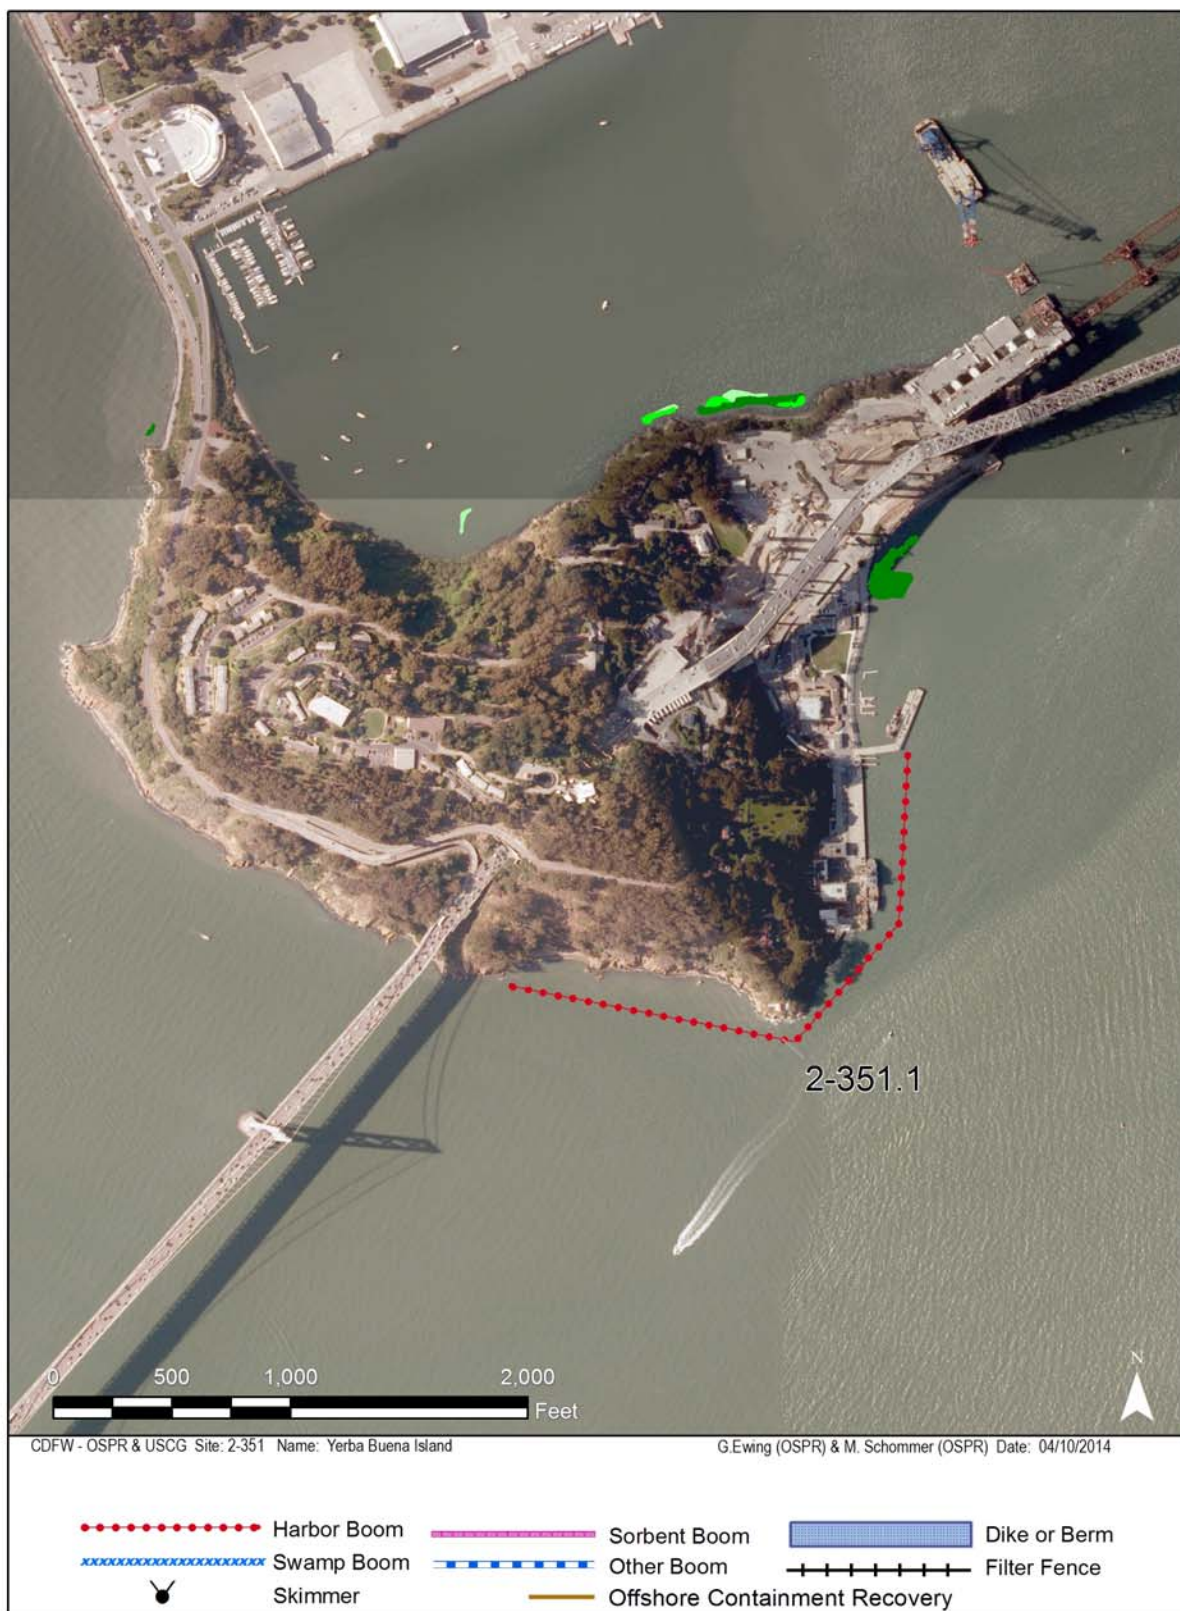
Deploy 3,000 feet of 9X9+ Hboom parallel to the shoreline around the south side of the island to keep oil off the pocket beaches between lighthouse point and the west span of the Oakland Bay Bridge. Great care must be taken to prevent oil from getting behind the boom at either end throughout the tidal cycle. A 200 foot deflection boom should be in place at the west end of the boom during the flood tide. (A similar deflection may be necessary at the east end of the boom under some wind and tide conditions.)

Anchoring Recommendations: Waters are very deep at the shore and there are relatively few obstructions. The east end of the boom may be fastened or anchored off the the lighthouse ( there is an EYE bolt embedded in the rock below the lighthouse which may be helpful). The west end of the boom should be anchored west of the sand and gravel beaches just south of the western span of the Bridge. Few midpoint anchors are needed because the boom is deployed parallel to straight shorelines and currents are minimal near the shoreline. (Although the tidal currents are strong, they run parallel to the shore in these areas.) Midpoint anchors are needed primarily to keep the boom off the shoreline. Danforth anchors are satisfactory in the soft bottoms off the beaches where seals haul out, but Northhill anchors should be used on the rocky bottom below the lighthouse. The boom may be attached to the dolphin pilings off the beaches.

Potential for 3 foot seas. Most of the water is very deep close to shore but there are occasional rocks and pilings. There are underwater cables just north of the Bay Bridge. Approach by foot is extremely hazardous because of steep cliff face.
