Memorandum

- Mary Small, California State Coastal Conservancy to Diana Hurlbert, Santa Monica Bay Restoration Commission
- Nick Garrity, P.E. from
- Ballona Wetlands Restoration Project (1793.13) subject Task 13: Technical Support for Environmental Review & Permitting Preliminary assessment of Alternative 4 culverts to Marina del Rey (Task 13.18)

Ballona Wetlands **Restoration Project**

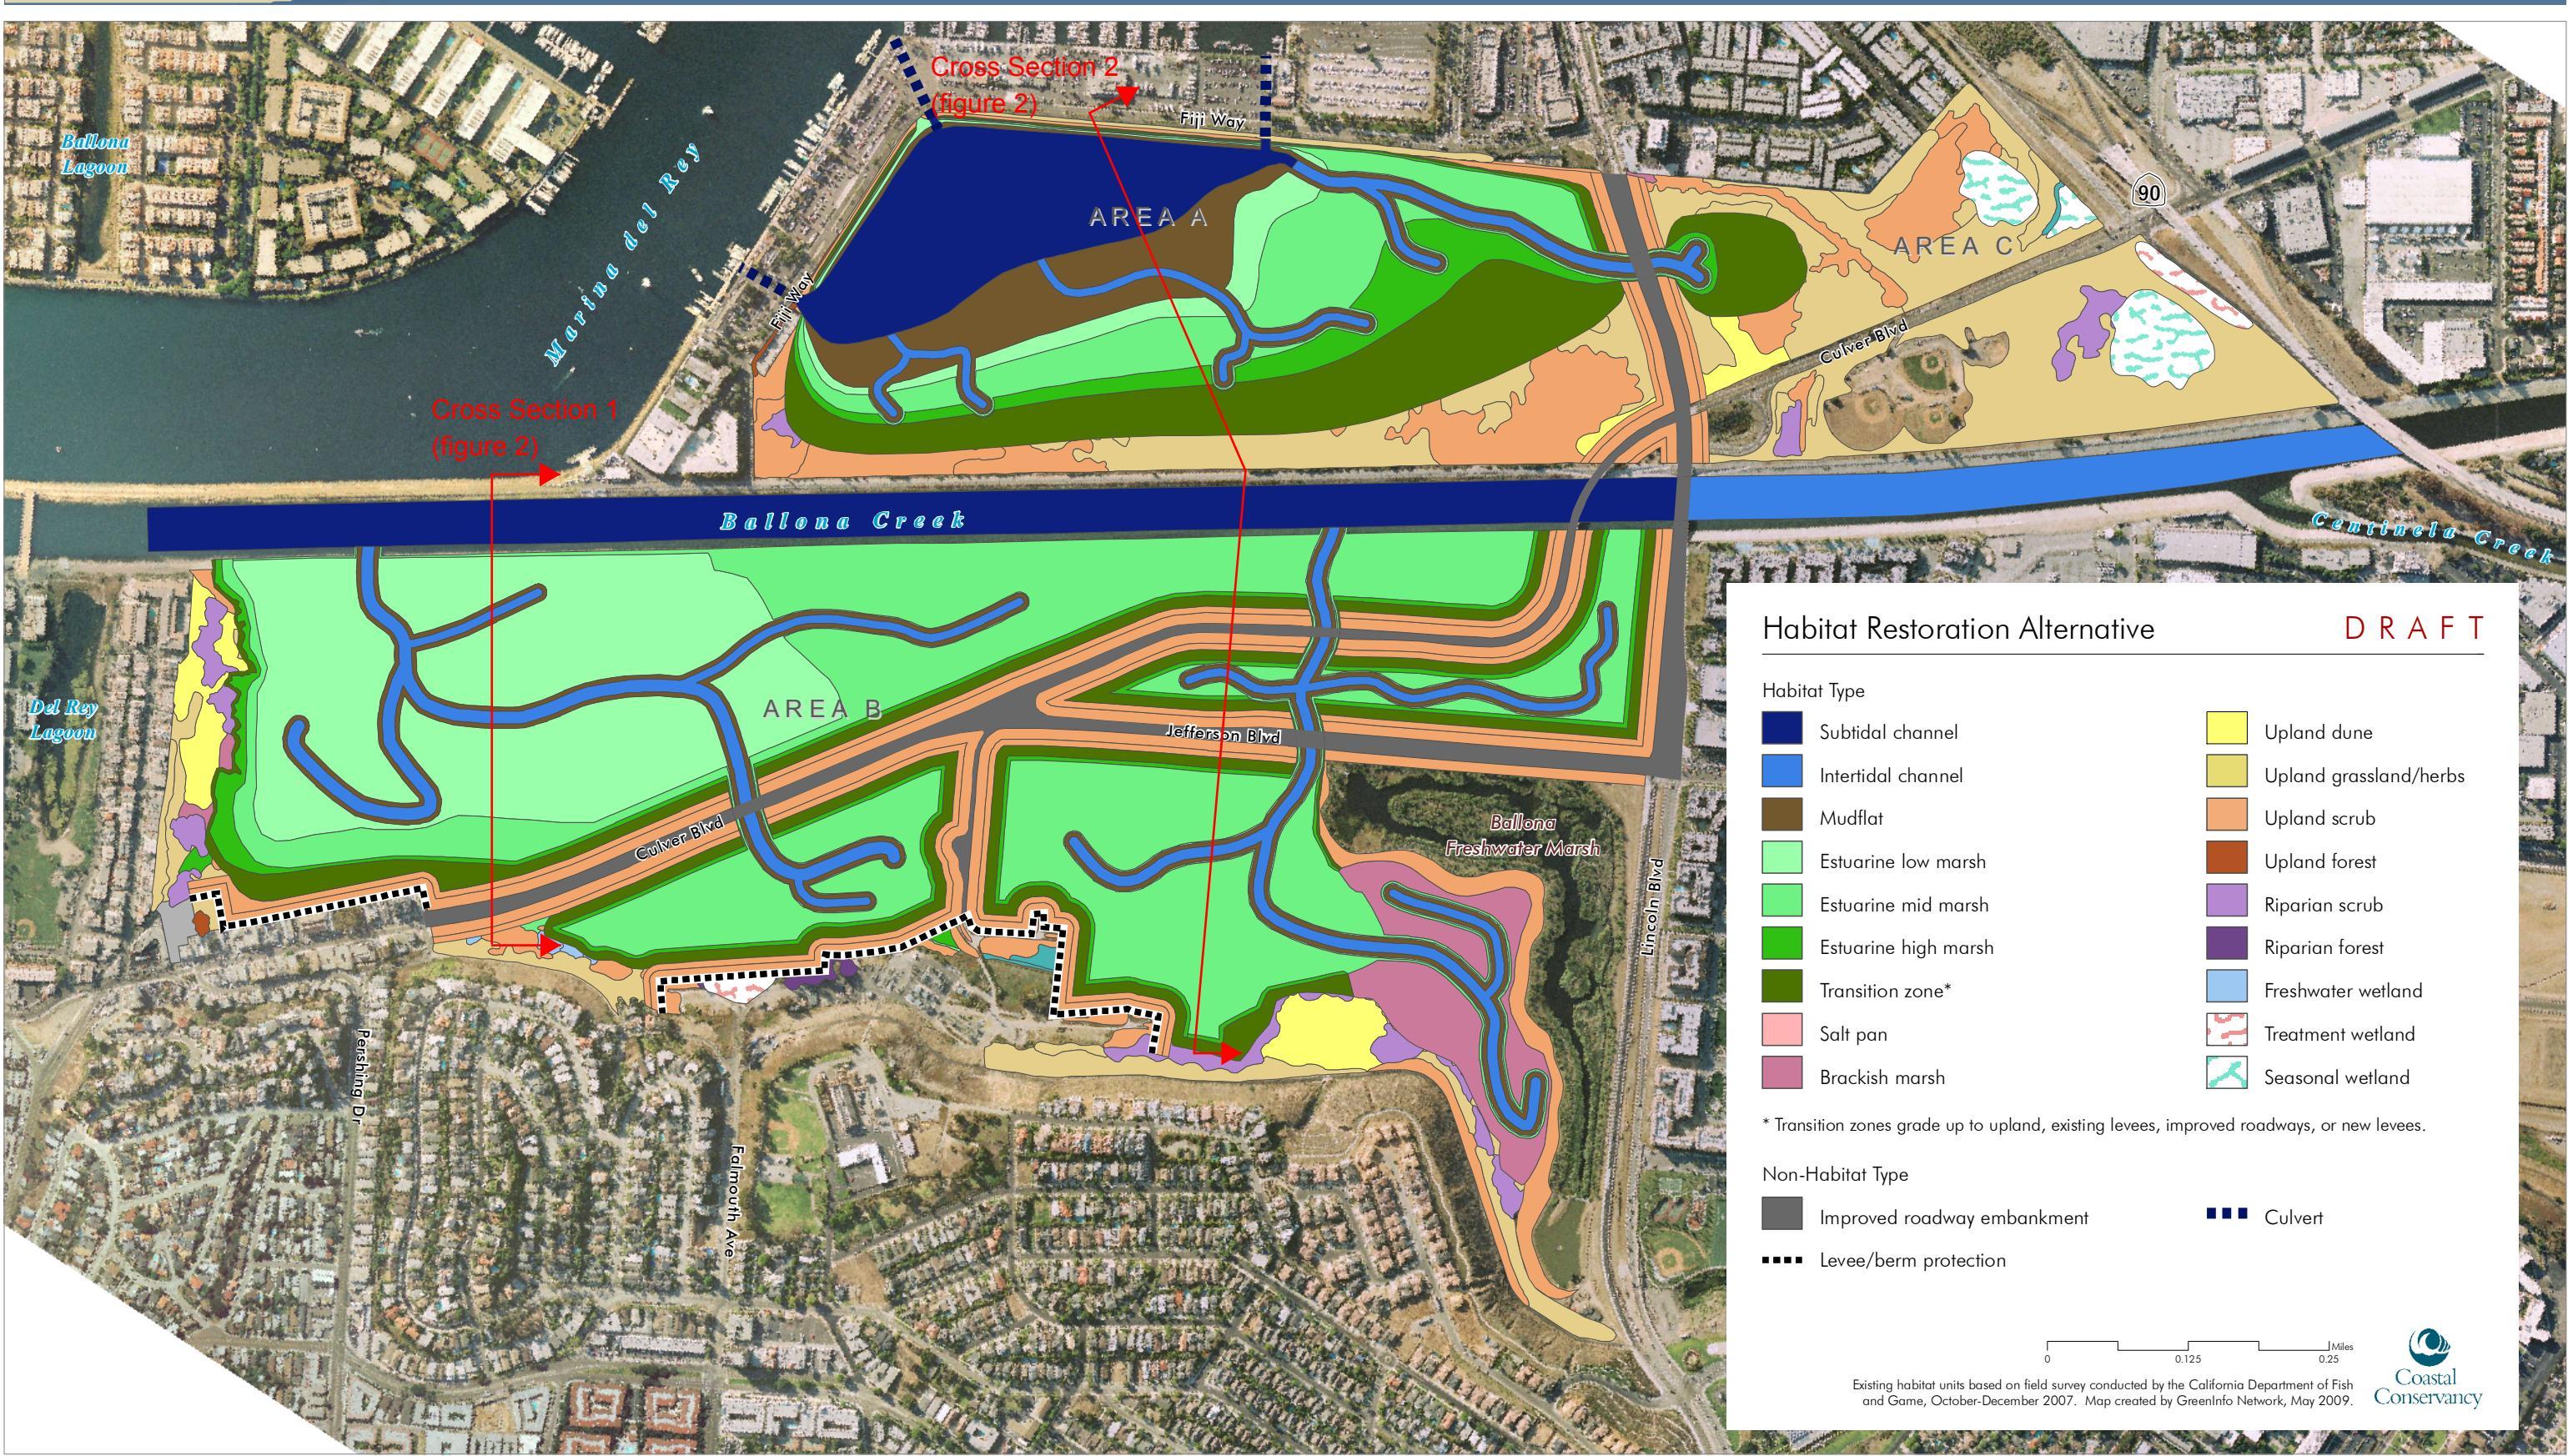
figure 1

Habitat Restoration Alternative

This memorandum provides hydrology and engineering information on the Ballona Wetlands Restoration Alternative 4 (Figures 1 and 2). Specifically, the purpose of this memorandum is to assess technical issues associated with constructing new culvert tidal connections between Area A and Marina del Rey (MDR) under Fiji Way. This memo is organized as follows:

Alternative 4 from the Ballona Wetlands Restoration Feasibility Report (PWA and others 2008) proposes to restore subtidal and intertidal habitat in Area A (north of Ballona Creek and west of Lincoln Blvd.) (Figures 1 and 2). The restored subtidal habitat would be tidally connected to MDR through culverts under Fiji Way with a total estimated cross-section area of approximately 500 square feet (e.g., approximately five 10-ft by 10-ft box culverts). Area A would not be connected to Ballona Creek. The existing culvert connecting the Fiji Ditch to MDR Basin H north of Area A would not be changed, however the existing culvert would provide tidal flows to the larger restored habitat area (see Figures 3 and 7).

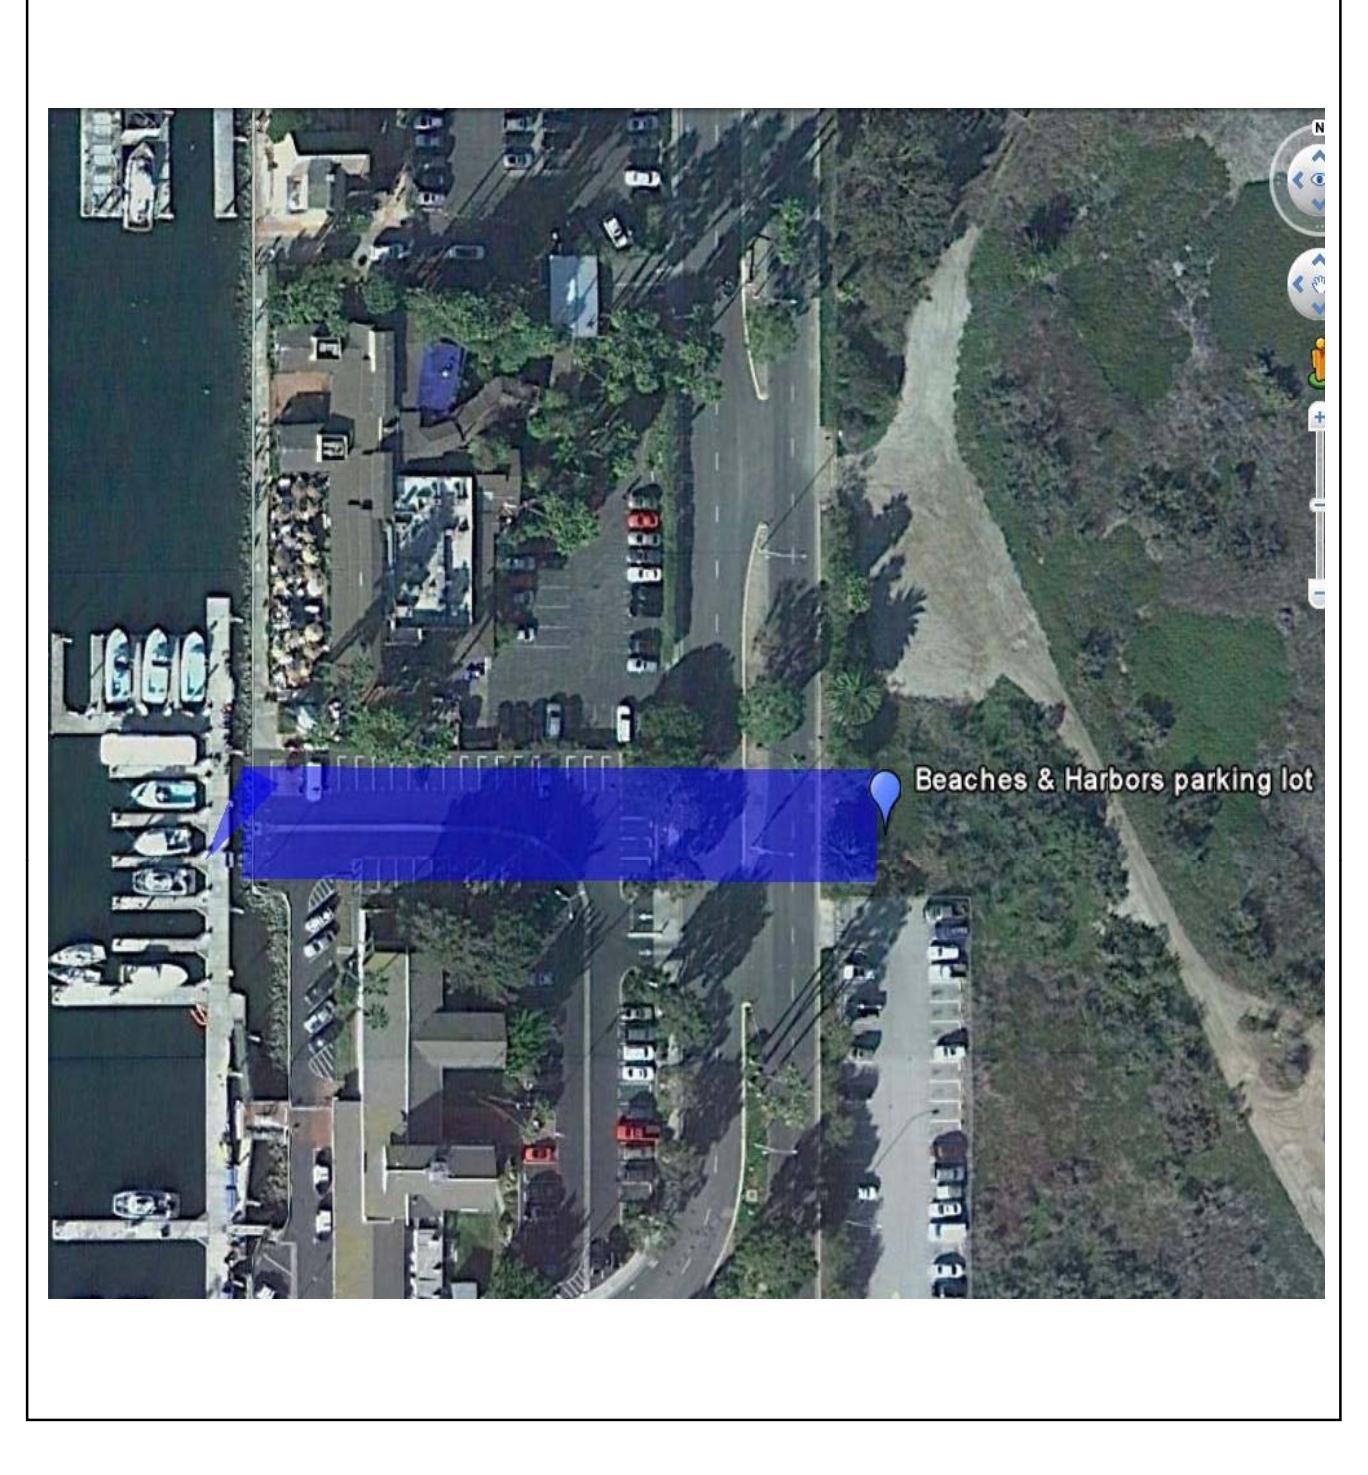
Figure 5

Beaches & Harbors Parking Lot Potential Culvert Location

- 2. Beaches & Harbors north parking lot (Figure 5). The culverts would be located under the existing Beaches & Harbors north parking lot. This location would require consideration of the MDR sea wall, underground utilities, and navigation constraints (see Sections 3.2, 3.3, and 3.4).

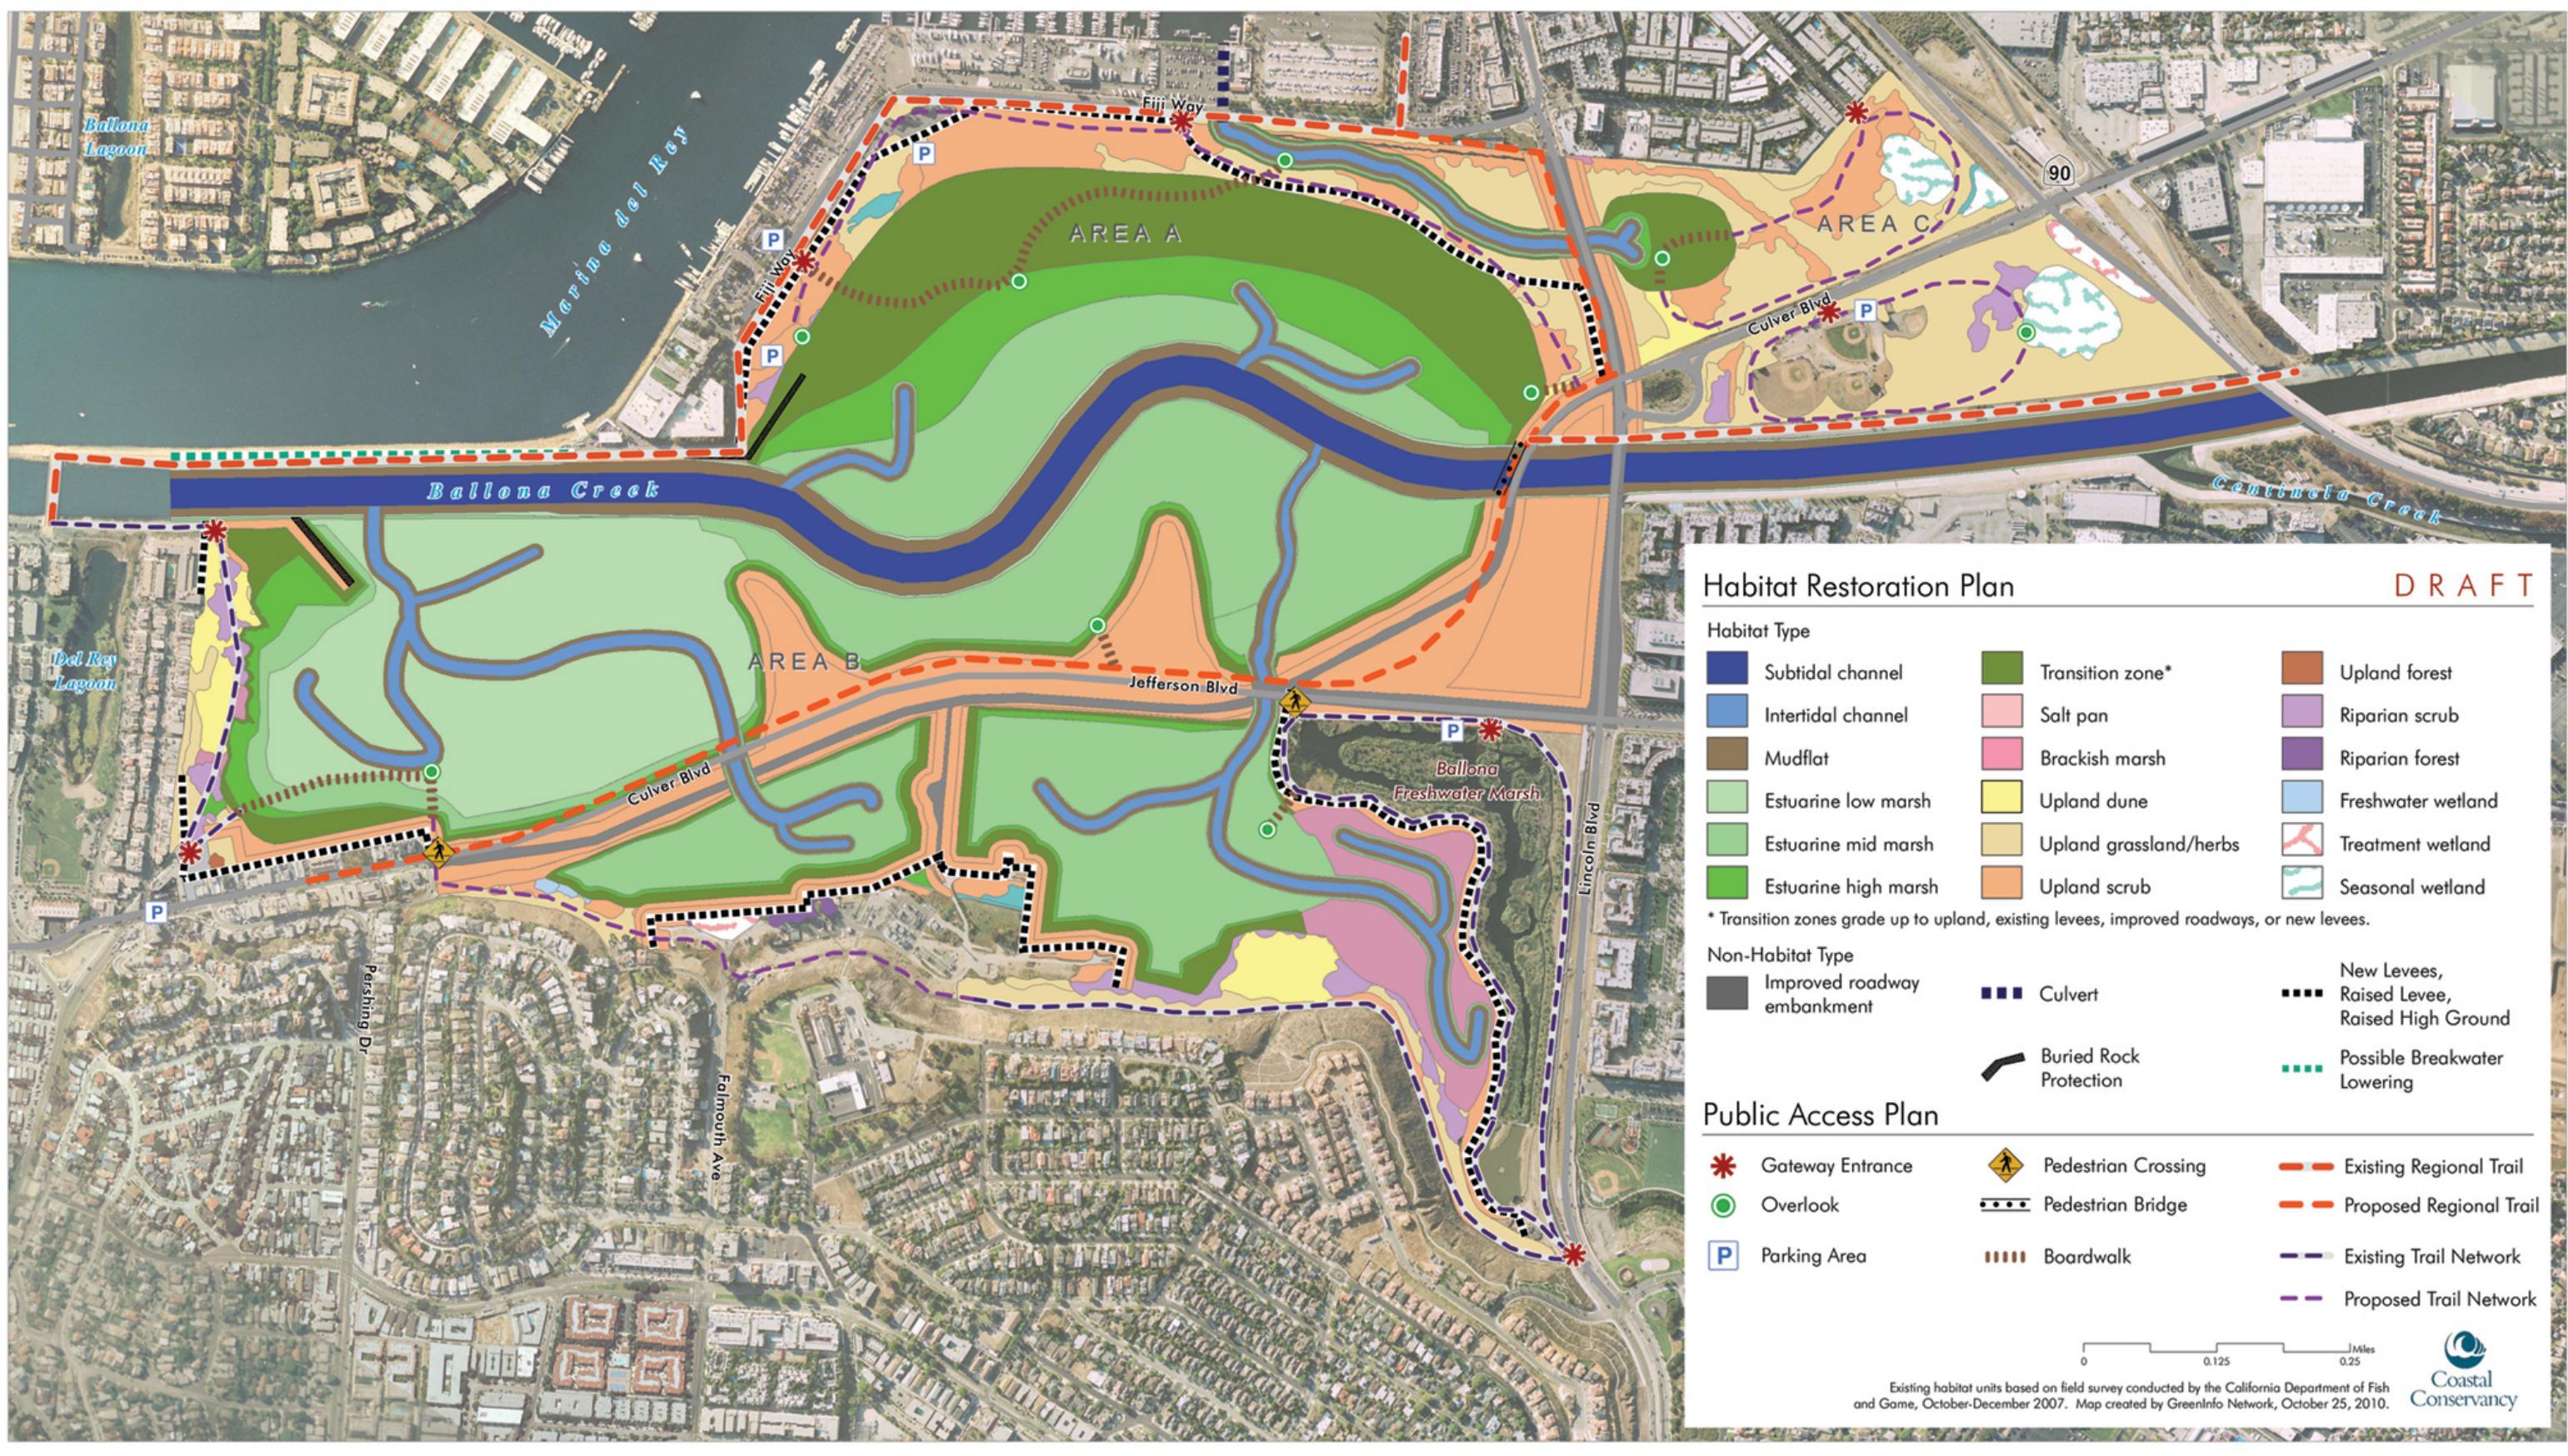
Figure 9

Proposed Restoration Plan - Habitat Restoration and Public Access

In comparison to Alternative 4, Alternative 5 (Figure 9) avoids these culvert constraints and uncertainties by connecting Area A to Ballona Creek. Alternative 5 is ranked as the highest alternative (above Alternative 4) in the Feasibility Report (PWA and others 2010). Given that connecting Area A to Ballona Creek avoids the culvert constraints and is preferred in terms of habitat connectivity, circulation, and other benefits of Alternative 5discussed in the Feasibility Report, variations of Alternative 5 that incorporate other elements of Alternative 4 may be preferable to Alternative 4. For example, variations of Alternative 5 that include additional subtidal habitat and/or maintain the existing alignment of Ballona Creek (as opposed to realigning the channel as shown in Figure 9) may be preferable to Alternative 5 (with Area A Management Team consider pursuing these or other variations of Alternative 5 (with Area A connected to Ballona Creek) as project alternatives in place of Alternative 4 (and MDR culvert connections to Area A).
