1-352-A Site Sun	Site Summary - White Slough & Salmon Creek			
County: Humboldt	ACP Division/Segment: HM - G - S16	HM - G - S17	HM - G - S18	HM - G - S25
NOAA Chart: 18622	Map Book: CA Road Atlas	Decimal	Degrees: 40.6	8474 -124.22364

1-352-A Site Summary - White Slough & Salmon Creek

Strategy: 1-352.1 Objective: Prevent oil from entering the slough

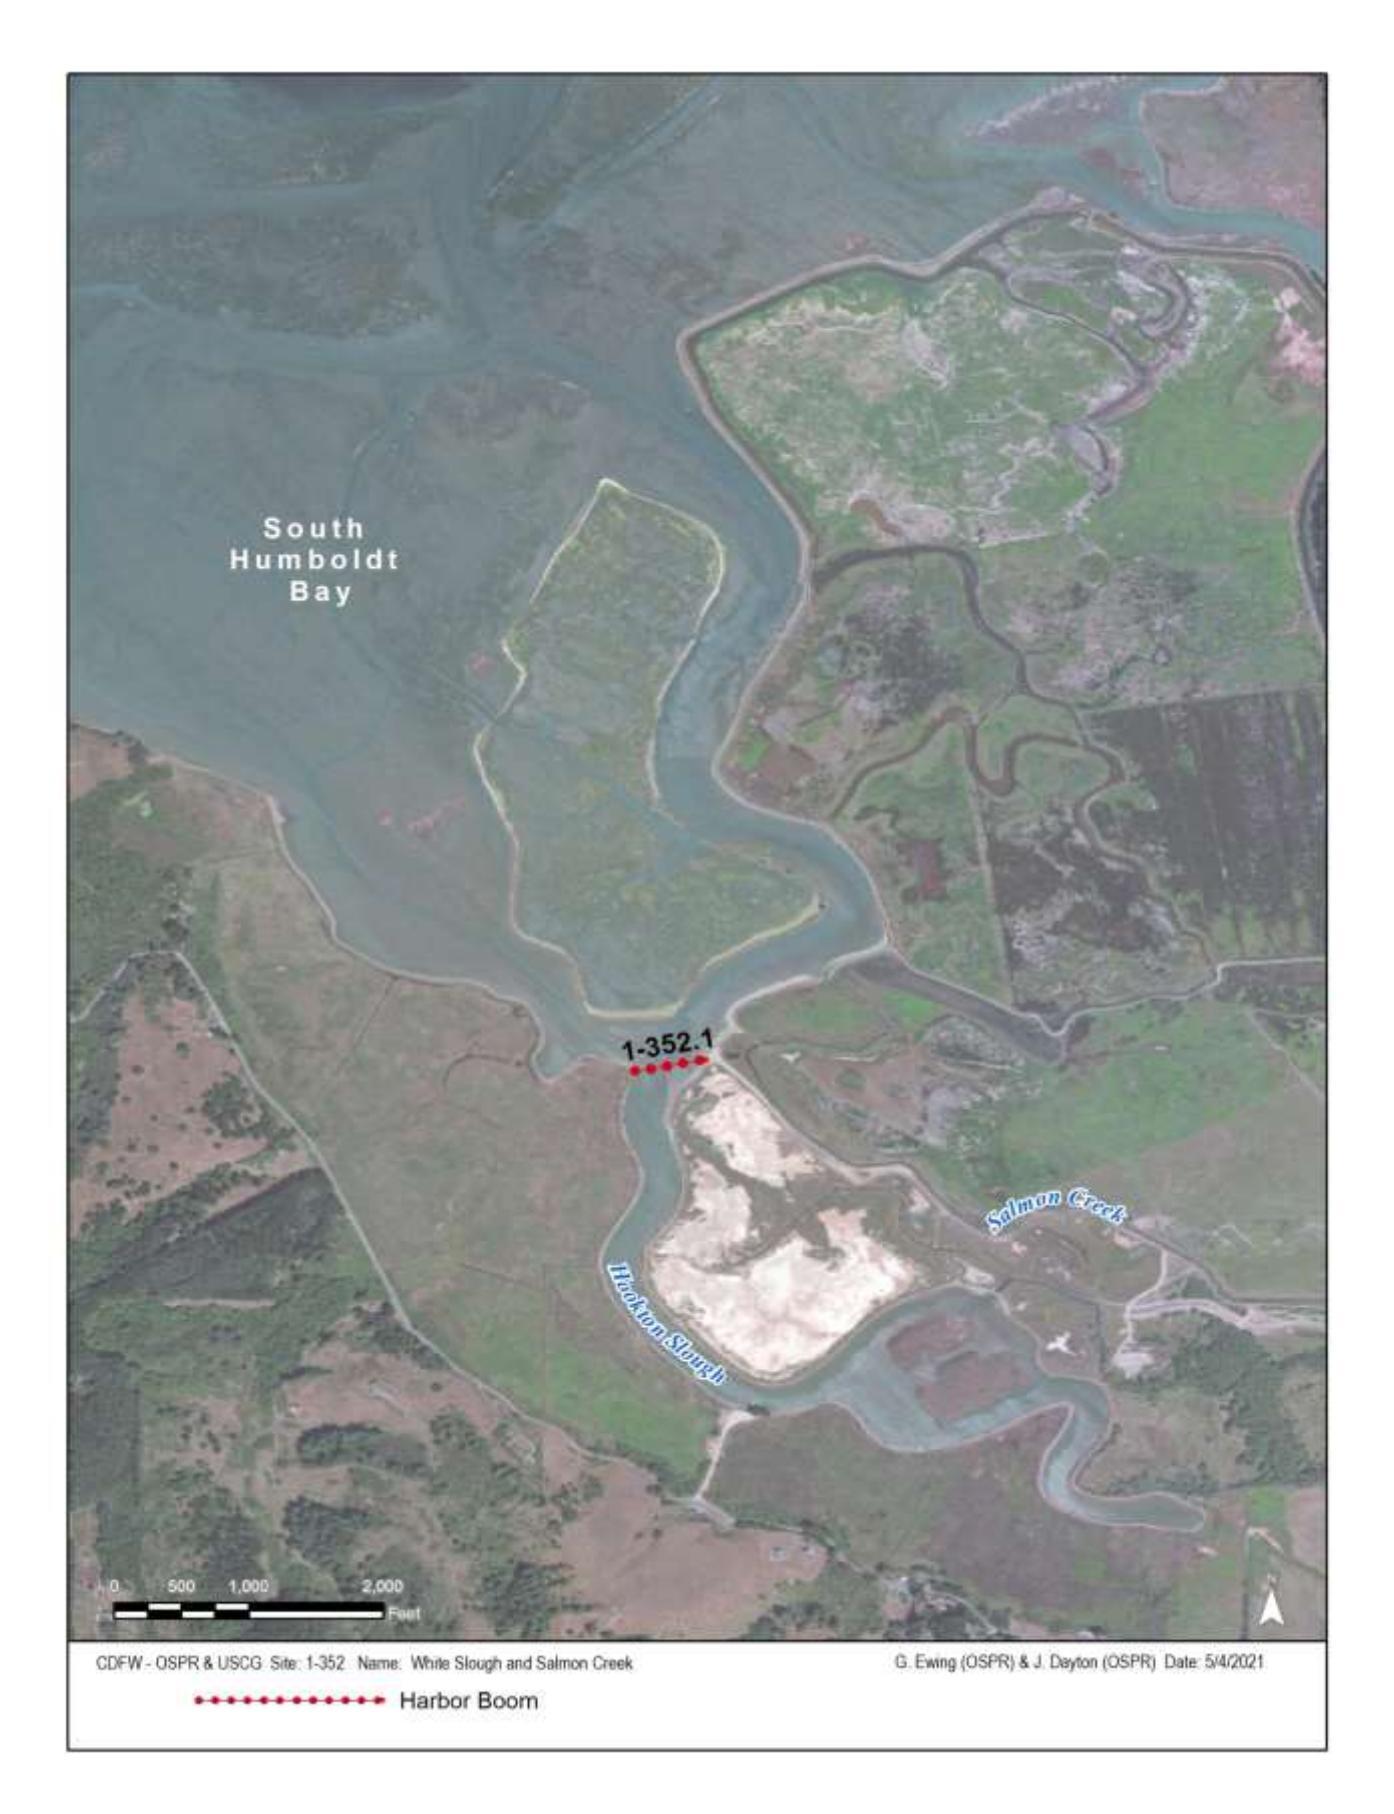
Strategy: Use 600' of hard boom, deliverable to site at Hookton Slough small boat launch off Hookton Road. Small, shallow draft vessel can be launched here to deploy boom to site.
