4-765-A Site Summary - Mandalay State Beach

4-765-A Site Strategy - Mandalay State Beach

CDFW - OSPR & USCG Site: 4-765 Name: Mandalay State Beach

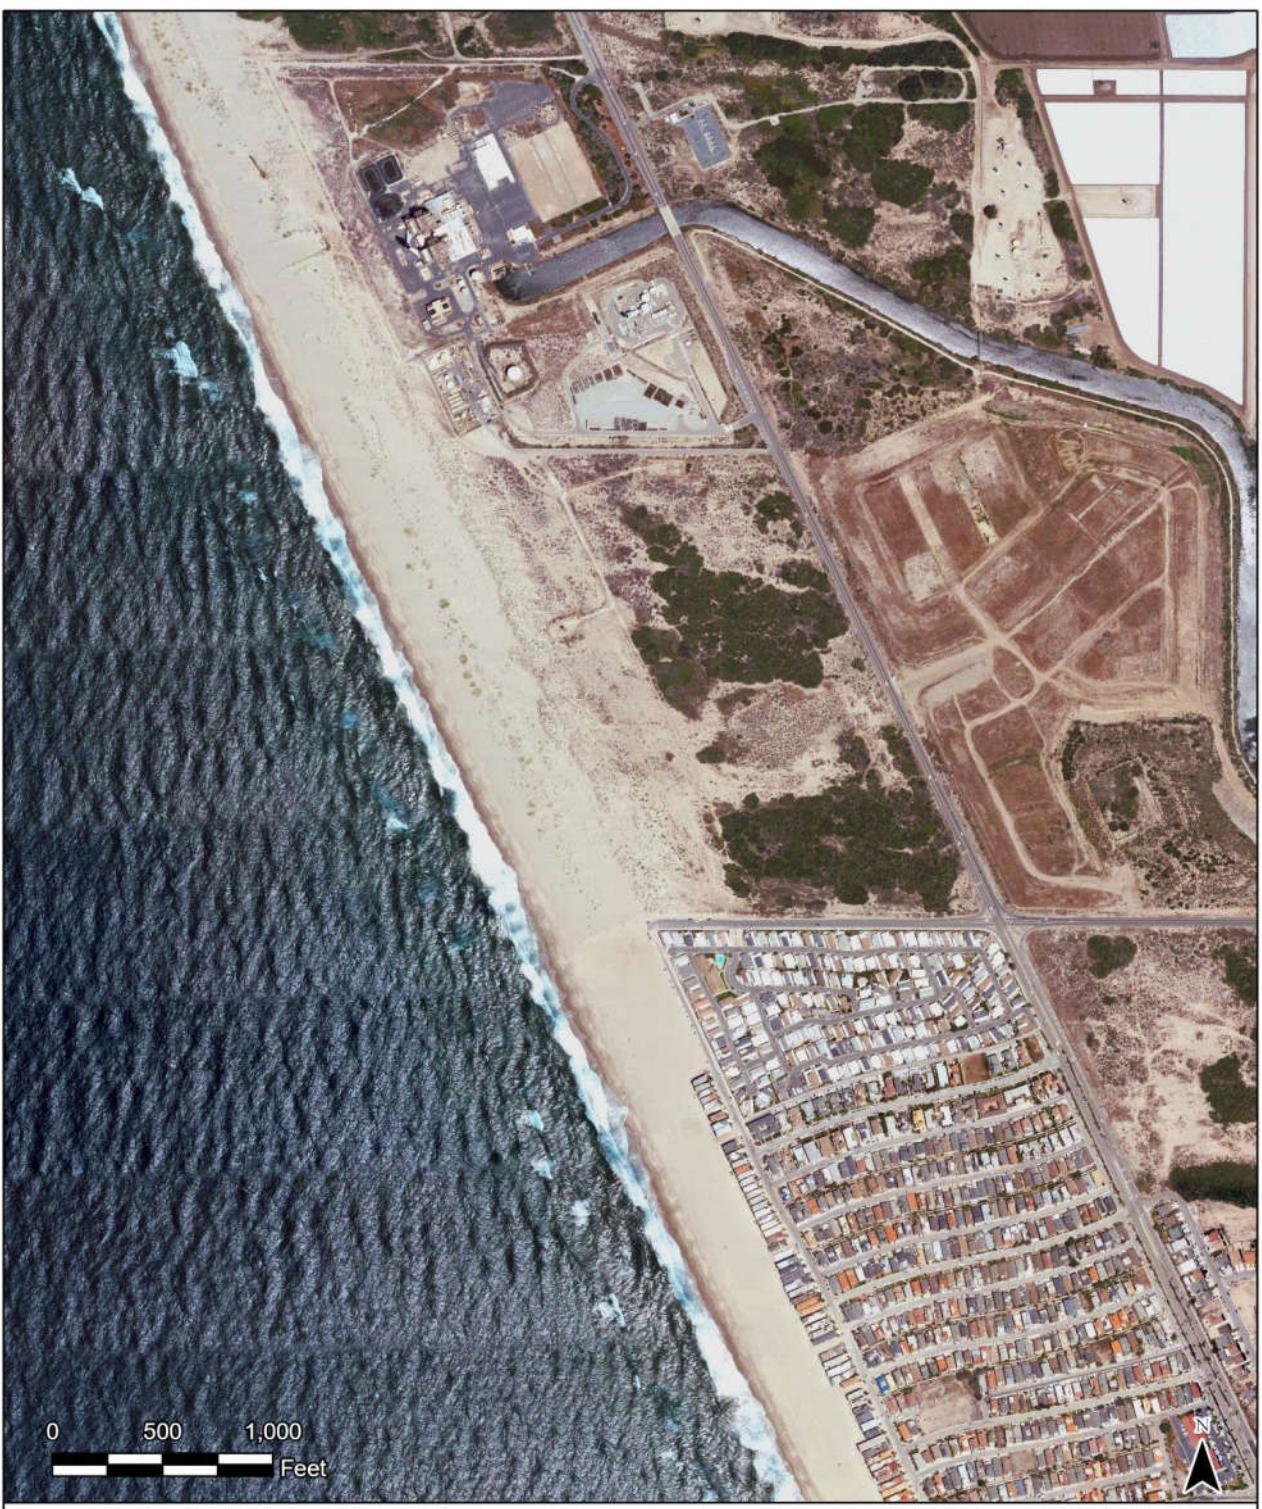
No shoreline strategies; consider offshore strategies

Strategy: **4-765.1** *Objective:* No Onsite Options: Consider Offshore Containment/Recovery/ART *Strategy:* There are no feasible onshore protection strategies for this area. Attempt to collect and/or disperse oil in offshore locations before it reaches the shoreline.
