Site De	escription and Field No	otes				
Site Location/Segment: MAR-SD-C-010	Site Description and Field Notes: The Santa Margarita River flows under Stuart Mesa Road at this site.						
Gradient: Medium	River Width: 70 m (230 ft)	Vehicular Access? All vehicles	Recreational Use? None	Boat Launches: None			
Site Contact/s: Provost Marshal's Office Camp Pendleton Desk Sergeant (760) 763-2077	MCB Camp Per (760) 725-9743	ndleton Spill Hotline	MCB Camp Pendleton Commanding Officer (760) 725-5061				
ESI Shoreline Type:	9-B Vegetated low banks						
		Site Images					
A Contraction of the second se		RL		RR			
Upstream	Downstream	Downstream

Site Objectives: Containment

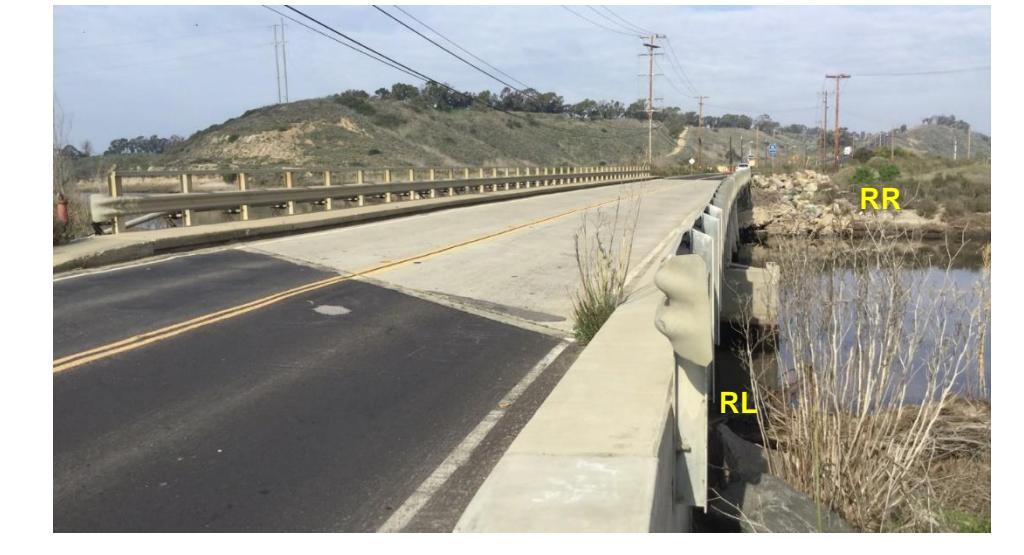
Upstream

Downstream

Straight Across

RR = River Right RL = River Left

Photo Date: 1/30/2019

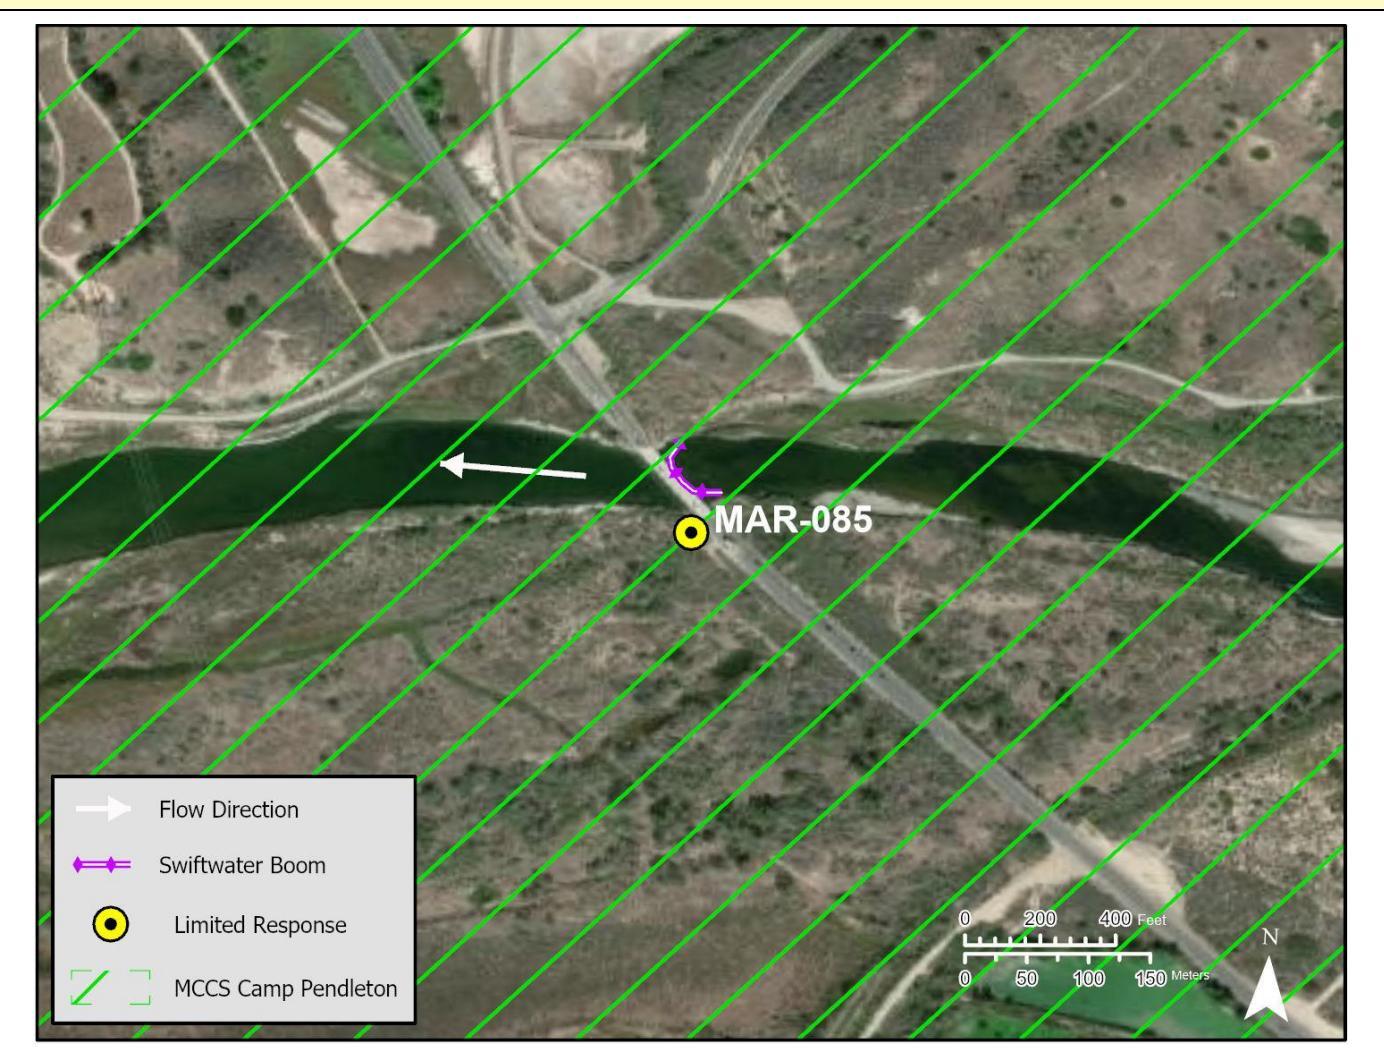
Response Strategy Map (overview)

Implementation: Deploy boom from the road. A road closure may be needed.

Table of Response Resources							
Туре	Sub-Type	Size	Unit	QTY - Unit	Special Equipment or Comments		
Boom		6	inch	300 feet			
Stakes				4 each	Secure boom in place		
Personnel				4
