1-135-A Site Summary - Point St. George 1-135-A

1-140-A Site Summary - Castle Rock National Wildlife Refuge

1-145-A Site Summary - Elk Creek and Crescent City Harbor

1-150-A Site Summary - Battery Point 1-150-A

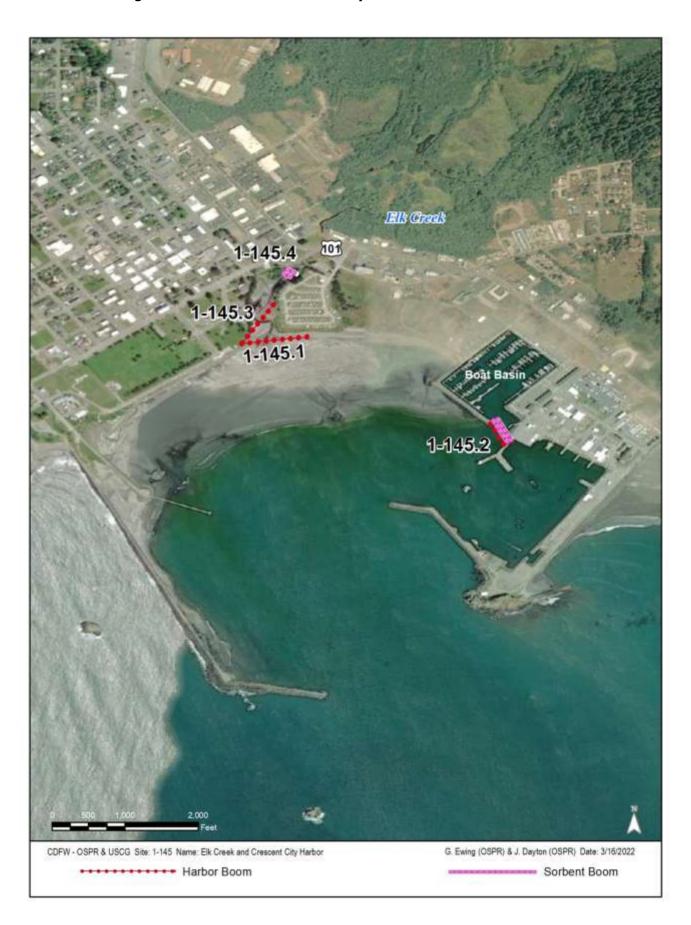
1-145-A

Strategy: Boom the mouth of Elk Creek with harbor boom to prevent oiling. The estuary can be boomed on foot at lower tides.

Strategy: Boom the entrance channel to the boat basin to exclude incoming oil or retain spilled oil within the inner boat basin for recovery.

Strategy: This is an alternate or secondary strategy to 1-145.1 and may be more appropriate under heavy wave action. Boom the mouth of Elk Creek and deflect oil to collection point near trailer park. This strategy was developed during the March 2011 tsunami response.

Strategy: This is an alternate or secondary strategy to 1-145.1 and 1-145.3 and may be more appropriate under heavy wave action. Deploy sorbent boom near creek mouth to prevent oil from moving upstream on flood tide. This strategy was developed during the March 2011 tsunami response.
