4-145-A Site Summary - Morro Strand State Beach (Pismo Clam Preserve)

County: San Luis Obispo **ACP Division/Segment:** SL - E - S003

CDFW - OSPR & USCG Site: 4-145 Name: Morro Strand Beach (Pismo Clam Preserve)

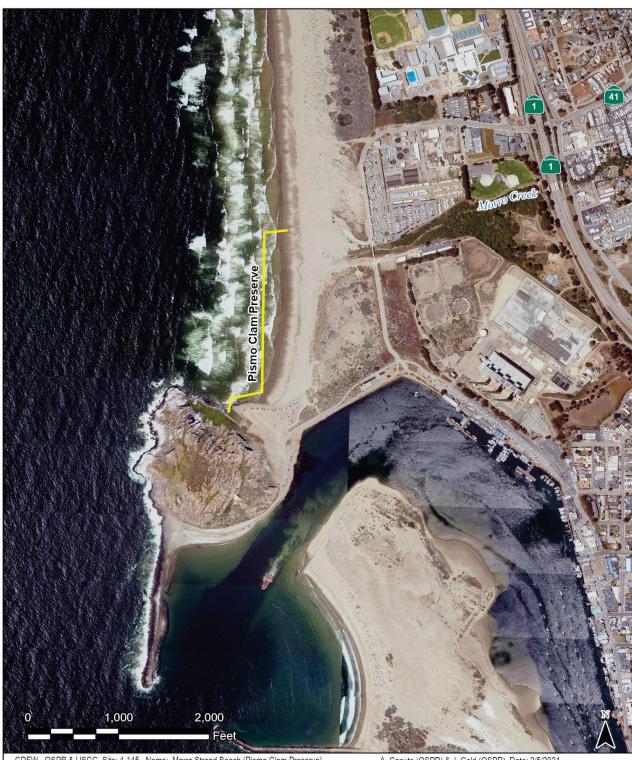
No shoreline strategies; consider offshore strategies

Strategy: 4-145.1 Objective: No Onsite Options: Consider Offshore Containment/Recovery/ART *Strategy:* Offshore containment and recovery (OCR) are the preferred option although heavy surf may hinder these operations. No specific response equipment listed due to the many variables associated with each spill regarding OCR. Early consideration should be given to the use of applied response technologies. Table of Response Resources
