**4-685-A Site Summary - Carpinteria Marsh****4-685-A****County :** Santa Barbara **ACP Division/Segment :** SB - S - S03**NOAA Chart :** 18725(a)**Map Book :** 998 A-C x 6-7**Decimal Degrees :** 34.396667 -119.535**Site Description:**

**Site Strategies:****Strategy: 4-685.1 Objective:** Exclude Oil

**4-685-A Site Strategy - Carpinteria Marsh****4-685-A**

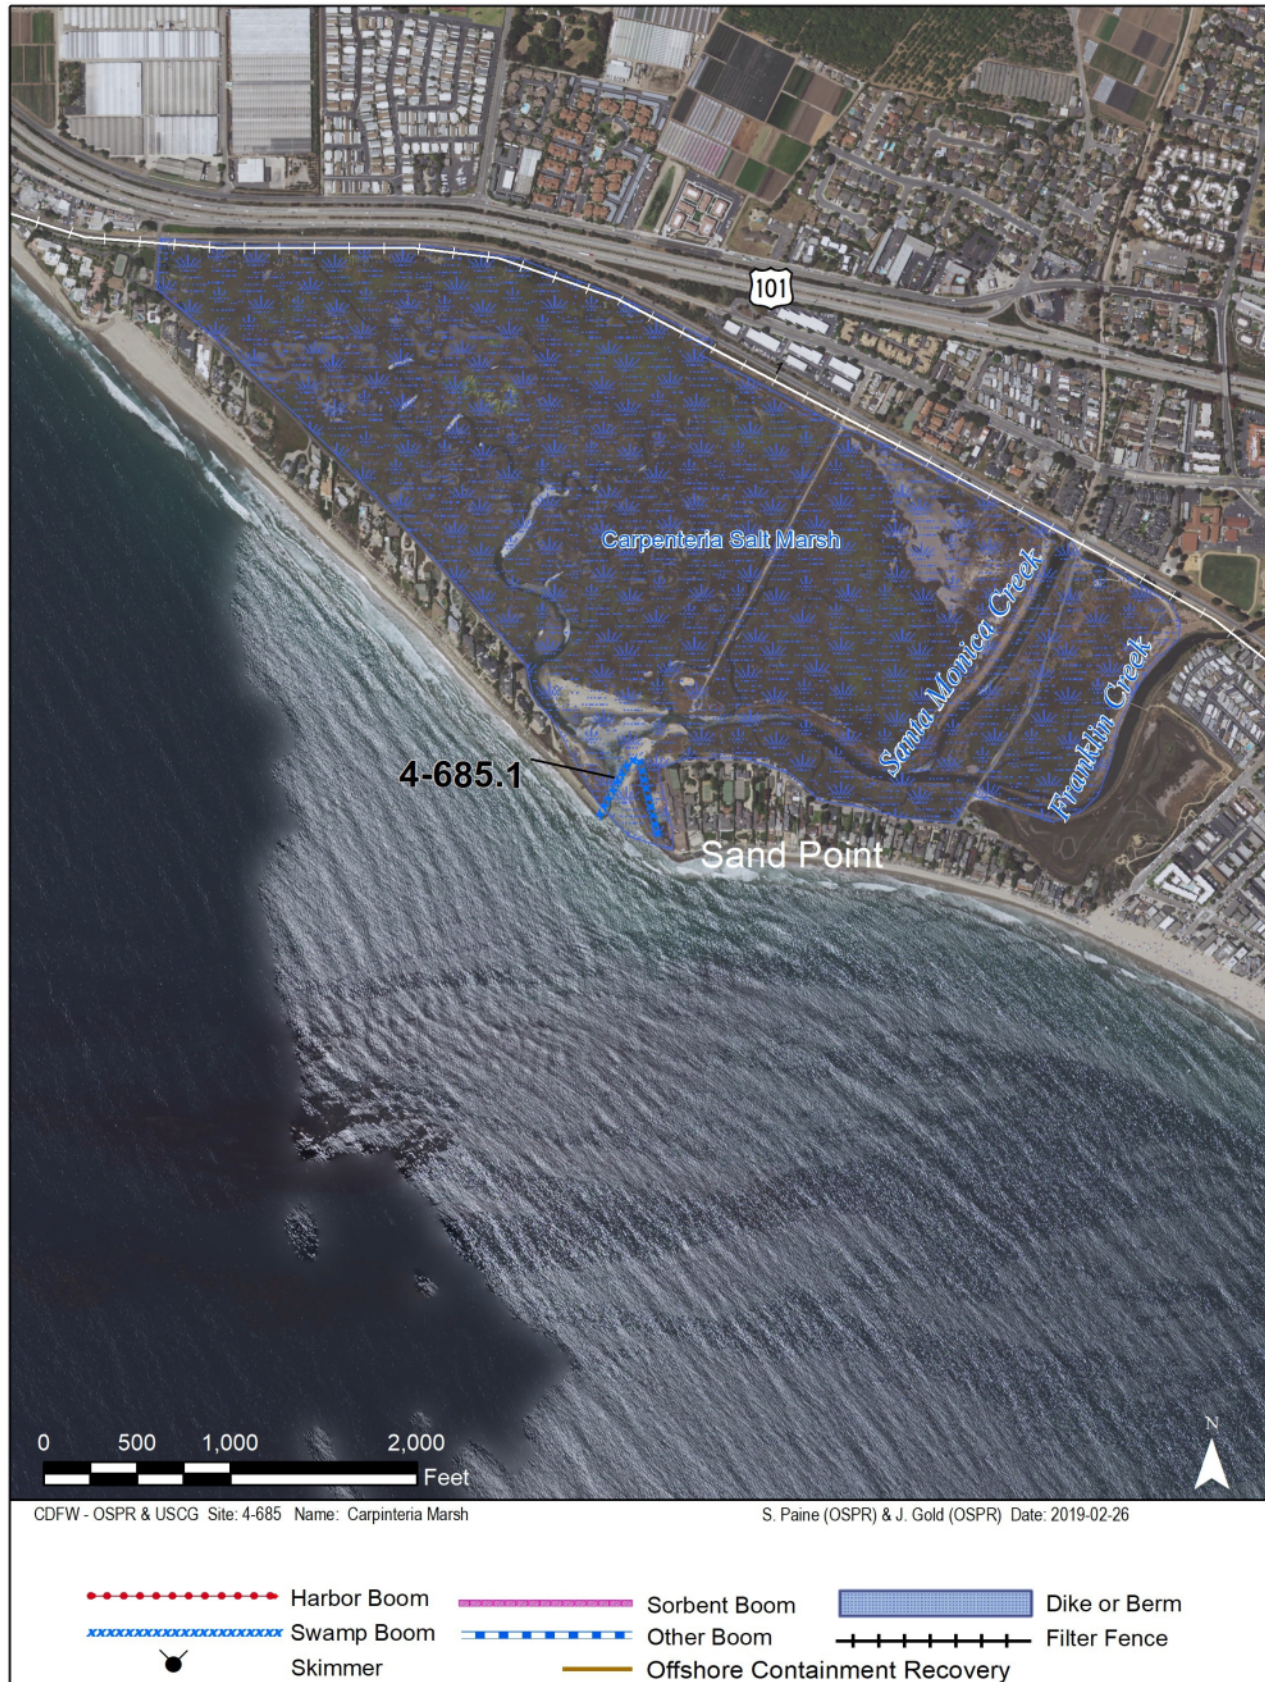
*Strategy:* Deploy exclusion booms across the inlet to minimize the likelihood of oiling the estuary. Place the booms in a configuration that forms an adjustable oil collection pocket that can accommodate changes in flow direction. Back exclusion booms with sorbent booms to minimize leakage. Line the shorelines and any side channels within the inlet to prevent collateral oiling. If there is recoverable oil on-water, deploy sorbents and contact the IC immediately regarding the use of skimmers. Monitor, adjust, and replace booms as needed to maintain effectiveness.
