County: San Luis Obispo **ACP Division/Segment:** SL - F - S006**NOAA Chart:** 18703**Map Book:** 631 G-3**Decimal Degrees:** 35.34057 -120.84211**Site Description:**

Site Strategies:**Site Validation Level: II****Strategy: 4-225.1 Objective:** Erect Filter Fence

4-225-A Site Strategy - Chorro Creek**4-225-A**

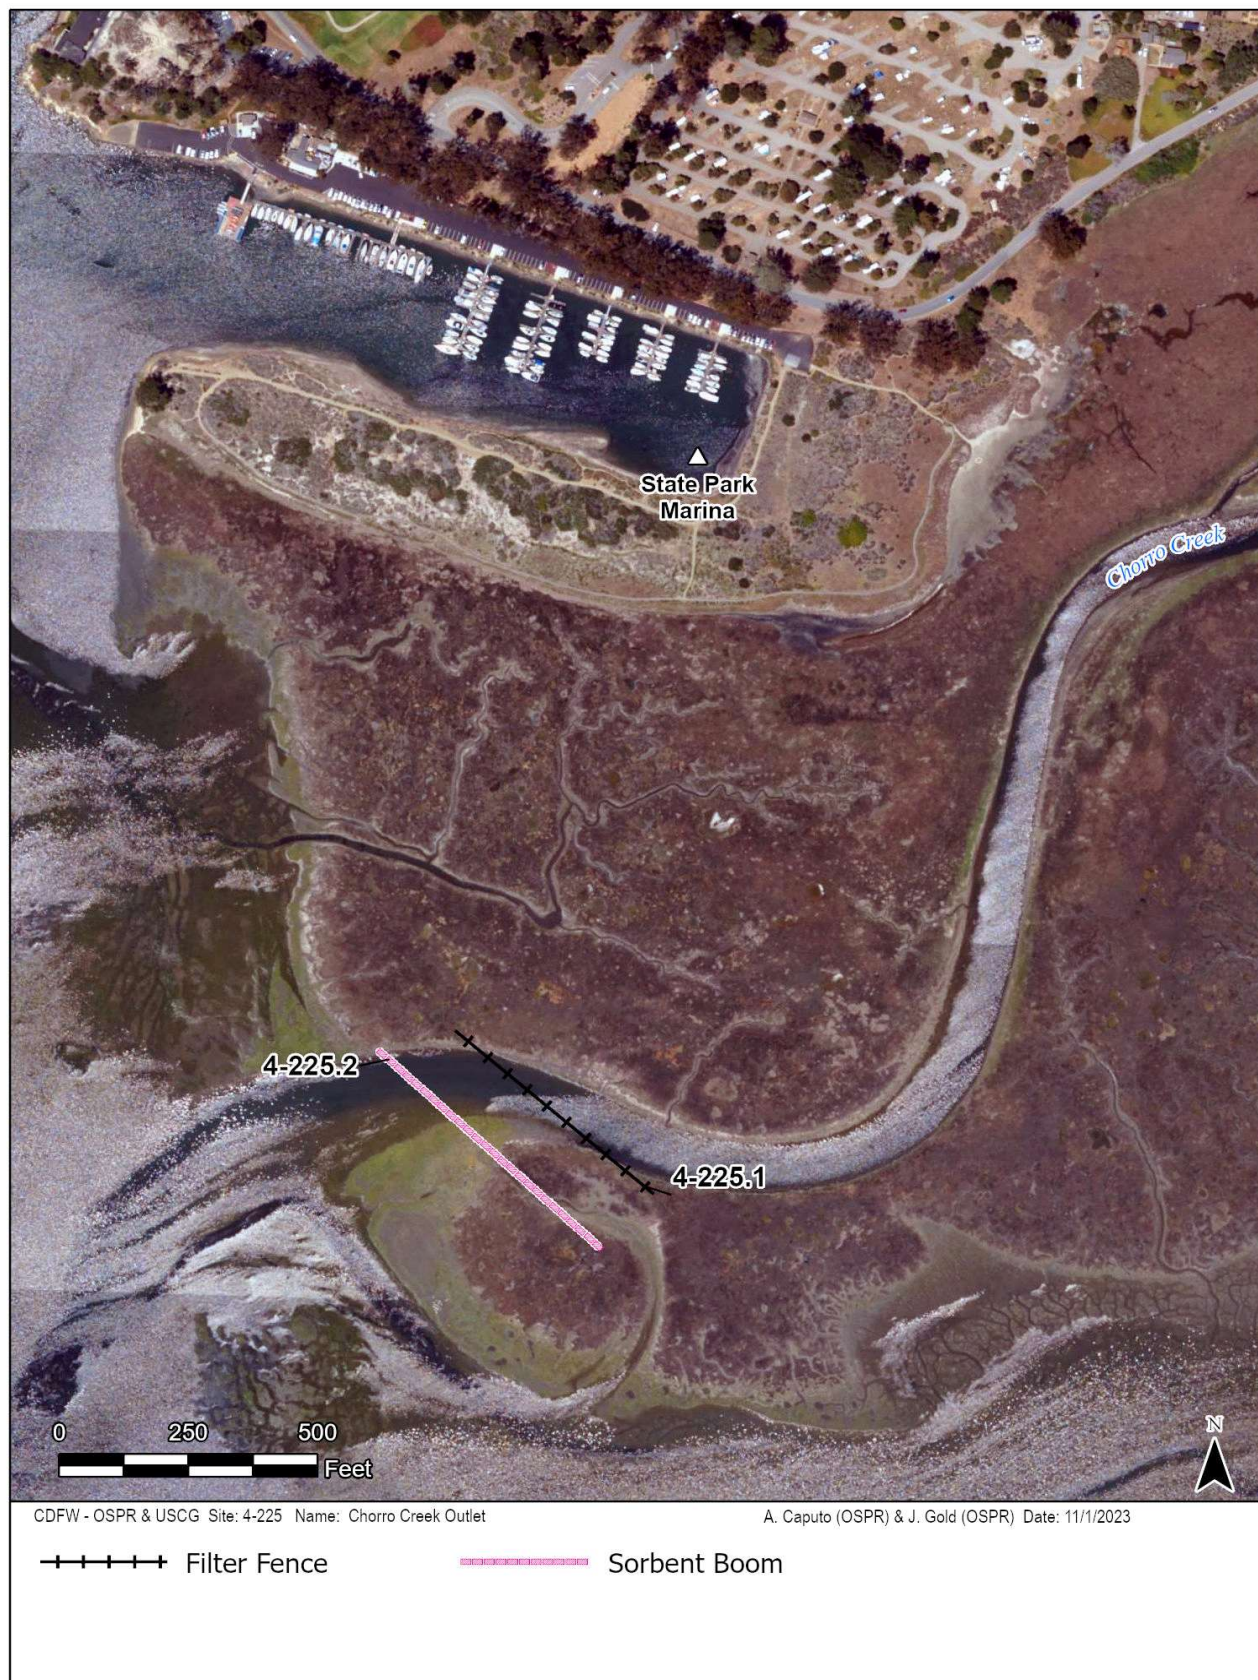
Strategy: Fencing/pompoms should be placed as close as possible, where the marsh vegetation (Pickleweed) ends and the mudflats begin; but tide height needs to be taken into account. Tend boom every tidal cycle. Chorro Creek Inlet can be accessed by walking along edge of mudflats at low tide in front of marsh vegetation which can be accessed by a hiking path at the south end of State Park Marina parking lot. If conditions allow, fence/pom-pom deployment and recovery to be done by only having one person position booming (and fence posts) to reduce disturbance. Check and maintain fencing for effectiveness.

Strategy: Place sorbent boom at creek mouth staked in place with fence posts. Boom should be placed as close as possible, where the marsh vegetation (Pickleweed) ends and the mudflats begin; but tide height needs to be taken into account. Tend boom every tidal cycle. Chorro Creek Inlet can be accessed by walking along edge of mudflats at low tide in front of marsh vegetation which can be accessed by a hiking path at the south end of State Park Marina parking lot. The number of personnel walking on the flats should be kept to a minimum. Check/maintain boom for effectiveness.
