County: Los Angeles*ACP Division/Segment:**NOAA Chart:* 18757*Map Book:**Decimal Degrees:* 33.4772 -118.5374**Site Description:**

Site Strategies:**Site Validation Level: 0**

CDFW - OSPR & USCG Site: 5-410 Name: Arrow Point - Catalina Island

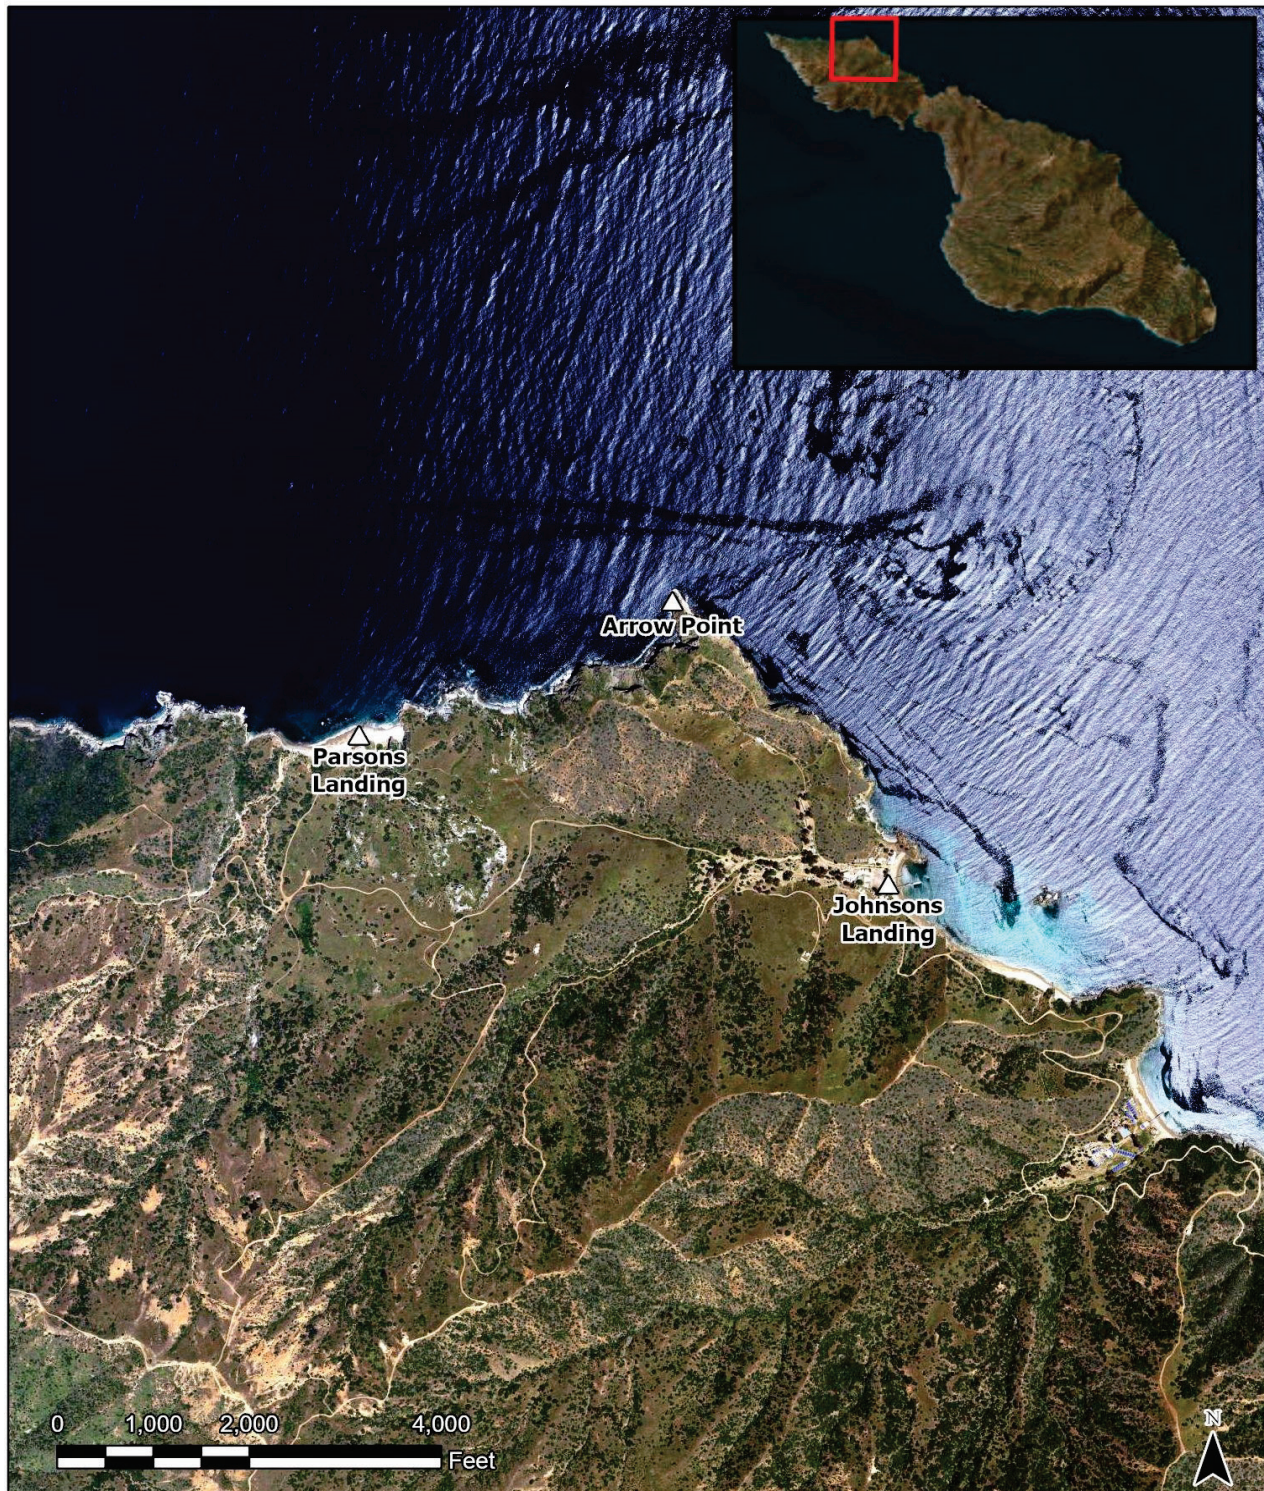
Strategy: 5-410.1 *Objective:* No Onsite Options: Consider Offshore Containment/Recovery/ART

Strategy: This site is difficult to protect. Mechanical shoreline protection techniques are not likely to be effective because of high wave energy and rocky conditions at the site.

**No shoreline strategies;
consider offshore strategies**

a) Recommended response strategy is on-water containment and recovery (e.g. towed boom arrays).

b) Pursue feasibility of alternative response technologies (e.g. dispersants and in-situ burning) to reduce the volume of oil reaching the site.
