Response Strategy Site: BNSF Maintenance Yard (CAJ-020)

Site Description and Field Notes							
River Width:	Site Location/Segment: CAJ-SR-A-003						
115 meters (377 feet)							
Gradient: Low Slow	Strategy/response will depend on water flow. There is a manmade structure on the southeast edge of the riverbank.						
	A roadway leads into the stream. Large staging area.						
Site Contact/s:							
	Vehicular Access: 4WD Pick-Up						
BNSF - (800) 832-5452	Recreational Use: N/A						
	Recreational Use: N/A						
UPRR - (888) 877-7267	Boat Launches: N/A						
	ESI Shoreline Type: 1B Exposed, solid man-made structures; 3A Fine to medium-grained sand; 4 Sandy bars and						
	gently sloping banks						
1

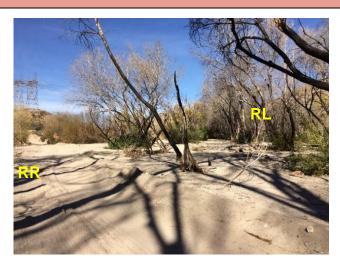
Upstream

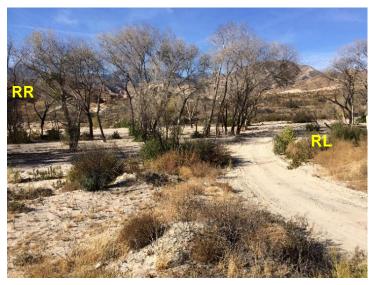
Straight Across

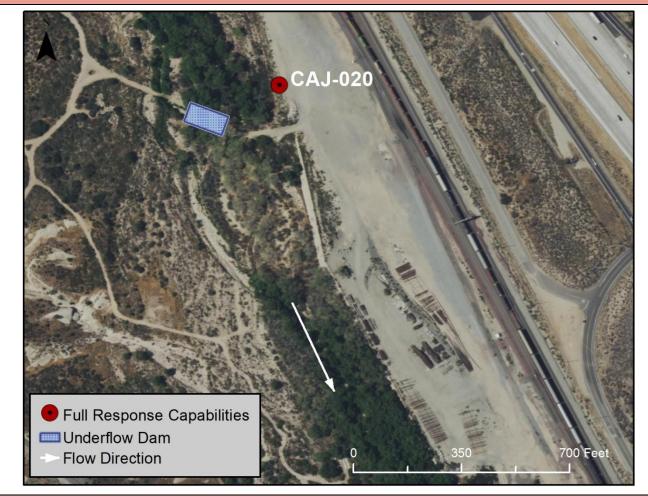
Response Strategy Map (overview)

Site Objectives: Earthen berm/underflow dam to prevent further movement of oil down gradient and collection of oil.

Table of Response Resources							
Туре	Sub-Type	Size	Unit	QTY - Unit	Special Equipment or Comments		
Backhoe					For earthen berm/underflow dam		
Piping					For earthen berm/underflow dam
