Response Strategy Site: East Side Calpella Road (RUS-110) Page						
Latitude: 39.23979 Longitude: -123.19902	Driving Directions					
Highway Postmile: N/A	From Hwy 101, take exit 555B onto Highway 20. Take a left on Road 144, t Calpella Rd. Take first turnout on the right, south of the Hwy 20 overpass.	hen take a left on Eastside				
Railroad Milepost: N/A						
Nearest Address:						
Thomas Guide #: 225/1A						
Cell Service: Yes

Response Strategy Site: East Side Calpella Road (RUS-110)

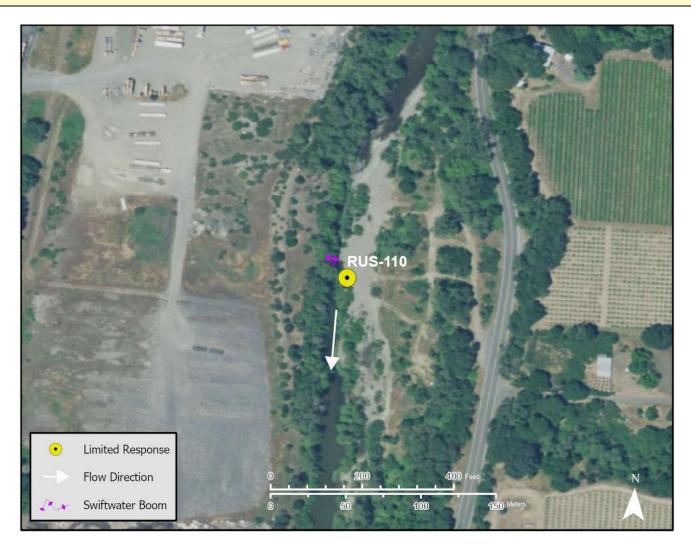
Response Strategy Map (overview)

Implementation: Boom would have to be deployed only at times of low flow. Crews may have to use waders to cross the river. Contact landowner for entrance to property.

Table of Response Resources						
Type	Sub-Type	Size	Unit	QTY - Unit	Special Equipment or Comments	
Boom	Swiftwater	8	inch	100 feet		
Anchor	Danforth	40	lb	1		
Stakes				3	Use shore-side stakes	
Personnel				4
