Response Strategy Site: Talmage Road Bridge (RUS-130)					
Latitude: 39.134562 Longitude: -123.186499	Driving Directions				
Highway Postmile: MEN 1.043	From Hwy 101 (in Ukiah), take exit 548A. Head east on CA-222 E pullout on the NW side of the bridge.	-/Talmage Rd for ~0.4mi. Park in a			
Railroad Milepost: N/A					
Nearest Address:					
Thomas Guide #: 308/7F					
Cell Service: Yes

Response Strategy Site: Talmage Road Bridge (RUS-130)

Site Description and Field Notes

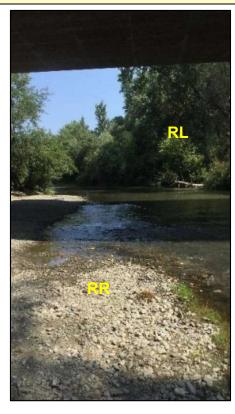
Upstream

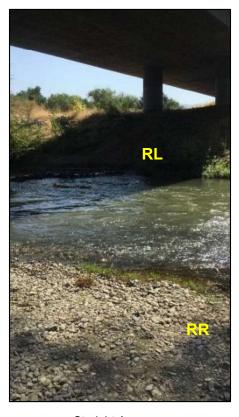
Straight Across

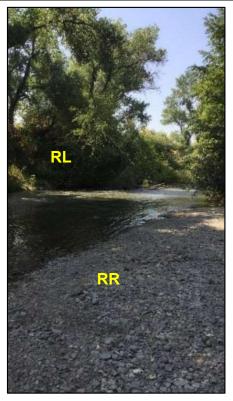
Downstream

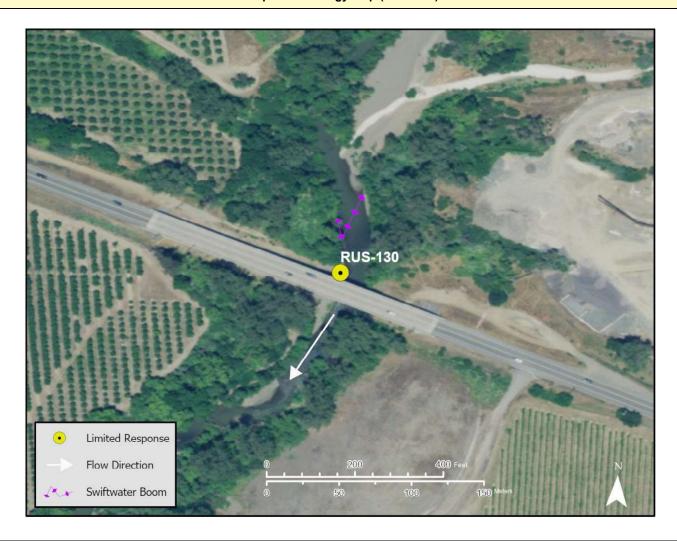
Response Strategy Map (overview)

Implementation: Under conditions that would allow for deployment of boom (low flow), set up a collection area on the west shore, north of the bridge. Wet conditions may make shoreline access difficult for response vehicles.

Table of Response Resources						
Туре	Sub-Type	Size	Unit	QTY - Unit	Special Equipment or Comments	
Boom	Swiftwater	8	inch	150 feet		
Anchors	Danforth	40	lb	2	Use 2 mid-stream anchors	
Stakes				3	Shore-side stakes	
Boat	skiff	14	ft	2		
Personnel				8	4 boat crew, 4 shoreside staff
