Site Description and Field Notes

Site Location/Segment: MAR-RV-C-010	Site Description and Field Notes: Temecula Creek at this site has a natural sediment bottom and banks and flows under Highway 79.			
Gradient: Low	River Width: 120 m (400 ft)	Vehicular Access? 4WD Pickup, 5000-gallon vac truck (dry season)	Recreational Use? None	Boat Launches: None
Site Contact/s:	Riverside Co. Flood Control No Fee Access Permit (951) 955-1200 M-F 0800-1700			
ESI Shoreline Type:	9B-Vegetated low banks

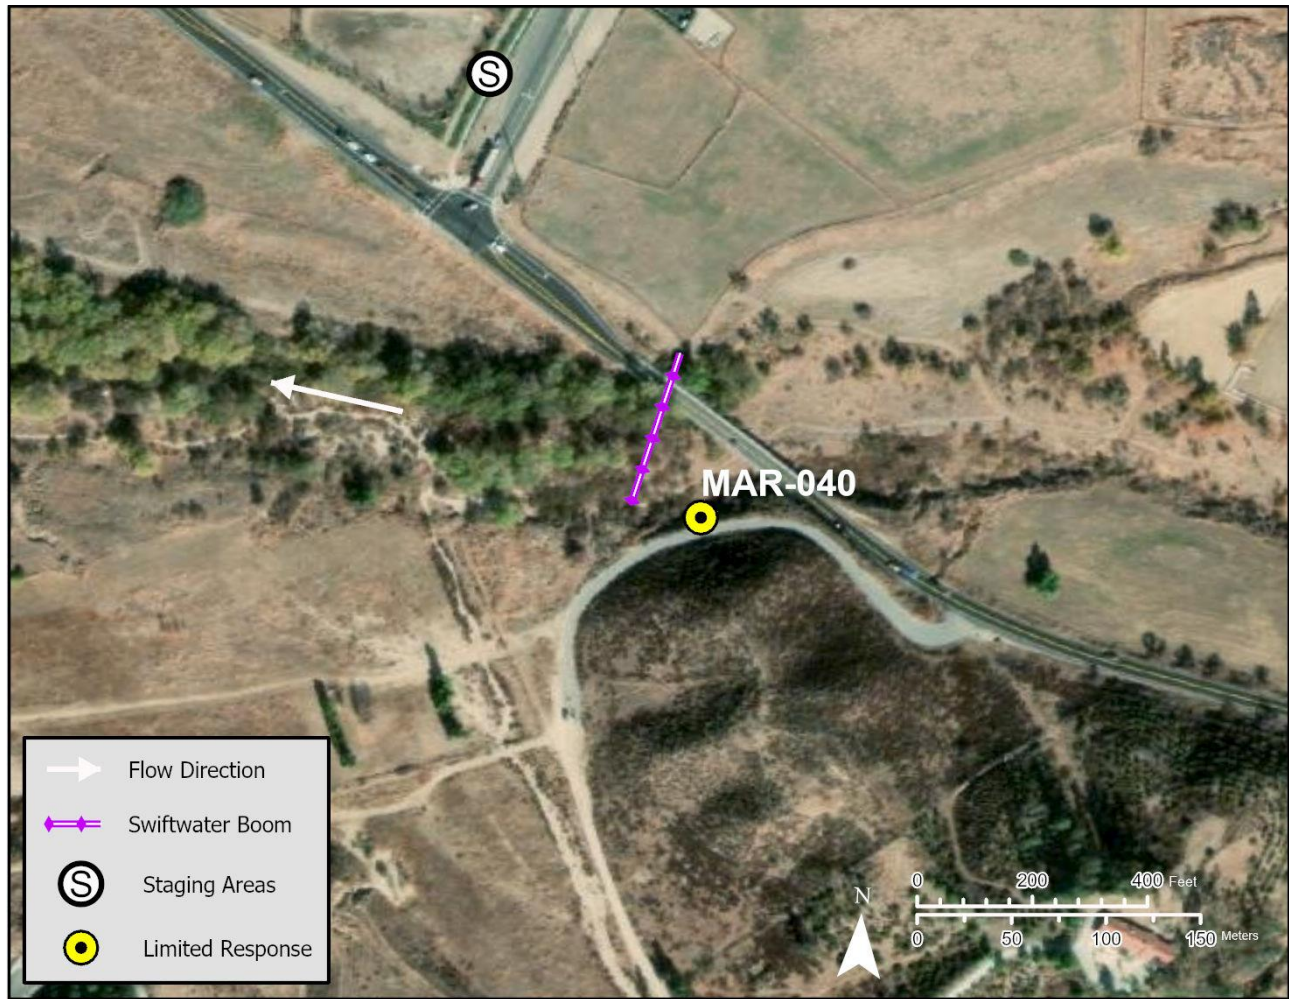
Response Strategy Map (overview)

Implementation: Deploy boom or excavators as needed according to conditions and weather forecast.

Type	Sub-Type	Size	Unit	QTY - Unit	Special Equipment or Comments
Boom		6	inch	200 feet	
Stakes				2 each	Secure boom in place
Backhoe					Excavate contaminated soil
Personnel				4
