Response Strategy Site: Temecula Creek at Redhawk Parkway (MAR-050)

Site Objectives: Containment and recovery

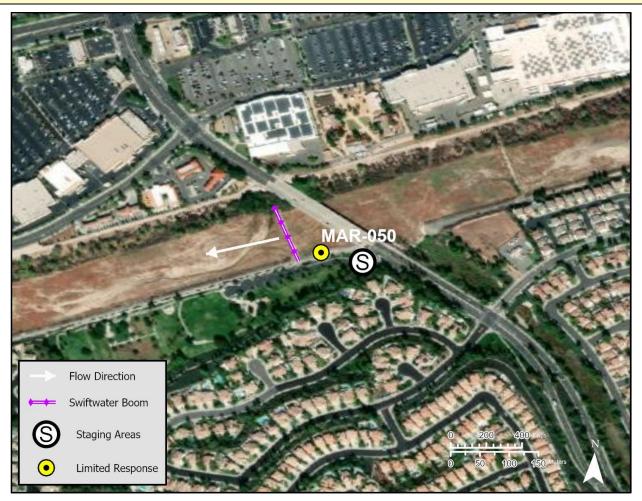
Response Strategy Map (overview)

Implementation: Deploy boom or excavators as needed according to conditions and weather forecast. Collect oil in a dry creek, if possible.

Table of Response Resources						
Туре	Sub-Type	Size	Unit	QTY - Unit	Special Equipment or Comments	
Boom		6	inch	400 feet		
Stakes				8 each	Secure boom in place	
Backhoe					Excavate contaminated soil	
Personnel				4
