Site Strategies:**Site Validation Level: II****Strategy: 6-120.1 Objective:** Build Berm

CDFW - OSPR & USCG Site: 6-120 Name: Las Flores Creek

A. Caputo (OSPR) & D. Lyons (OSPR) Date: 2/28/2023

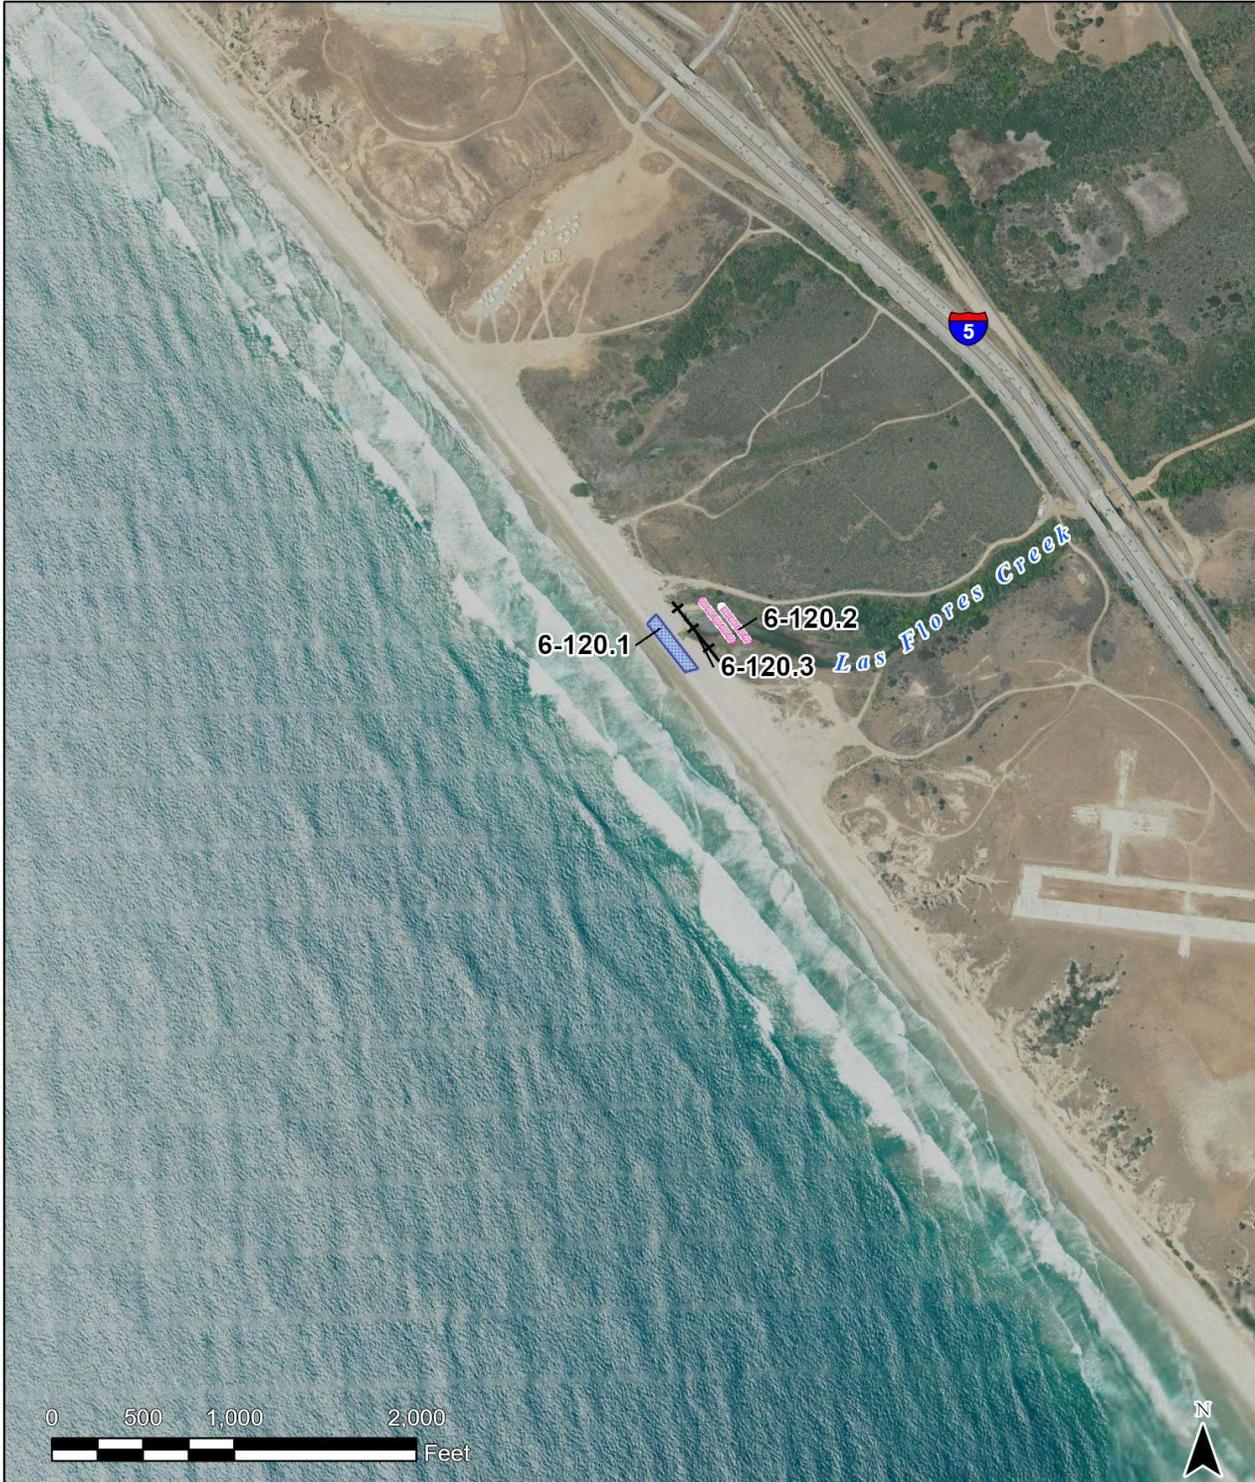
Strategy: Close the creek mouth to tidal flow by constructing a sand berm using borrowed sand from the lower beach face. Minimize sand relocation from the upper beach face.

Strategy: Deploy sorbent boom across the creek mouth to intercept floating oil. Plan to deploy two parallel layers of sorbent material if oil is threatening the wetland.

Strategy: Construct a filter fence across the creek mouth to prevent oil from entering the wetland on high tide.

- +++++ Filter Fence
- Sorbent Boom
- ▨ Dike or Berm
