6-450-A Site Summary - Chula Vista Wildlife Reserve Island**6-450-A****County:** San Diego**ACP Division/Segment:** SD - J - S005 SD - J - S006**NOAA Chart:** 18773**Map Book:** 1329 H3**Decimal Degrees:** 32.61366 -117.10971**Site Description:**

CDFW - OSPR & USCG Site: 6-450 Name: Chula Vista Wildlife Reserve Island

A. Caputo (OSPR) & D. Lyons (OSPR) Date: 2/28/2023

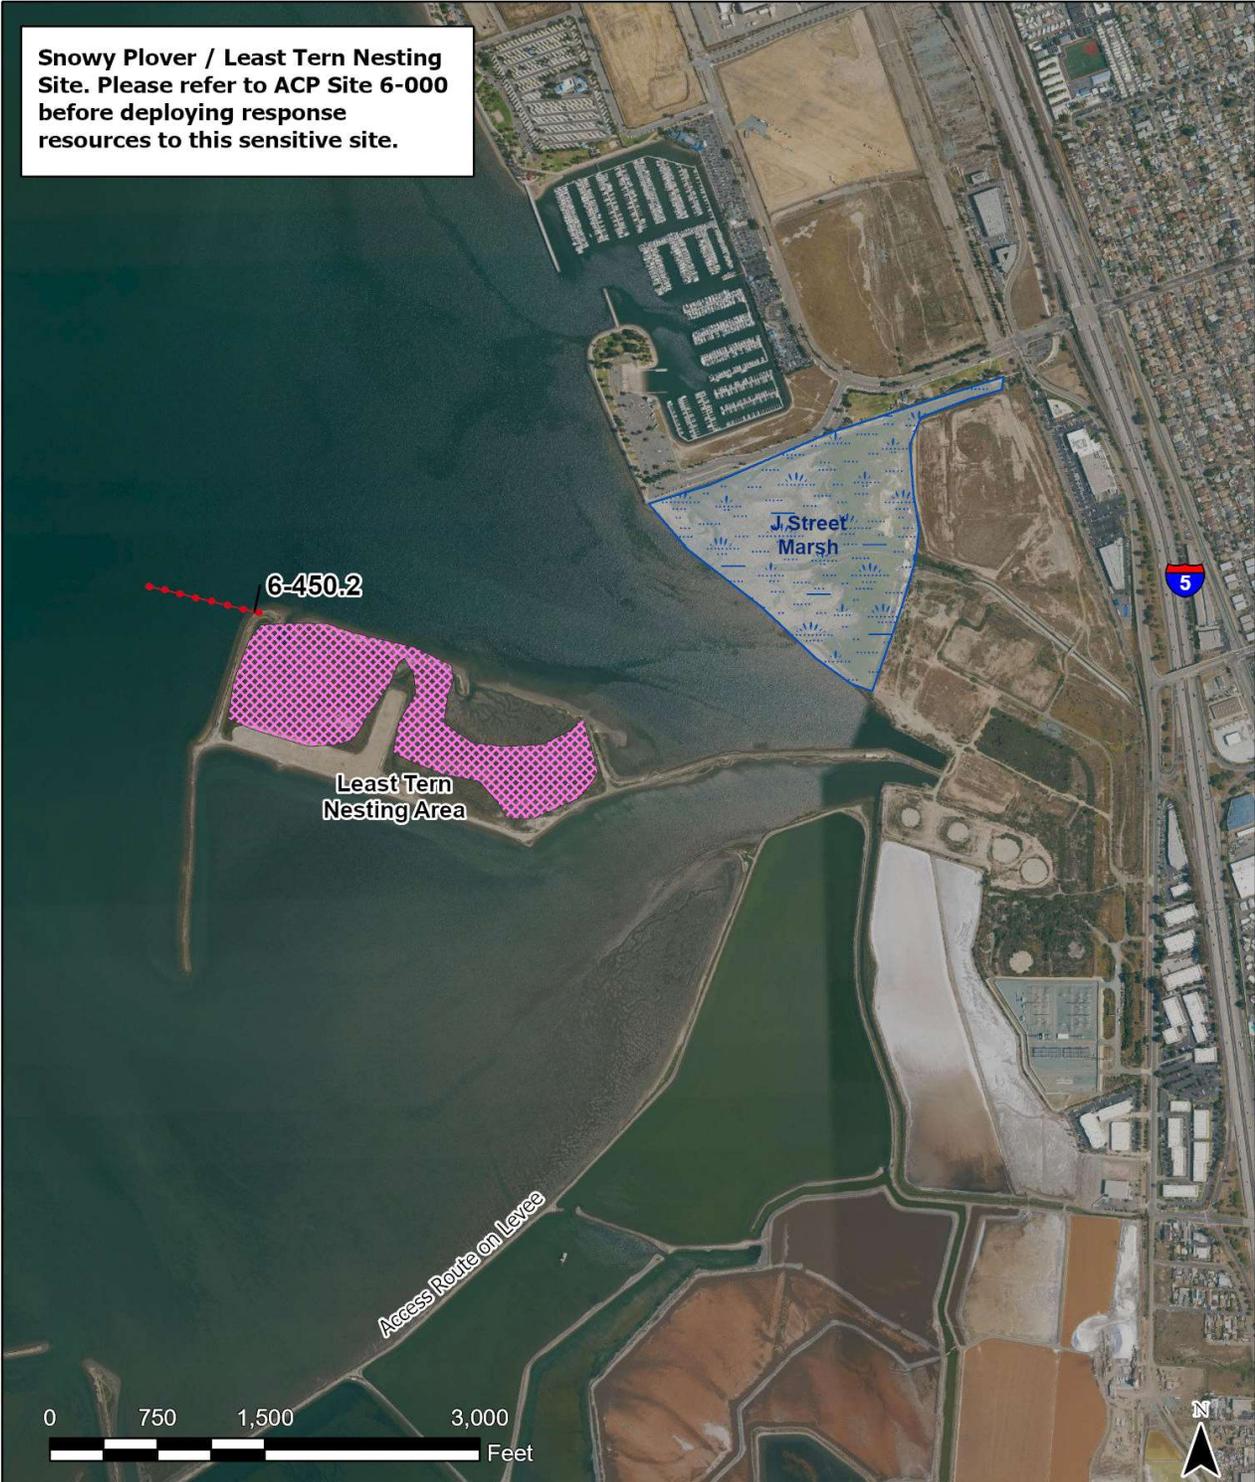
Strategy: 6-445.2 and 6-450.2: Deploy harbor boom from the south corner of the Chula Vista Marina seawall southward toward the northwest corner of the Chula Vista Wildlife Reserve. A 400 foot segment should be extended to the west from the CV Wildlife Reserve corner to serve as a containment area to allow recovery of deflected oil. Vacuum trucks can be staged at this corner for recovery operations.

Harbor Boom
-

Nesting Area
-

Marsh

Strategy: 6-450.1 Objective: See the Cross-Bay Boom Strategy 6-420.

Strategy: Collect oil off-site using boom sets or towed boom arrays to prevent oil migration to this site.
