Response Strategy Site: 138 Crossing (CAJ-010) Page 1 of				
Latitude: 34.311865 Longitude: -117.479304	Driving Directions			
Highway Post Mile: SDB-138-15	From North I-15, take the exit for Hwy.138, turn left and cross over the freeway, turn right on Cajon Blvd, directly after Union 76 station. Small staging area.			
Railroad Milepost: N/A	From South I-15 take the exit for Hwy.138, keep right off the freeway turn right on Cajon Blvd, directly after Union 76 station. Small staging area.			
Nearest Address and Thomas Guide #: 14757 State Hwy. 138, West Cajon Valley				
4734 C-1				
Cell Service: Yes

Response Strategy Site: 138 Crossing (CAJ-010)

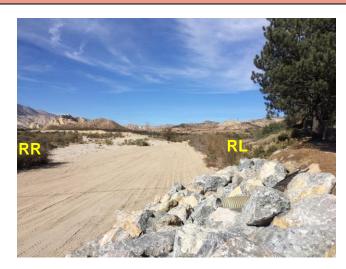
Upstream

Downstream

Straight Across

RR = River Right RL = River Left

Photo Date: 12/28/2017

Access down riprap side on east side, dirt embankment on the west.

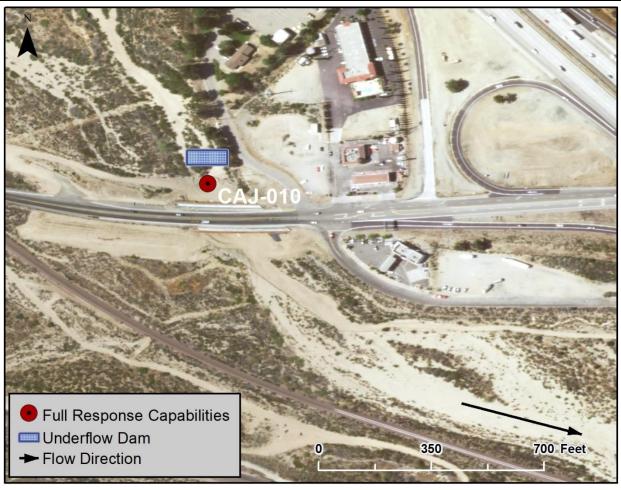
Response Strategy Map (overview)

Site Objectives: Earthen berm/underflow dam to prevent further movement of oil down gradient and collection of oil.

Implementation: Minimize ingress and egress routes through vegetation to prevent erosion and disturbance of the surrounding ecosystem. Weather and water flows will determine specific site strategies.

Table of Response Resources						
Туре	Sub-Type	Size	Unit	QTY - Unit	Special Equipment or Comments	
Backhoe					For earthen berm/underflow dam	
Piping					For earthen berm/underflow dam
