#### **Site Description and Field Notes**

Site Location/Segment: SAC-SA-A-010

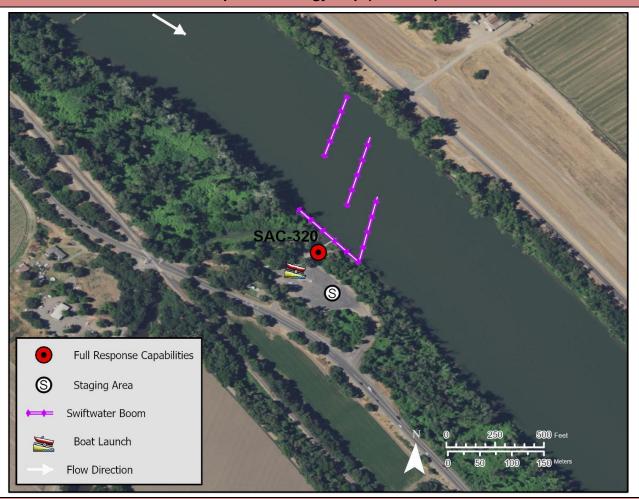
# **Response Strategy Map (overview)**

**Implementation:** Cascade 3 – 400-foot legs of boom toward boat launch for collection; use 300 feet of boom to line shoreline and use to collect product.
